**Acciona Energy Australia Global Pty Ltd**

Mortlake South Wind Farm Transmission Line  
Traffic Management Plan  
Final Report Version 3

**INITIAL DILAPIDATION REPORT**

## MORTLAKE SOUTH WIND FARM LOCAL UPGRADED ROADS ORIGINAL CONDITION DILAPIDATION REPORT

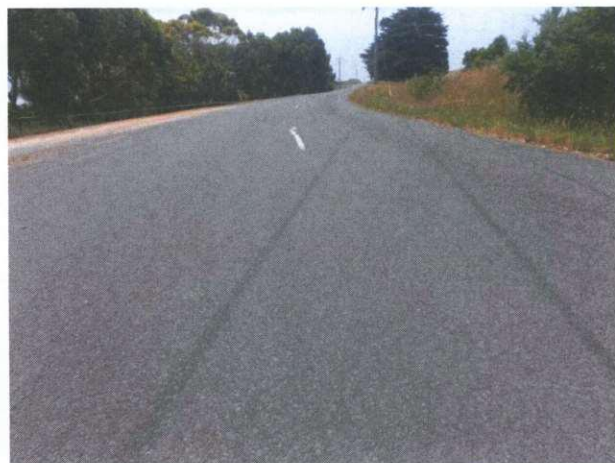
**Photo 12** 'GOPR7029.JPG' - (-38.4133869, 142.5842975)

-  
Guide posts damaged through curve

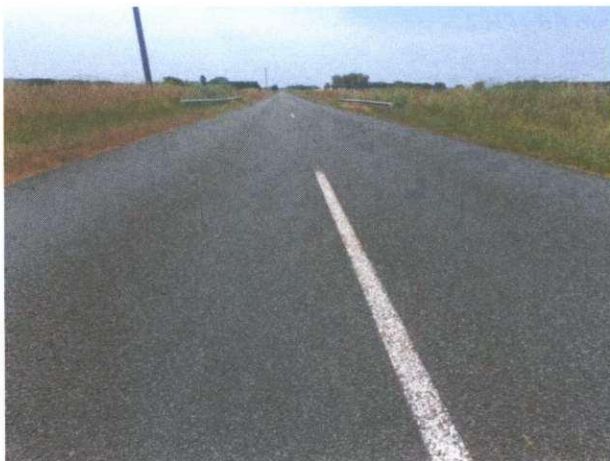
**Photo 18** 'GOPR7035.JPG' - (-38.4066423, 142.5852517)

-  
Guide post missing

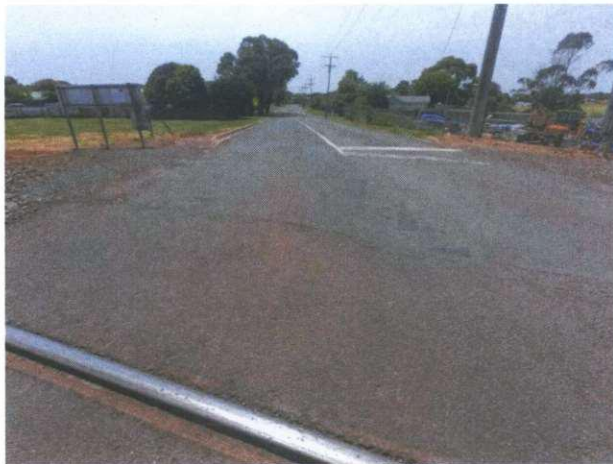
Photo 35 'GOPR7052.JPG' - (-38.3891927, 142.5940665)

-  
General view at approach to railway line, Seal moderately flush and lateral crack across pavement 1 meter before railway line.

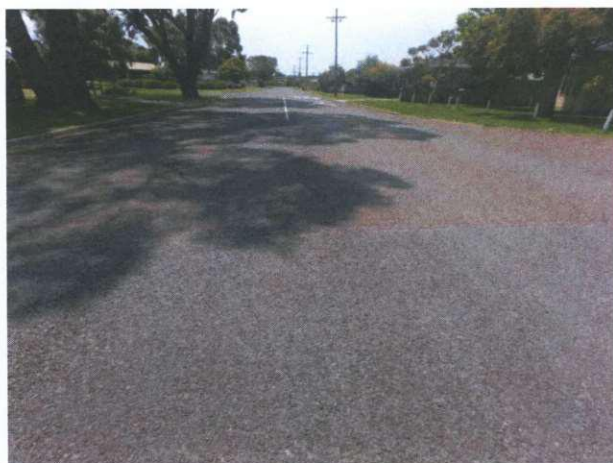
Photo 36 'GOPR7053.JPG' - (-38.3886429, 142.5938653)

-  
General view at departure from railway line with shove in centre of northbound lane and crocodile cracking in southbound lane

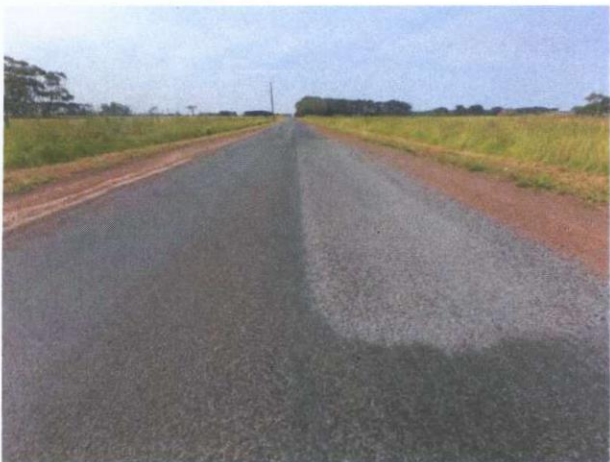
**Photo 48** 'GOPR7066.JPG' - (-38.2561076, 142.8891671)

Recent patch east side, crocodile cracking west side.

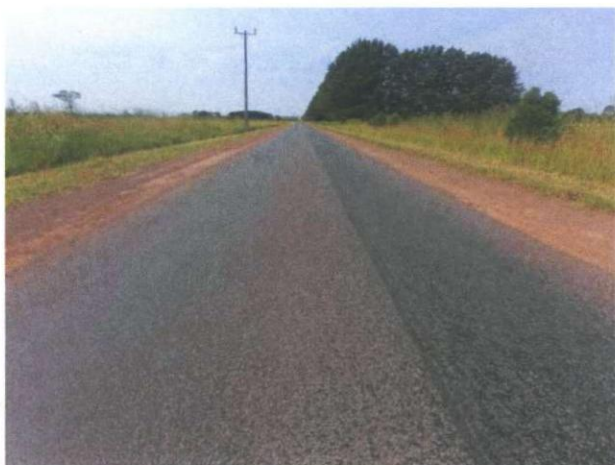
**Photo 50** 'GOPR7068.JPG' - (-38.2533764, 142.8896849)

Recent patch west side, some crocodile cracking east side.

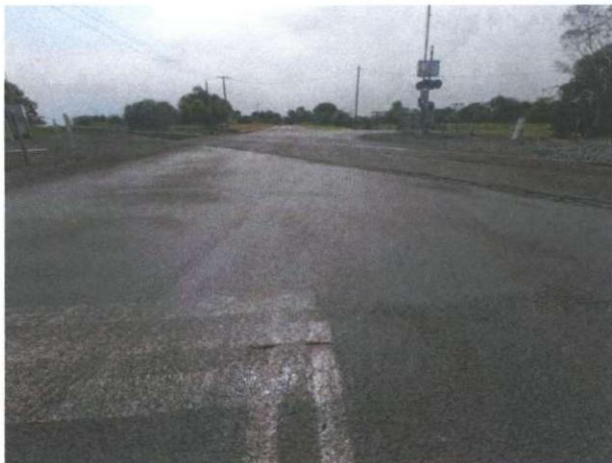
**Photo 62** 'GOPR7080.JPG' - (-38.2370418, 142.8931486)

-  
View at Terang-Framlingham Rd Intersection.  
Crocodile cracking through left turn of Noogee Rd

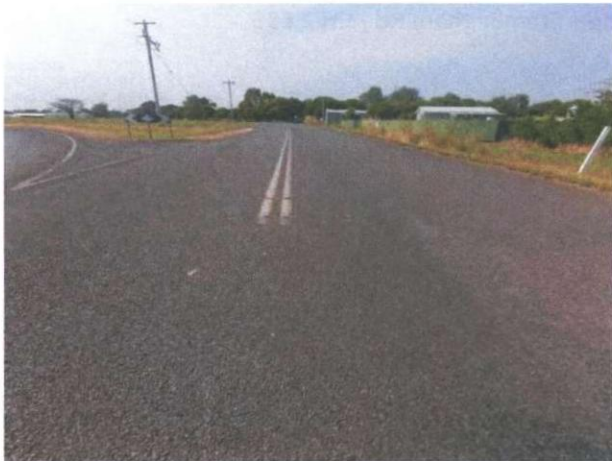
**Photo 68** 'GOPR7086.JPG' - (-38.2353165, 142.8879601)

-  
Extensive crocodile cracking in curve.

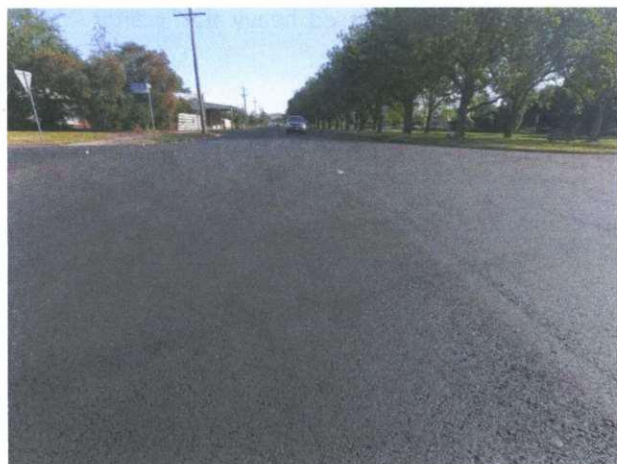
**Photo 94** 'GOPR7115.JPG' - (-38.2403083, 142.9202885)

-  
Crocodile cracking through intersection particularly  
east bound lane with seal breaking out

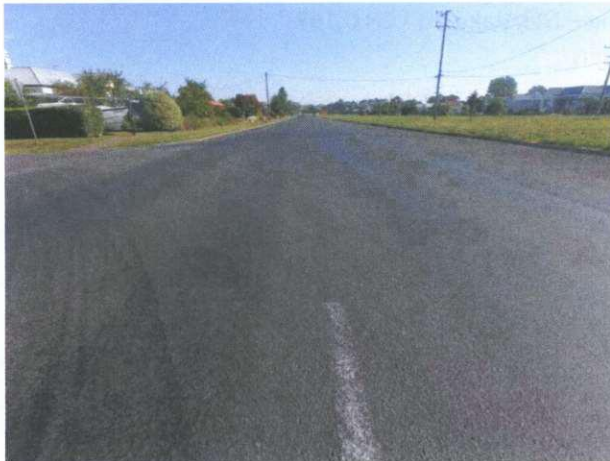
**Photo 99** 'GOPR7120.JPG' - (-38.2368247, 142.9210009)

General view of railway crossing, crocodile cracking both sides

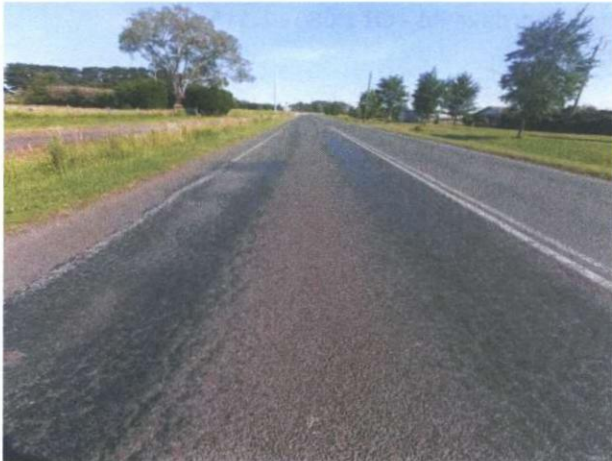
**Photo 110** 'GOPR7131.JPG' - (-38.2297163, 142.9213487)

-  
Shoving, rutting, seal breaking out, and edge line tracking southbound lane. Crocodile cracking both lanes.

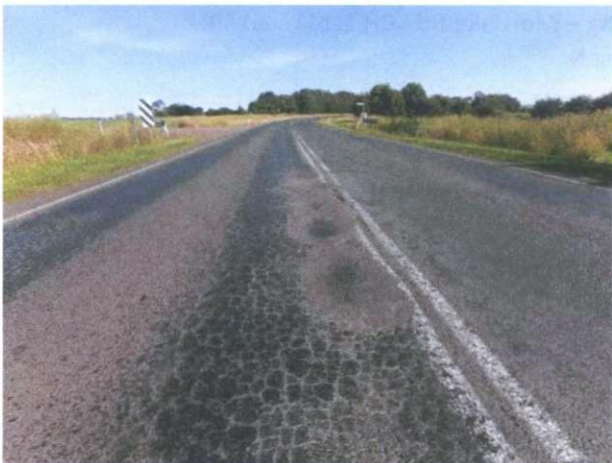
**Photo 111** 'GOPR7132.JPG' - (-38.2282552, 142.9202398)

-  
Crocodile cracking, rutting and flushing to north bound lane

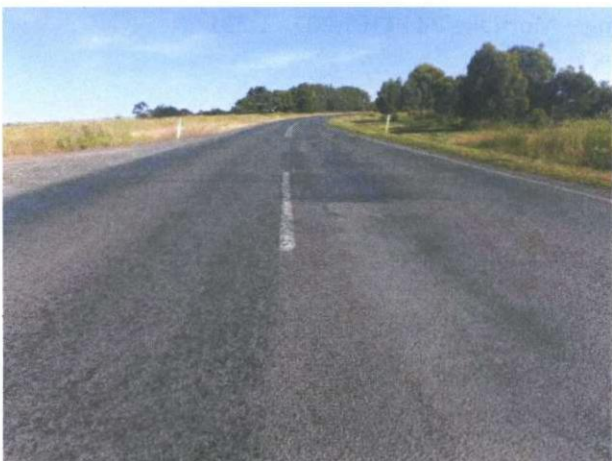
**Photo 112** 'GOPR7133.JPG' - (-38.2280671, 142.9200999)

-  
Crocodile cracking, rutting, flushing and seal breaking out, north bound lane.

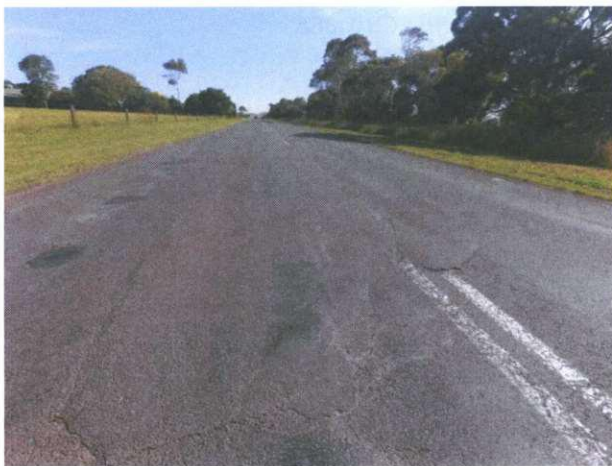
**Photo 117** 'GOPR7138.JPG' - (-38.2254094, 142.9197836)

-  
General view of pavement with flushing, crocodile cracking, rutting and filled potholes.

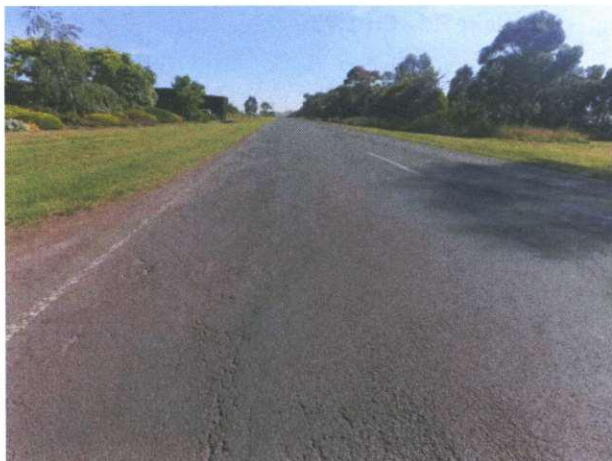
**Photo 118** 'GOPR7139.JPG' - (-38.2245218, 142.9199469)

-  
General view of pavement with flushing, crocodile cracking, rutting and filled potholes.

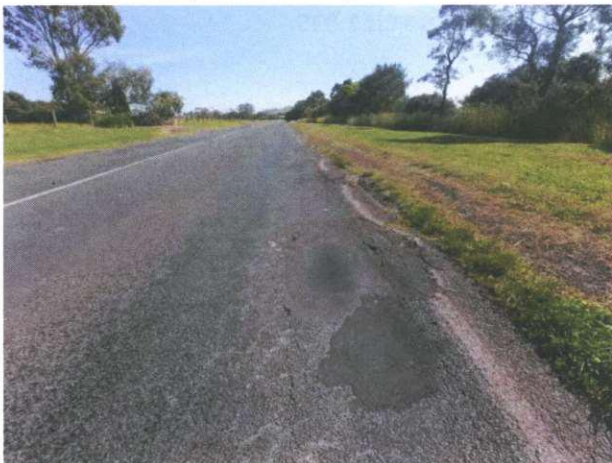
**Photo 123** 'GOPR7144.JPG' - (-38.2217881, 142.9205325)

-  
General view of pavement with flushing, crocodile cracking, rutting, filled potholes and seal breaking out both lanes.

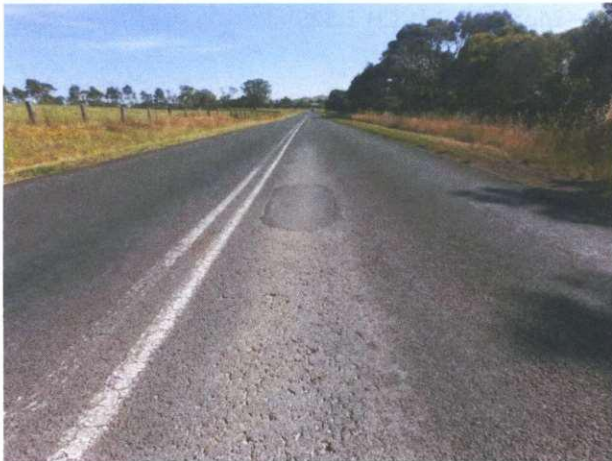
**Photo 129** 'GOPR7150.JPG' - (-38.220292, 142.9207783)

-  
Edge of seal breaking out, crocodile cracking and flushing to south bound lane

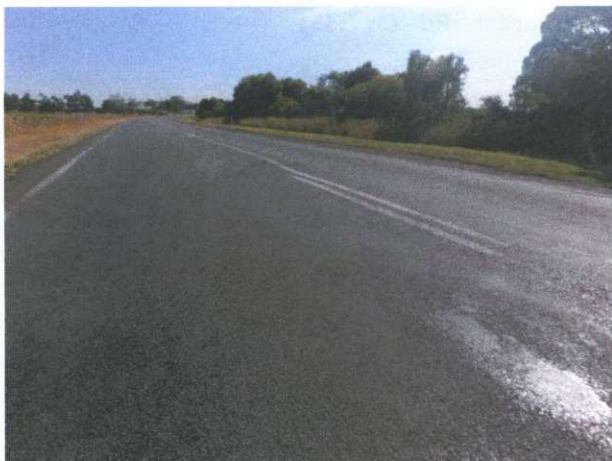
**Photo 130** 'GOPR7151.JPG' - (-38.218824, 142.9210262)

-  
Patched pothole with crocodile cracking and minor rutting, south bound lane

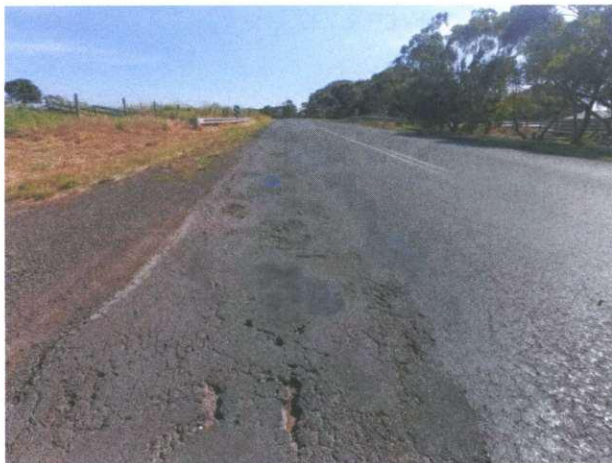
**Photo 135** 'GOPR7156.JPG' - (-38.2160052, 142.9221702)

-  
General view of Le Couteur Road with crocodile cracking and filled potholes to north bound lane

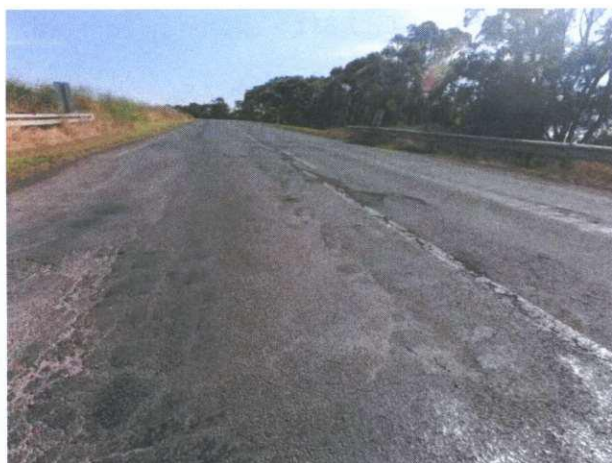
**Photo 136** 'GOPR7157.JPG' - (-38.2158459, 142.9222563)

-  
Rutting, flushing, shoving, crocodile cracking filled potholes and seal breaking out north bound lane

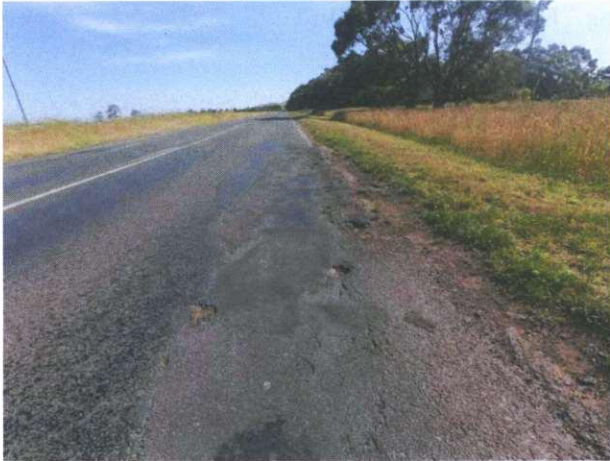
**Photo 141** 'GOPR7162.JPG' - (-38.2127633, 142.9232917)

-  
Rutting, flushing, shoving, crocodile cracking filled  
potholes and seal breaking out south bound lane

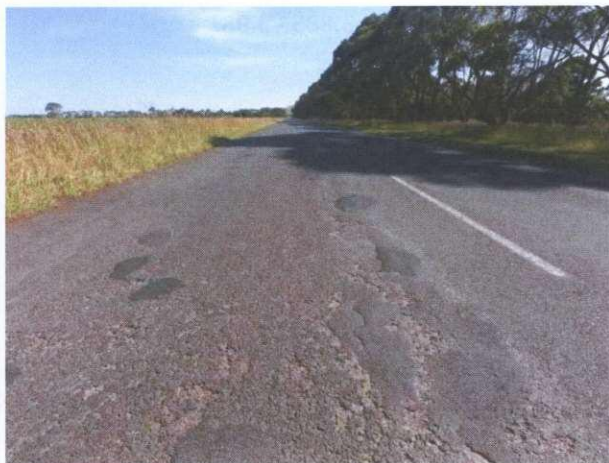
**Photo 144** 'GOPR7165.JPG' - (-38.2105033, 142.9236574)

-  
Filled potholes, crocodile cracking and seal breaking  
out north bound lane

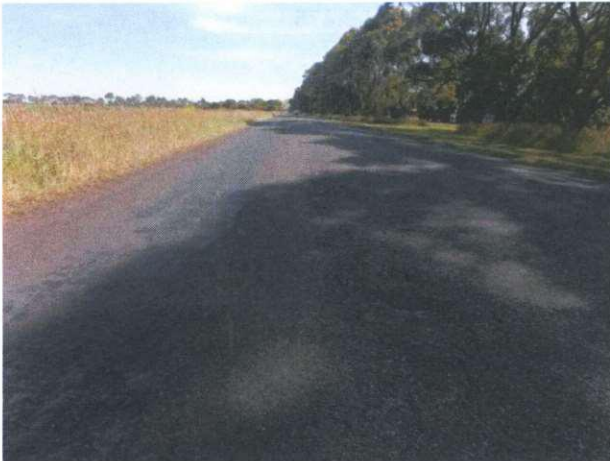
Photo 146 'GOPR7167.JPG' - (-38.2095775, 142.9238238)

-  
Filled potholes, crocodile cracking and seal breaking  
out north bound lane

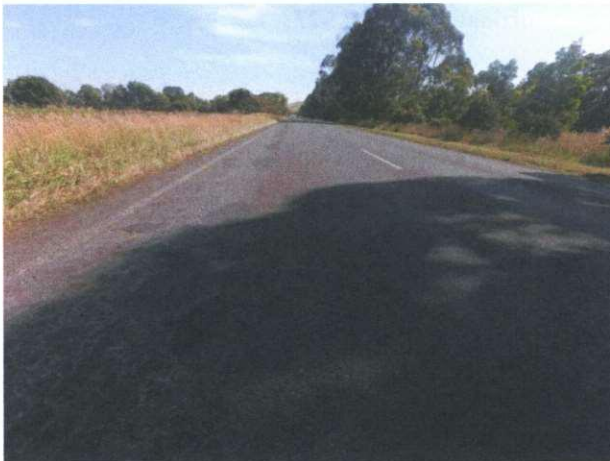
Photo 147 'GOPR7168.JPG' - (-38.2073072, 142.924265)

Filled potholes, flushing, crocodile cracking and seal breaking out north bound lane

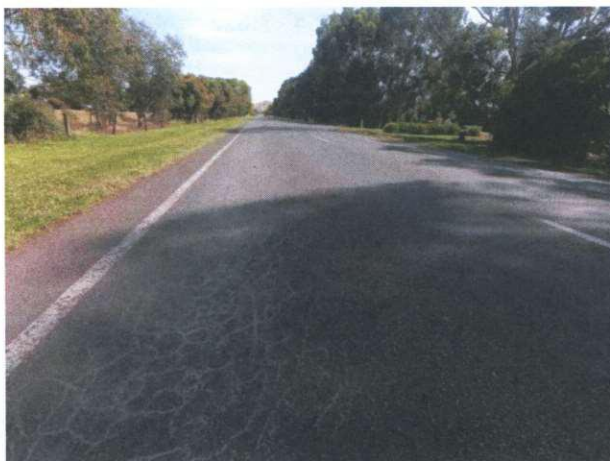
Photo 148 'GOPR7169.JPG' - (-38.206342, 142.9244367)

Filled potholes, crocodile cracking and seal breaking out, north bound lane and to a lesser extent in south bound lane

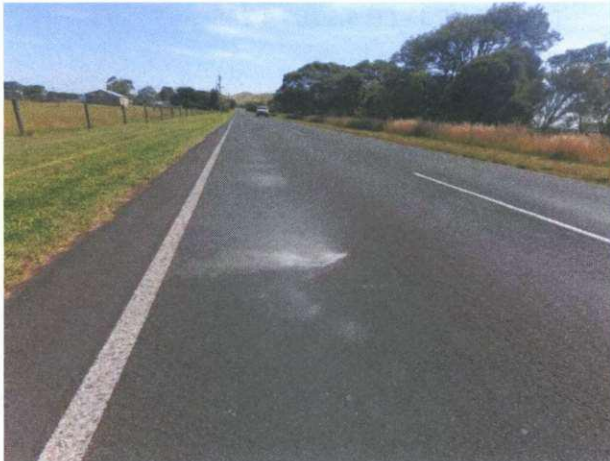
**Photo 152** 'GOPR7173.JPG' - (-38.2026985, 142.925103)

- Lateral crack in north bound lane typical of segment

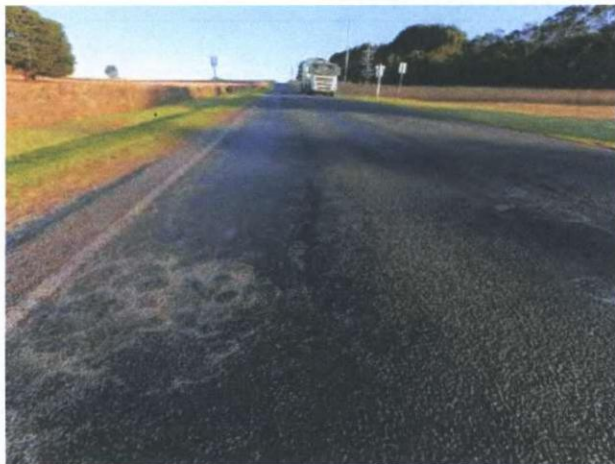
**Photo 4** 'GOPR7843.JPG' - (-38.18704, 142.92587)

Edge shove and crocodile cracking through all wheel paths

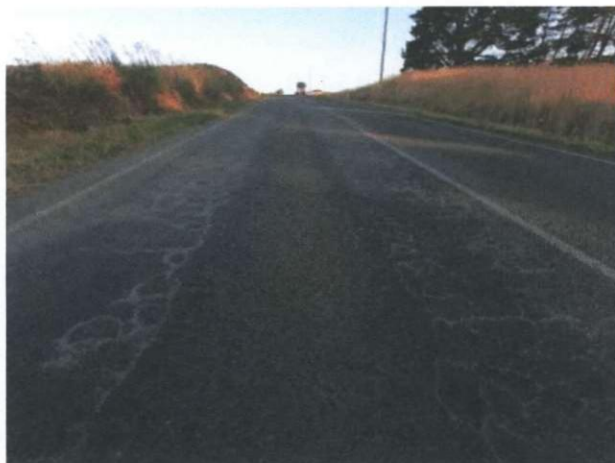
**Photo 5** 'GOPR7844.JPG' - (-38.18428, 142.92475)

Rutting and crocodile cracking. Seal flush.

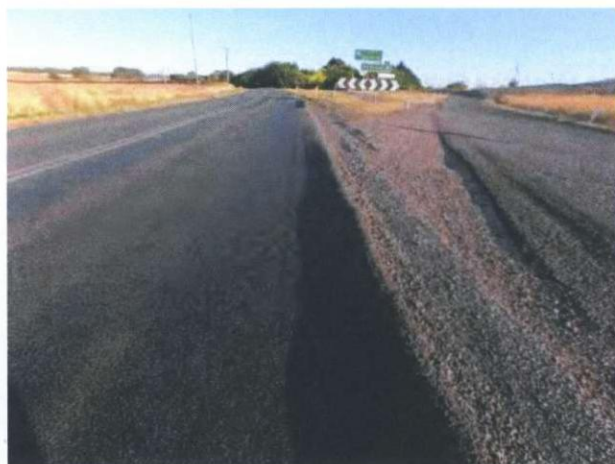
**Photo 6** 'GOPR7845.JPG' - (-38.1747, 142.92093)

Typical view of crocodile cracking through segment.

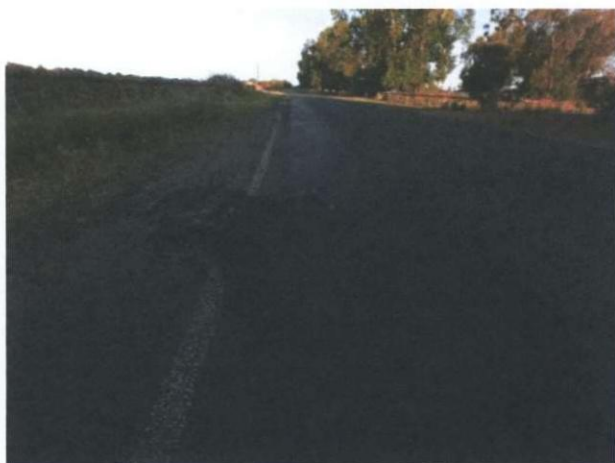
Photo 12 'GOPR7851.JPG' - (-38.15736, 142.89664)

Potholes patched but shoving out, crocodile cracking north bound lane

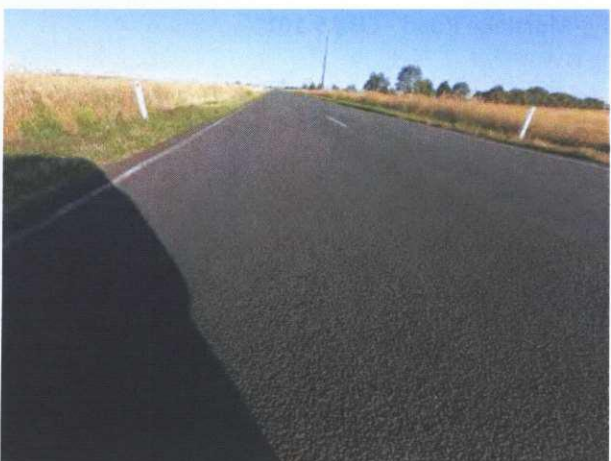
**Photo 21** 'GOPR7860.JPG' - (-38.14183, 142.87588)

Rutting and crocodile cracking in south bound lane

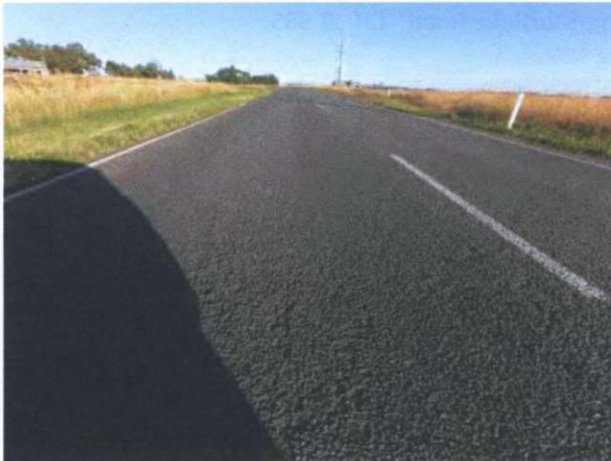
**Photo 22** 'GOPR7861.JPG' - (-38.13485, 142.86679)

Guide post replaced NE side of road.

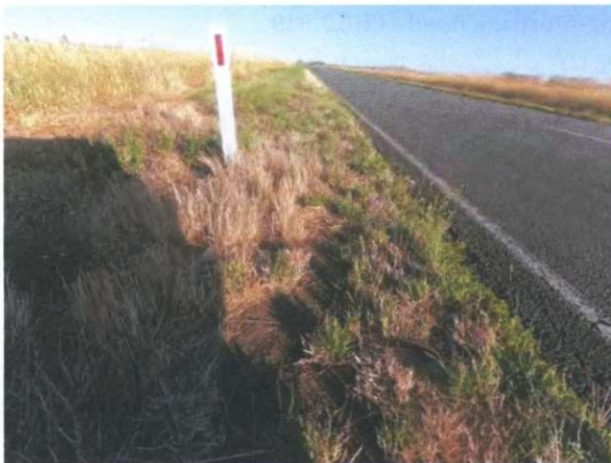
**Photo 23** 'GOPR7862.JPG' - (-38.13095, 142.86198)

Guide post damaged SW side of road

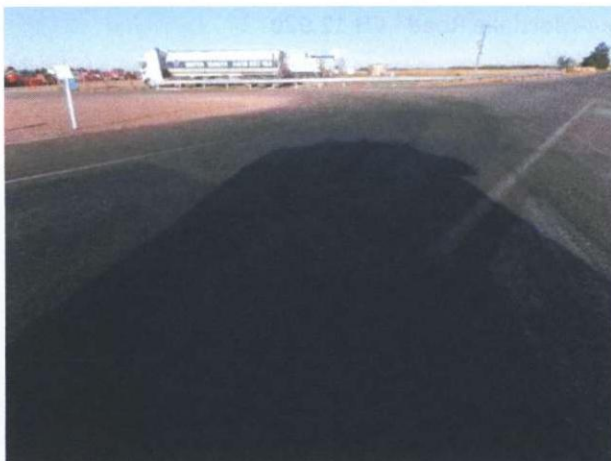
**Photo 24** 'GOPR7863.JPG' - (-38.12751, 142.85788)

Guide post replaced south west side of road

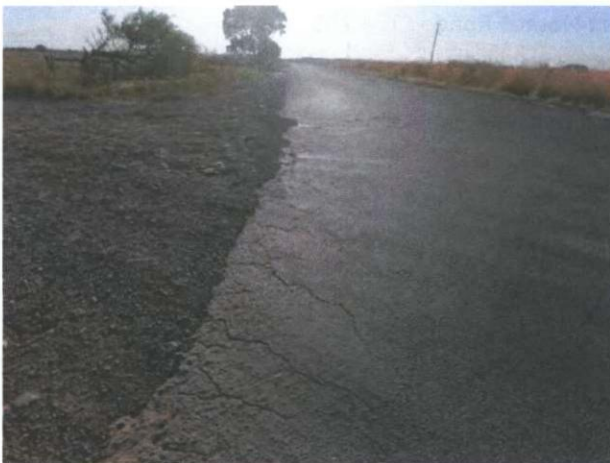
Photo 29 'GOPR7868.JPG' - (-38.19515, 142.82967)

Crocodile cracking through long heavy patch.

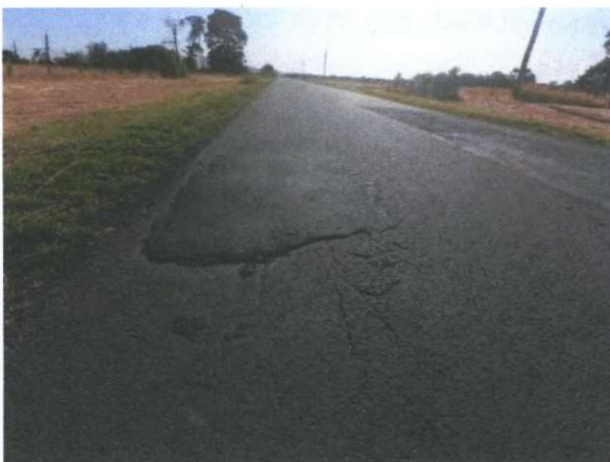
**Photo 42** 'GOPR7881.JPG' - (-38.19656, 142.8672)

Crocodile cracking and patch breaking up

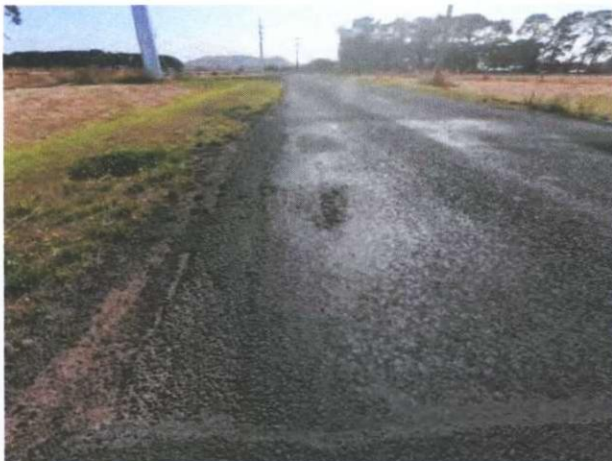
Photo 48 'GOPR7887.JPG' - (-38.19371, 142.88207)

Recent patch repair. Seal beyond thin and breaking out.

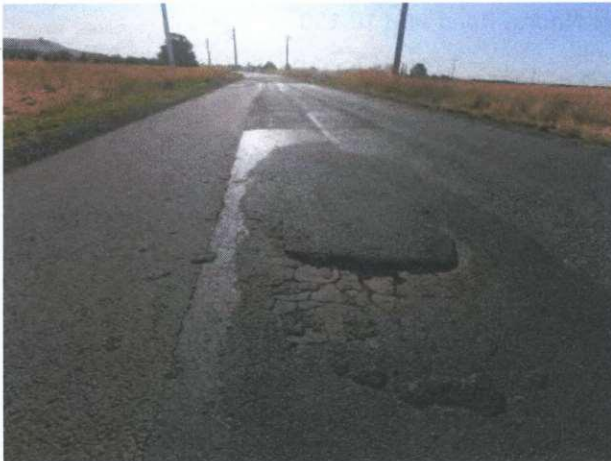
**Photo 52** 'GOPR7891.JPG' - (-38.19484, 142.89608)

Crocodile cracking around recent patches.

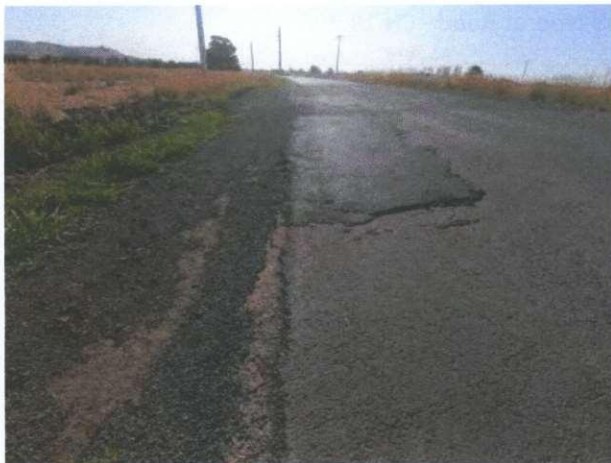
**Photo 53** 'GOPR7892.JPG' - (-38.19482, 142.8963)

Recent patch repaired and beginning to break out.

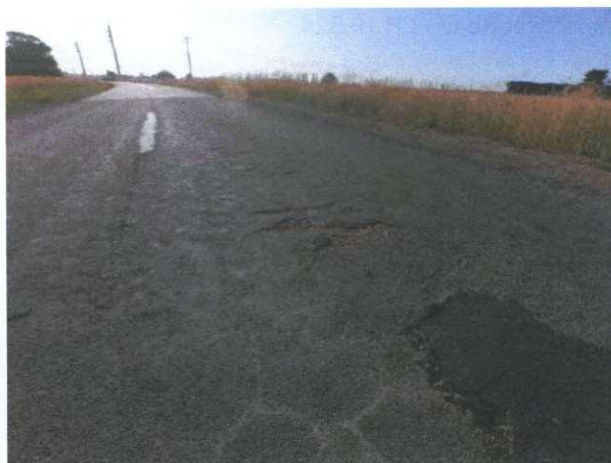
**Photo 54** 'GOPR7893.JPG' - (-38.19487, 142.89642)

Shoving repaired with asphalt. Spoil dumped in table drain.

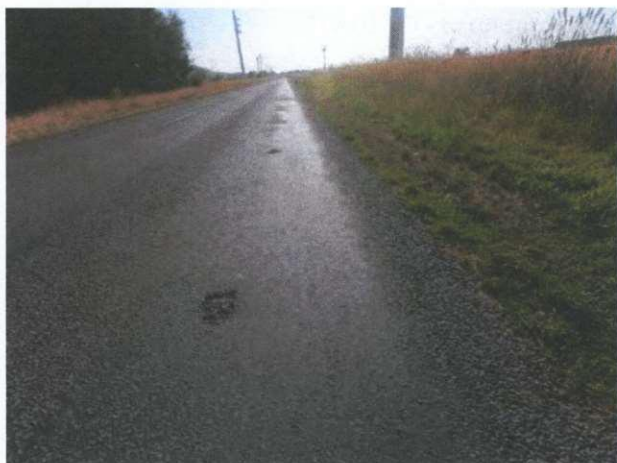
**Photo 58** 'GOPR7897.JPG' - (-38.19468, 142.89949)

Edge break out repaired.

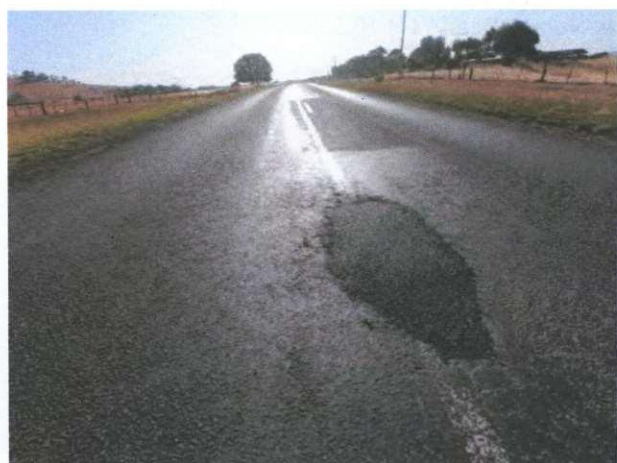
**Photo 60** 'GOPR7899.JPG' - (-38.19193, 142.9173)

Recent patches breaking out have been repaired.

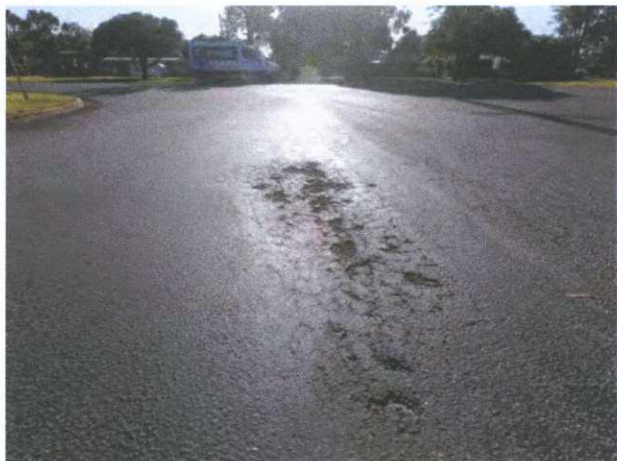
**Sisters-Noorat Road - CH 13.107**

Seal breaking out and crocodile cracking.
