Mortlake South Wind Farm Transmission Line

Traffic Management Plan

Final Report Version 3

18 February 2020

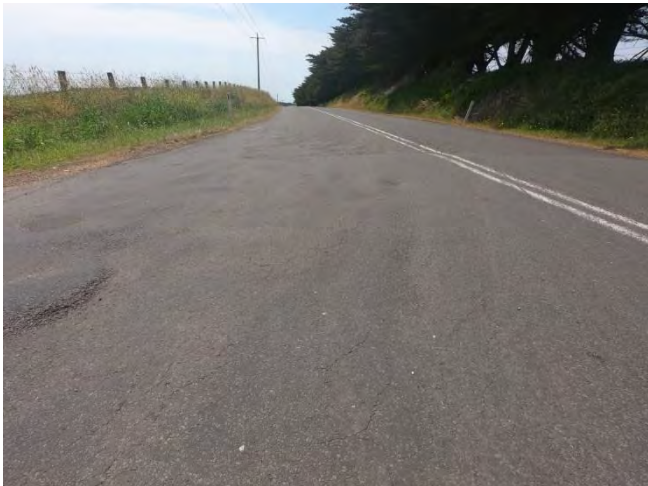
Tooram Rd - CH 1.92

-
Crocodile Cracking and shoving through left turn at
intersection.

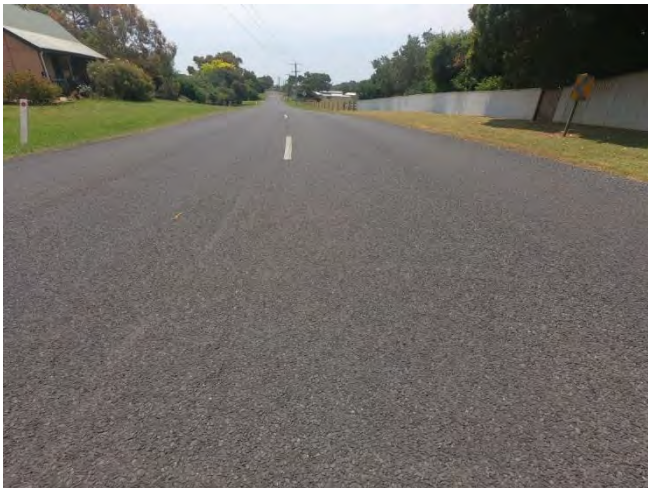
Tooram Rd - CH 4.436

-
Guidepost missing

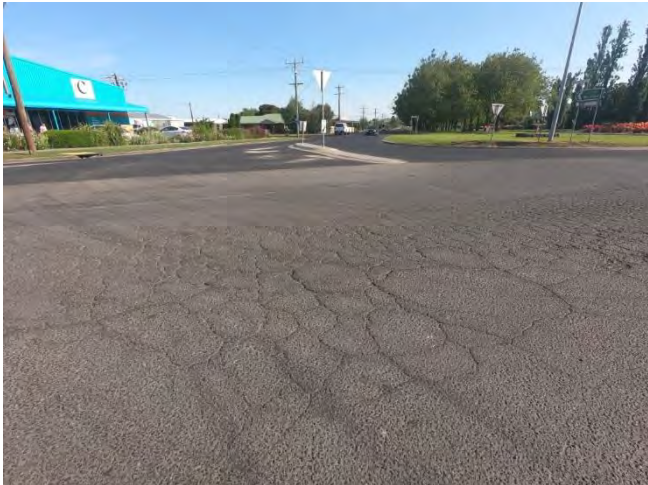
Terang – Mortlake Rd - CH 0
Facing N

- Crocodile cracking through intersection particularly east bound lane with seal breaking out

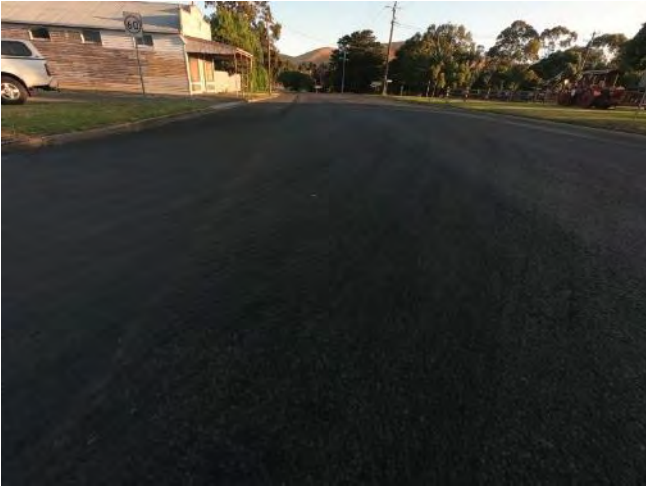
Terang-Mortlake Road - CH 5.567

Crocodile cracking through intersection

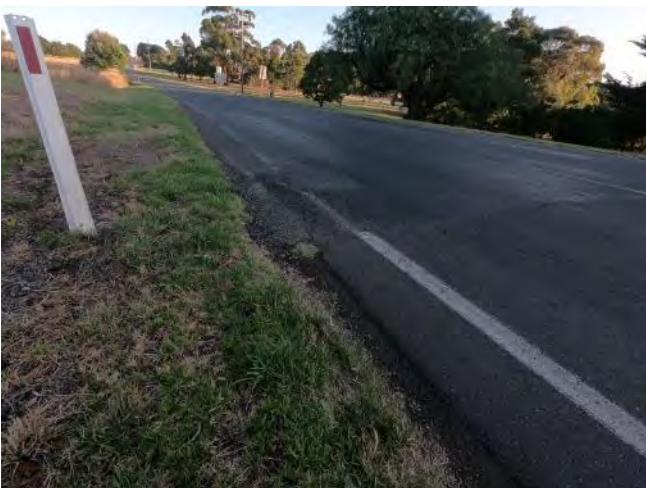
Terang-Mortlake Road - CH 5.689

Shoving of patch on west side, guide post missing on east side.

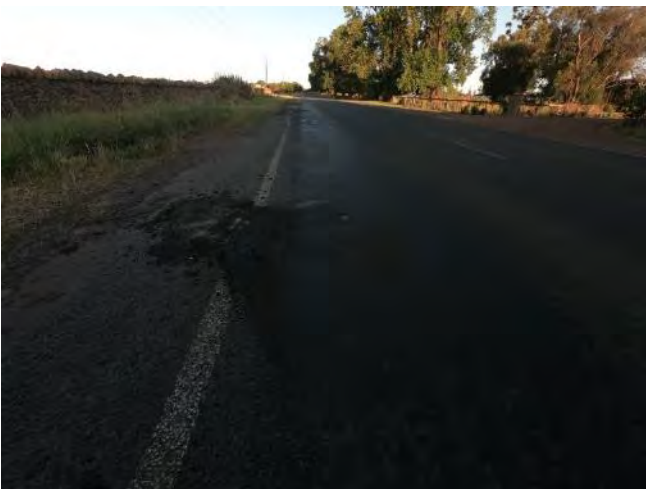
Terang-Mortlake Road - CH 10.405 – 10.439

Potholes patched but shoving out, crocodile cracking north bound lane

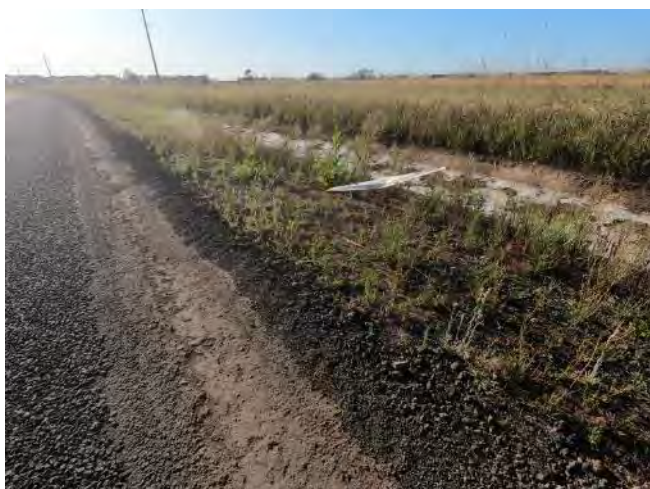
Sisters-Noorat Road - CH 6.610

Recently damaged guide post south side of road.

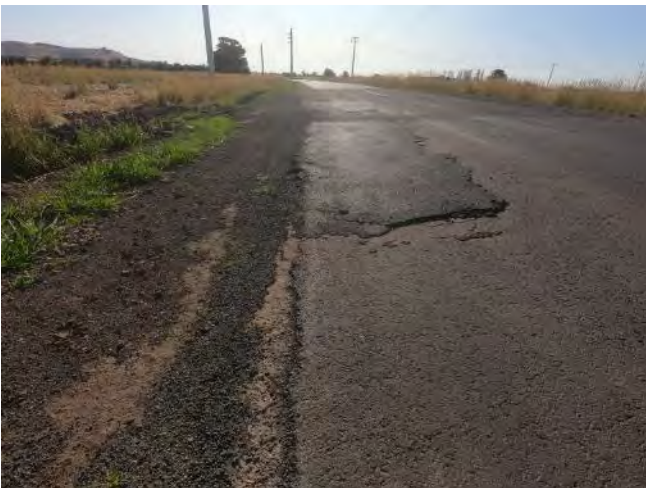
Sisters-Noorat Road - CH 10.380

Shoving repaired with asphalt. Spoil dumped in table drain.

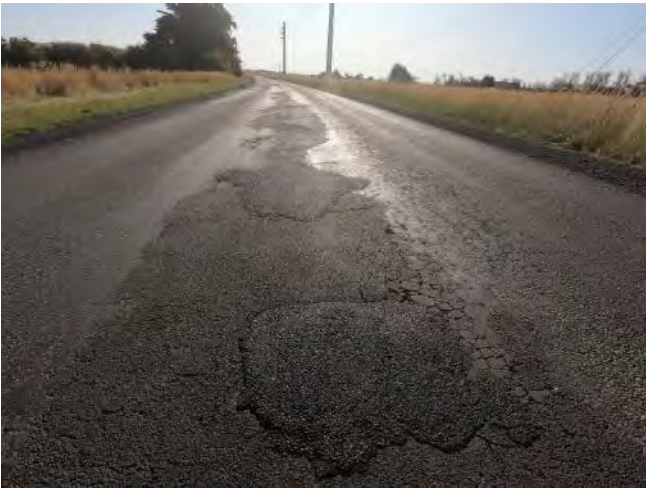
Sisters-Noorat Road - CH 10.490 – 10.526

Recent patches breaking out have been repaired, but cracking around repairs.

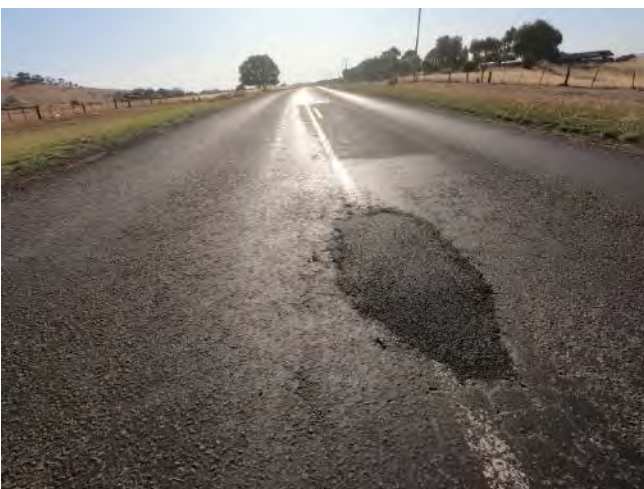
Sisters-Noorat Road - CH 12.255

Seal break out repaired.
