**Acciona Energy Australia Global Pty Ltd**

Mortlake South Wind Farm Transmission Line  
Traffic Management Plan  
Final Report Version 3

**INITIAL DILAPIDATION REPORT**

## MORTLAKE SOUTH WIND FARM LOCAL UPGRADED ROADS ORIGINAL CONDITION DILAPIDATION REPORT

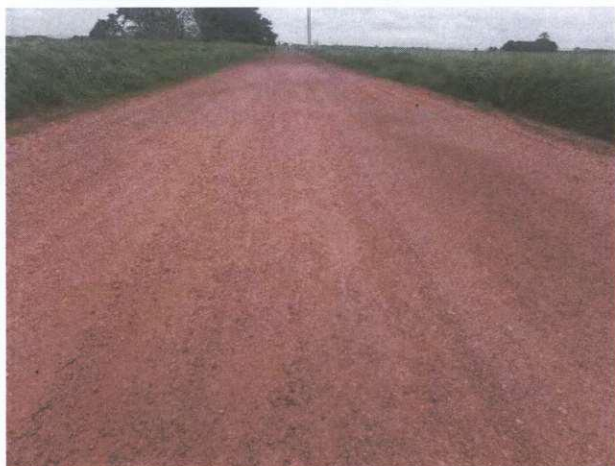
**Photo 1** (GOPR6057.JPG) - E661926, N5773203

### TAPPS LANE - CH 5302

GOOD

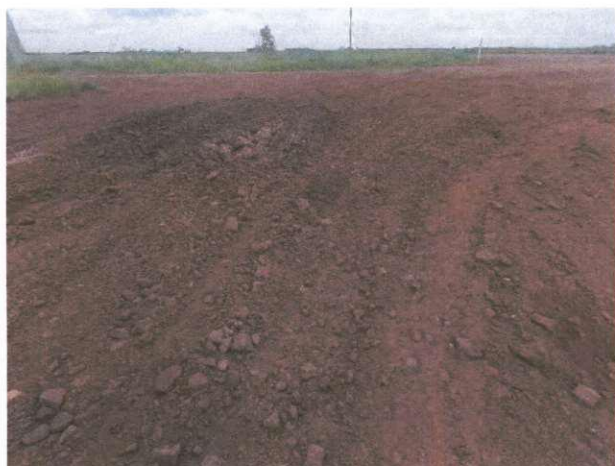
**Photo 2** (GOPR6058.JPG) - E661910, N5773022

### TAPPS LANE - CH 5482

FAIR

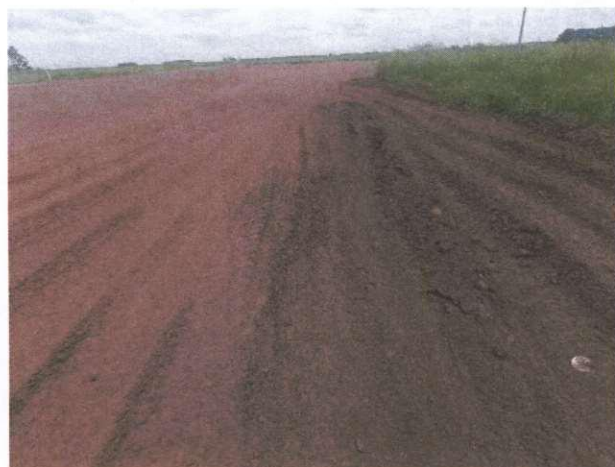
**Photo 3** (GOPR6059.JPG) - E661894, N5773030

### TAPPS LANE - CH 5477

FAIR

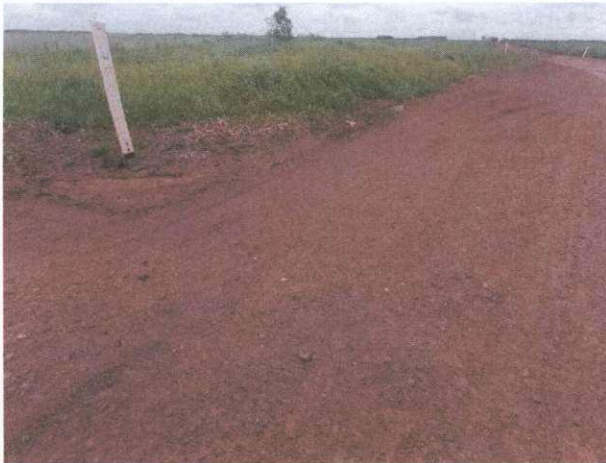
**Photo 4** (GOPR6060.JPG) - E661898, N5773007

**TAPPS LANE - CH 5499**

Wheel rutting on south-east corner of Cliffords Lane (Londrigans Lane) intersection due to U-turn movements. Soft edges.

FAIR

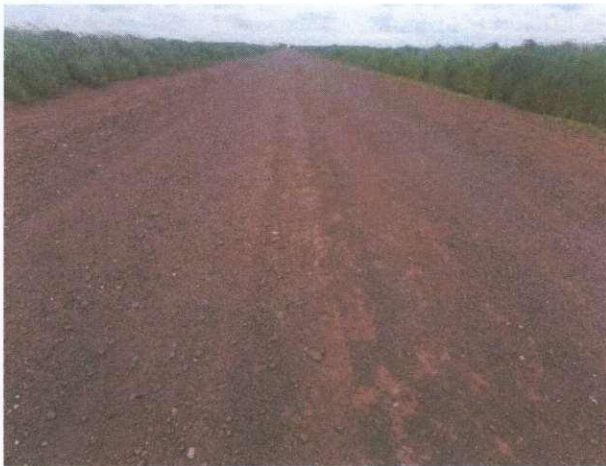
**Photo 5** (GOPR6061.JPG) - E661874, N5772884

**TAPPS LANE - CH 5625**

GOOD

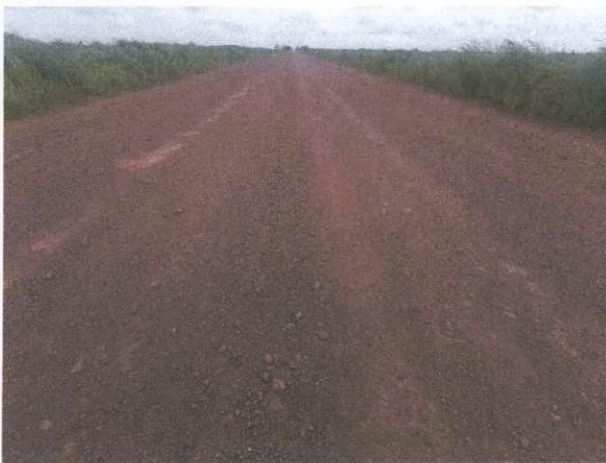
**Photo 6** (GOPR6062.JPG) - E661826, N5772604

**TAPPS LANE - CH 5908**

GOOD

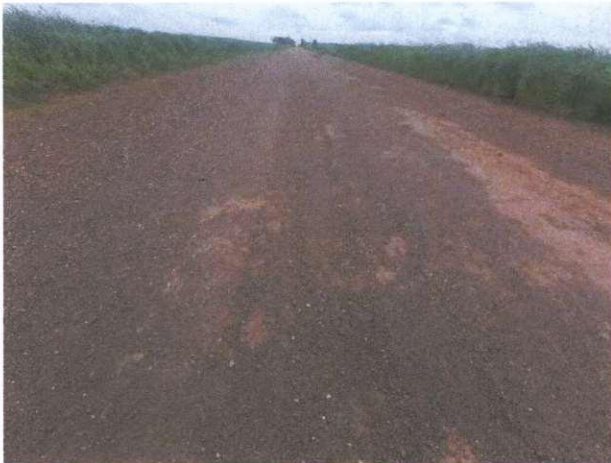
**Photo 7** (GOPR6063.JPG) - E661774, N5772288

**TAPPS LANE - CH 6229**

GOOD

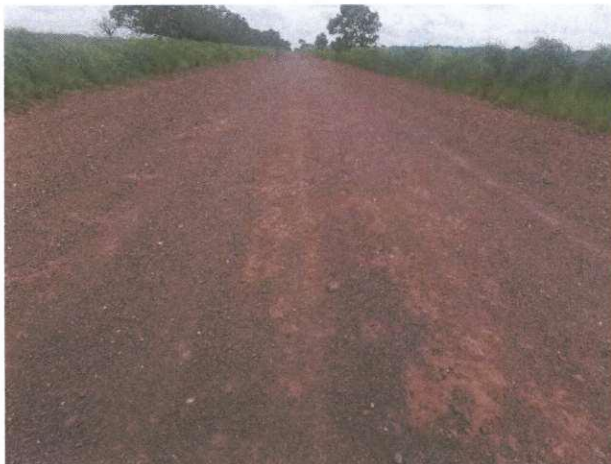
**Photo 8** (GOPR6064.JPG) - E661723, N5771987

**TAPPS LANE - CH 6534**

GOOD

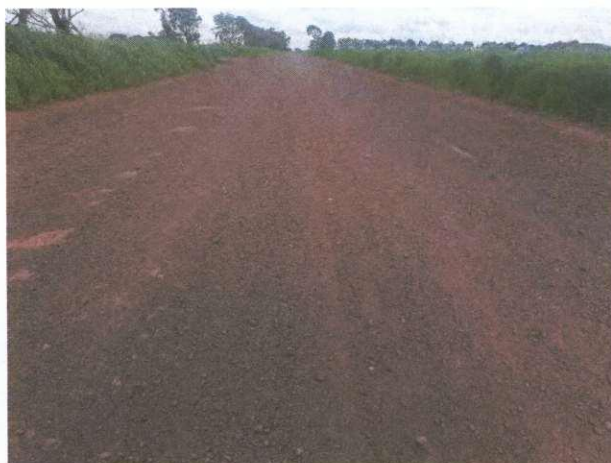
**Photo 9** (GOPR6065.JPG) - E661674, N5771700

**TAPPS LANE - CH 6825**

GOOD

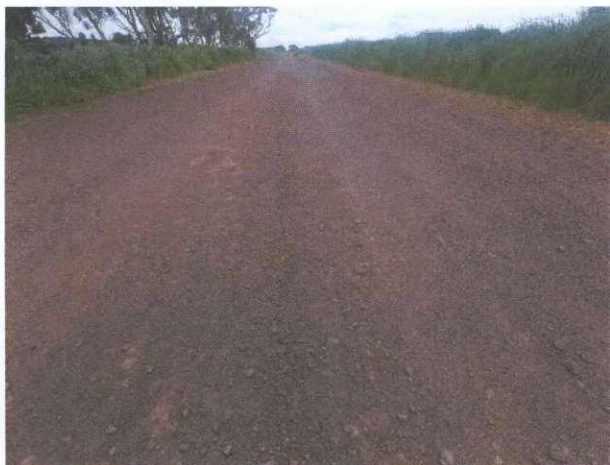
**Photo 10** (GOPR6066.JPG) - E661624, N5771407

**TAPPS LANE - CH 7123**

GOOD

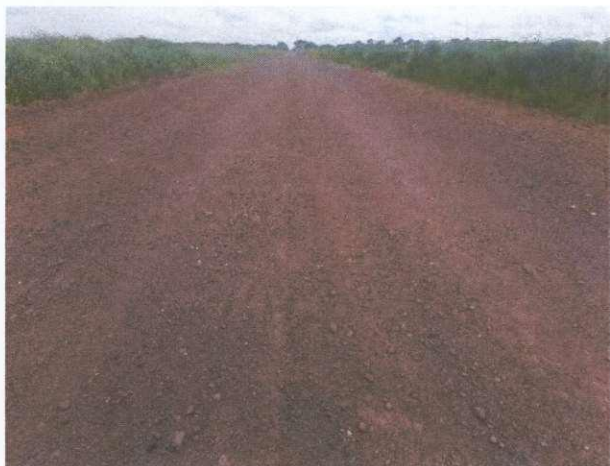
**Photo 11** (GOPR6067.JPG) - E661573, N5771108

**TAPPS LANE - CH 7426**

GOOD

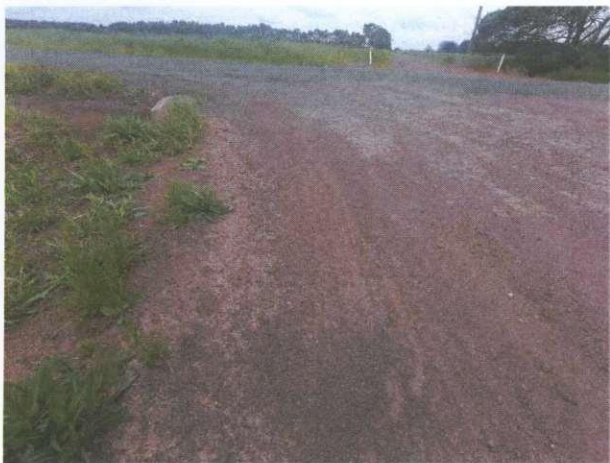
**Photo 12** (GOPR6068.JPG) - E661517, N5770765

**TAPPS LANE - CH 7773**

GOOD

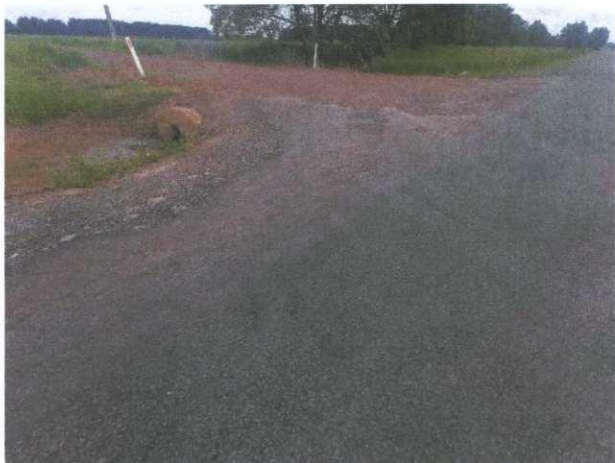
**Photo 13** (GOPR6069.JPG) - E661519, N5770755

**TAPPS LANE - CH 7783**

General view of the Sisters-Noorat Rd intersection at south-east side.

GOOD

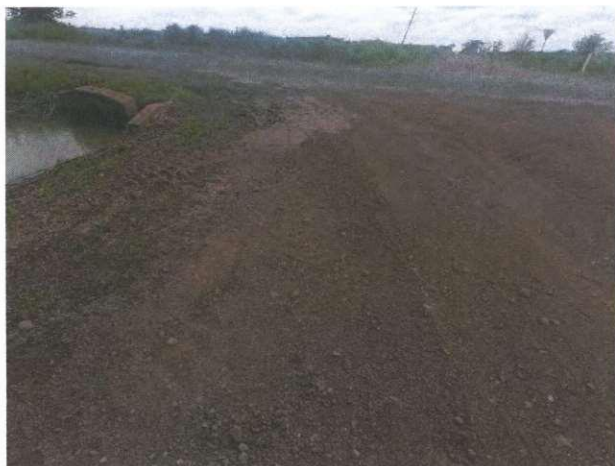
**Photo 14** (GOPR6070.JPG) - E661506, N5770750

**TAPPS LANE - CH 7790**

General view of the Sisters-Noorat Rd intersection at south-west side.

GOOD

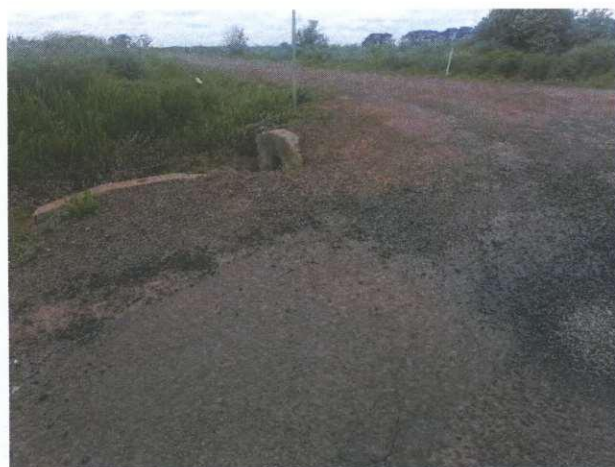
**Photo 15** (GOPR6071.JPG) - E661506, N5770771

**TAPPS LANE - CH 7770**

General view of the Sisters-Noorat Rd intersection at north-west side.

GOOD

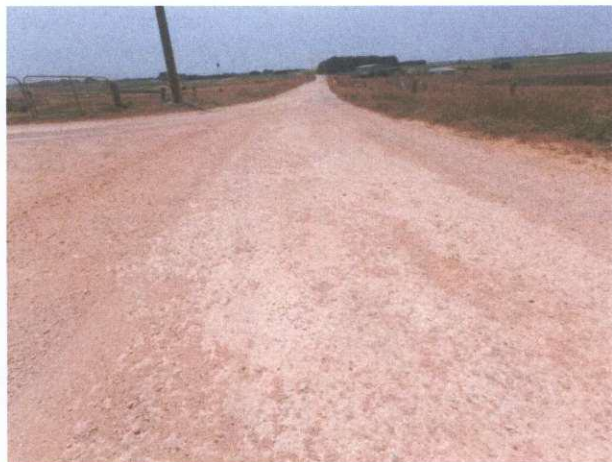
**Photo 1** 'GOPR7018.JPG' - (-38.4240513, 142.58381)

**Buckleys Rd - CH 0**

Intersection at quarry entrance

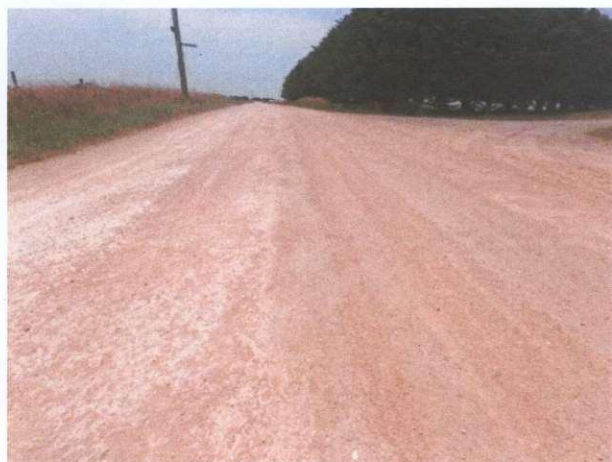
**Photo 2** 'GOPR7019.JPG' - (-38.4223609, 142.585503)

**Buckleys Rd - CH 0.245**

Dallimores Road intersection

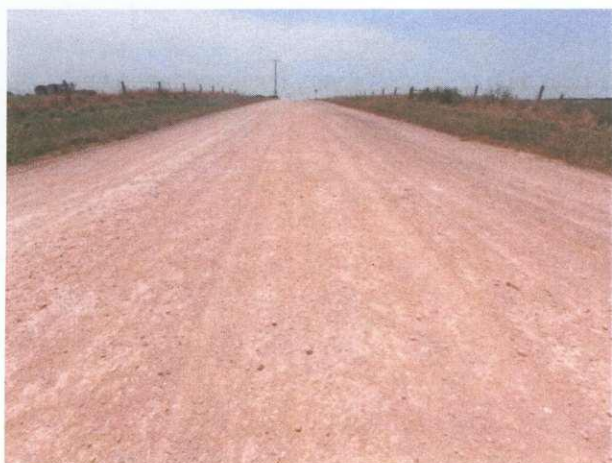
**Photo 3** 'GOPR7020.JPG' - (-38.4203667, 142.5870279)

**Buckleys Rd - CH 0.5**

General view of pavement

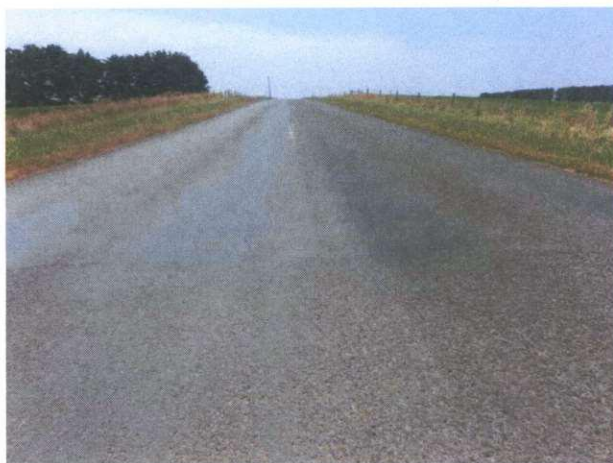
**Photo 5** 'GOPR7022.JPG' - (-38.4181538, 142.5887401)

**Buckleys Rd - CH 0.793**

- 
- Change in seal

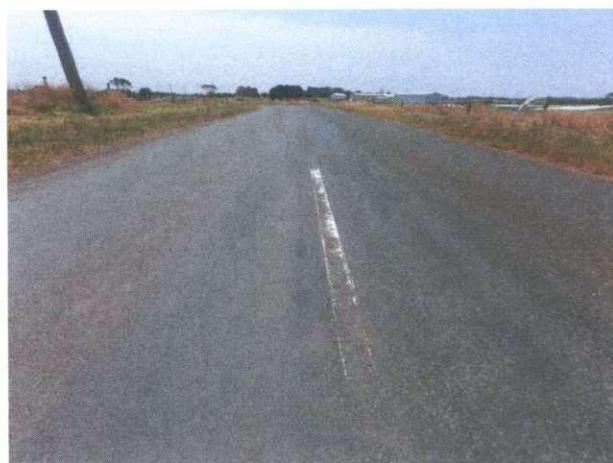
**Photo 6** 'GOPR7023.JPG' - (-38.4170412, 142.5896321)

**Buckleys Rd - CH 0.945**

- 
- Guide post damage, surface very flush and faded line marking.

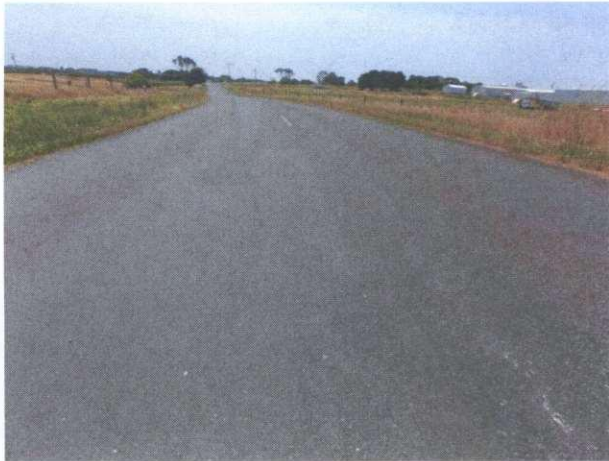
**Photo 7** 'GOPR7024.JPG' - (-38.4165095, 142.589957)

**Buckleys Rd - CH 1**  
Facing NE

-  
General view of pavement, surface very flush faded line marking.

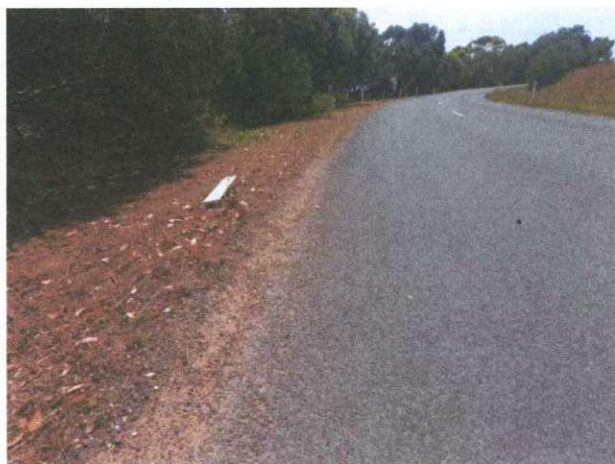
**Photo 11** 'GOPR7028.JPG' - (-38.4138525, 142.5845074)

**Burkes Rd - CH 1.705**  
Facing N

-  
Guide posts damaged through curve

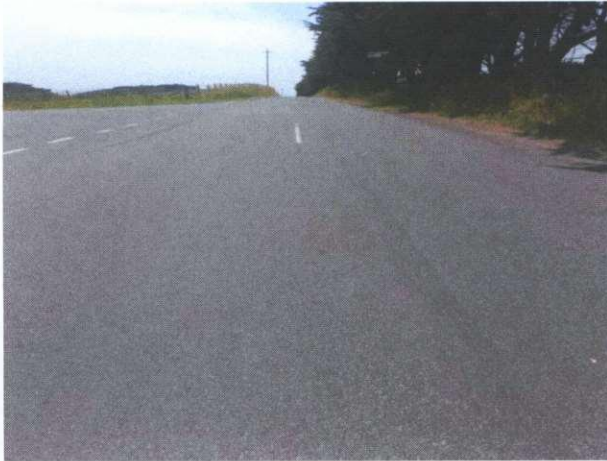
**Photo 13** 'GOPR7030.JPG' - (-38.4121419, 142.5844301)

**Burkes Rd - CH 1.895**

-  
Intersection with Hopkins Point Road. Crocodile  
Cracking through intersection

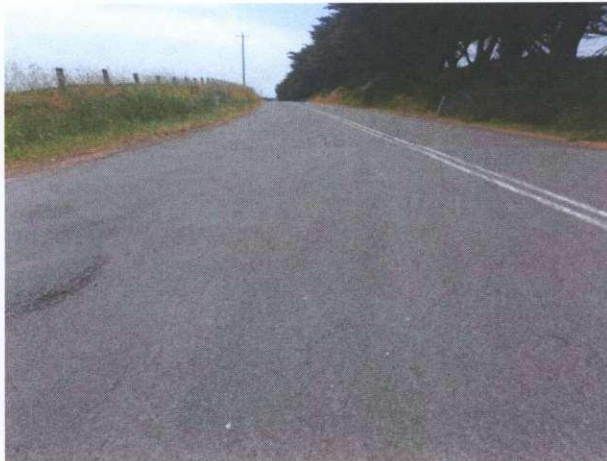
**Photo 14** 'GOPR7031.JPG' - (-38.4118801, 142.584468)

**Tooram Rd - CH 1.92**

-  
Crocodile Cracking and shoving through left turn at  
intersection.

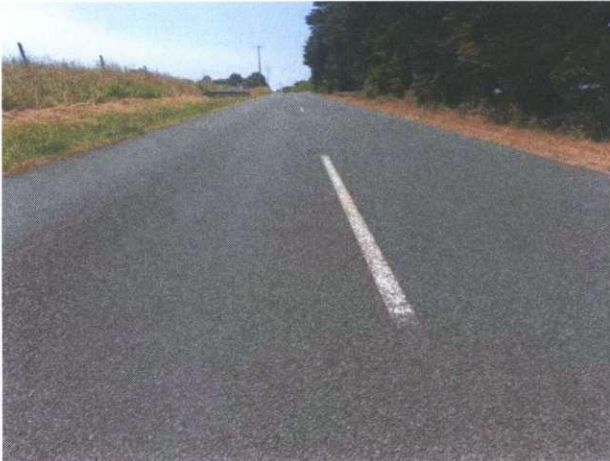
**Photo 22** 'GOPR7039.JPG' - (-38.3987816, 142.5893903)

**Tooram Rd - CH 3.546**

-  
View of pavement at cattle underpass with some minor depressions across full width of pavement

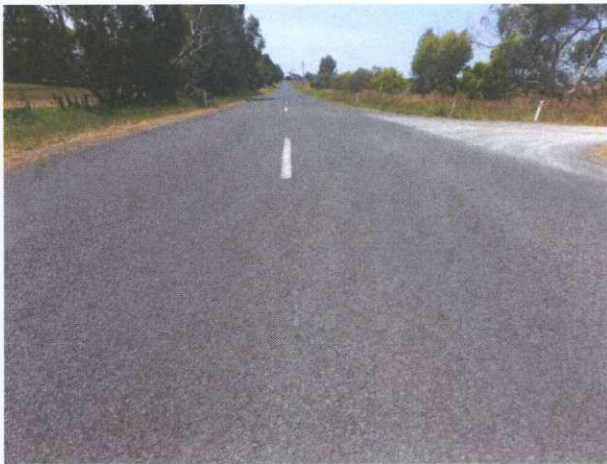
**Photo 26** 'GOPR7043.JPG' - (-38.3951476, 142.5928503)

**Tooram Rd - CH 4.02**

-  
General view of pavement at Morgan's road intersection, Crocodile cracking through seal on Morgan's road

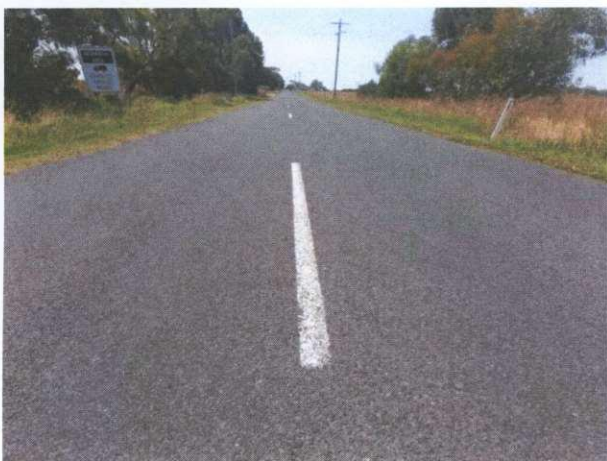
**Photo 27** 'GOPR7044.JPG' - (-38.3944422, 142.5933747)

**Tooram Rd - CH 4.112**

-  
Guidepost missing

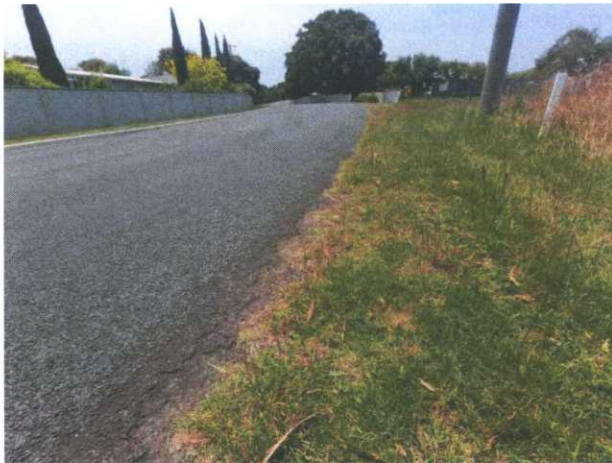
**Photo 29** 'GOPR7046.JPG' - (-38.3924755, 142.5949149)

**Tooram Rd - CH 4.36**

-  
Guidepost missing on West Side

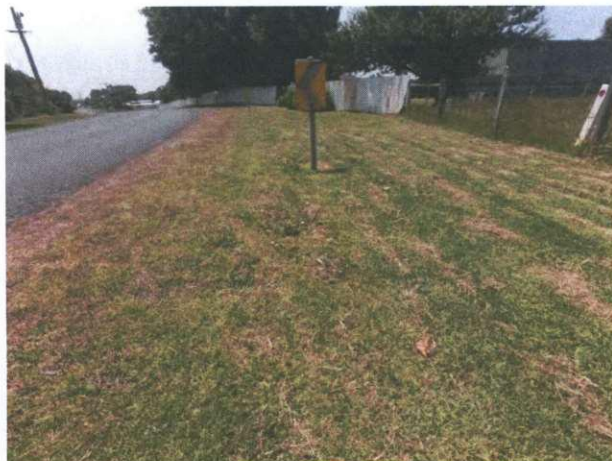
**Photo 30** 'GOPR7047.JPG' - (-38.392208, 142.5950476)

**Tooram Rd - CH 4.39**

-  
4 sets of Chevron signs faded through curve

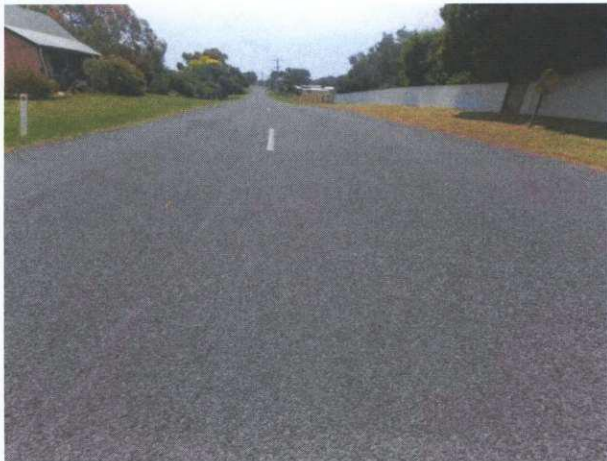
**Photo 31 'GOPR7048.JPG' - (-38.3918391, 142.5950064)**

**Tooram Rd - CH 4.436**  
Facing N

-  
Guidepost missing

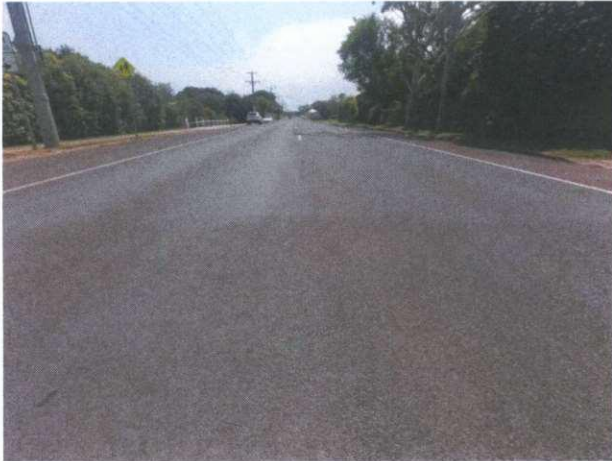
**Photo 40** 'GOPR7057.JPG' - (-38.3856095, 142.5926311)

**Ziegler Pd - CH 5.19**

Change in seal, Seal moderately flush

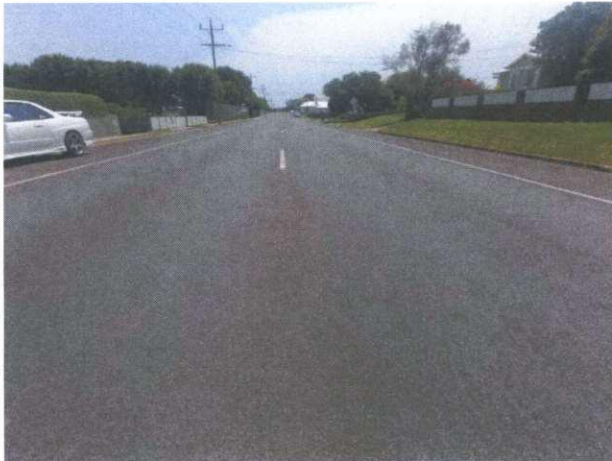
**Photo 41** 'GOPR7058.JPG' - (-38.3855301, 142.5919016)

**Ziegler Pd - CH 5.25**

General view of pavement seal moderately flush

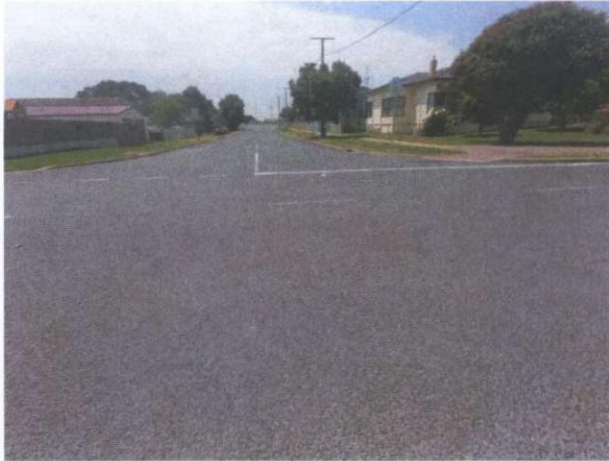
**Photo 43** 'GOPR7060.JPG' - (-38.3853909, 142.5908809)

**Ziegler Pd - CH 5.346**

-  
General view of pavement at intersection Ziegler Parade with minor crocodile cracking throughout.

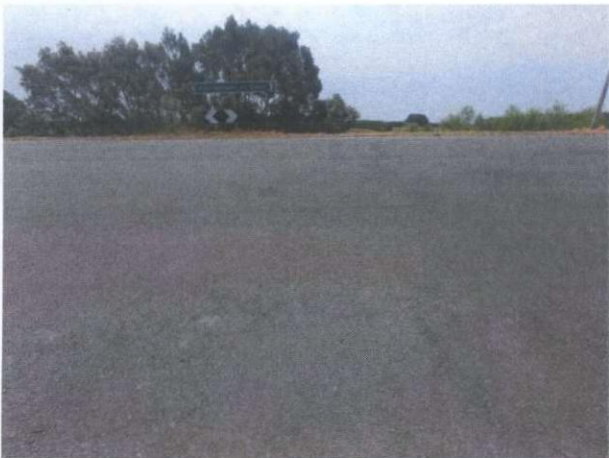
**Photo 45** 'GOPR7062.JPG' - (-38.3840377, 142.5909662)

**Garabaldi Ln - CH 5.5**

-  
General view of pavement at Princes Highway intersection, some lateral cracking through eastbound lane.

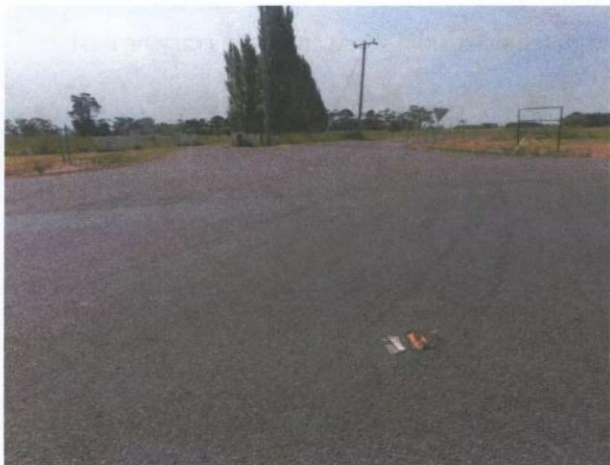
**Photo 46** 'GOPR7064.JPG' - (-38.2578627, 142.8890244)

**Noogee Rd - CH 0**  
Facing N

General view at intersection with Princes Hwy. VERY GOOD

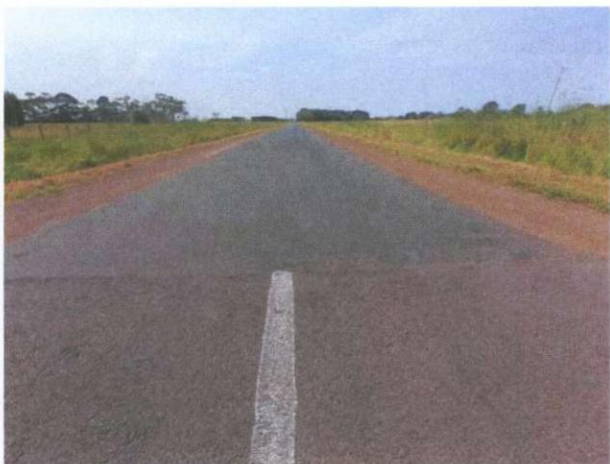
**Noogee Rd - CH 0.043**  
Facing N

Change in seal

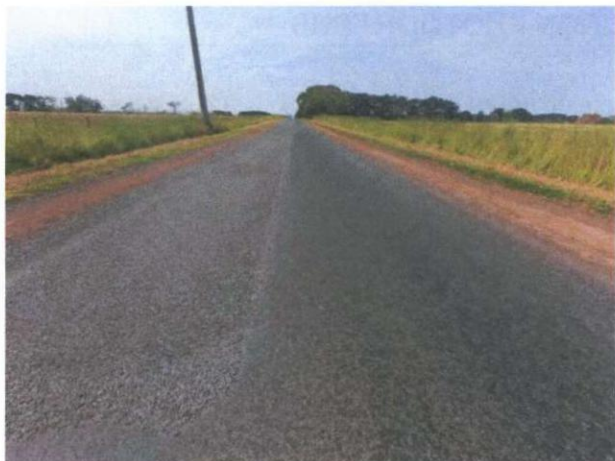
**Photo 49** 'GOPR7067.JPG' - (-38.2554471, 142.8892851)

**Noogee Rd - CH 0.272**

Recent patch west side, some crocodile cracking east side.

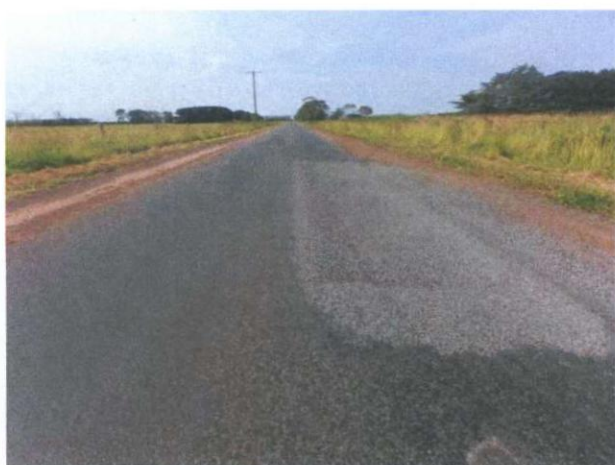
**Photo 51** 'GOPR7069.JPG' - (-38.2510185, 142.8901427)

**Noogee Rd - CH 0.768**

Recent patch east side

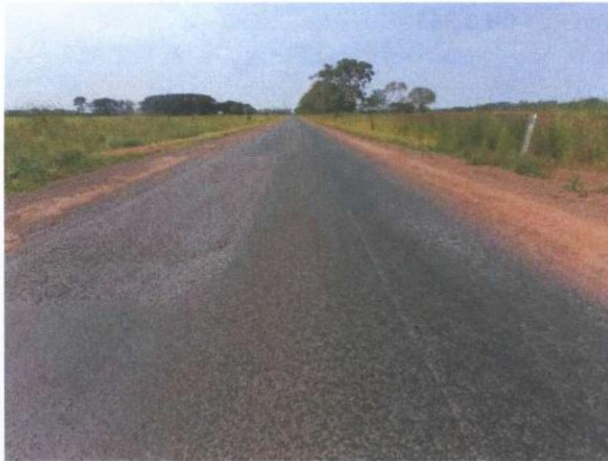
**Photo 52** 'GOPR7070.JPG' - (-38.2502719, 142.890274)

**Noogee Rd - CH 0.852**

-  
Recent patch west side, crocodile cracking east side,  
over culvert.

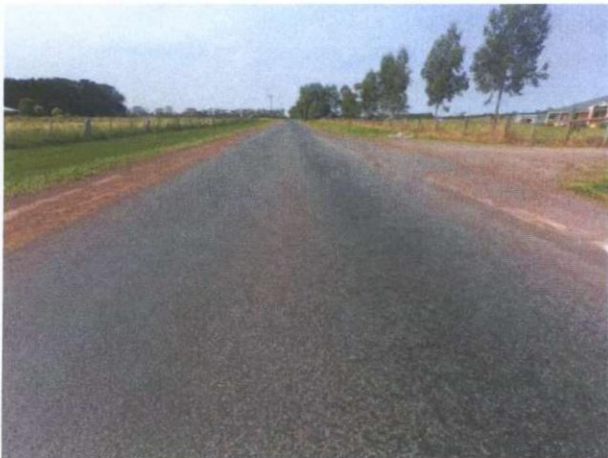
**Photo 54** 'GOPR7072.JPG' - (-38.2467047, 142.8909494)

**Noogee Rd - CH 1.25**

-  
General view of pavement, some crocodile cracking

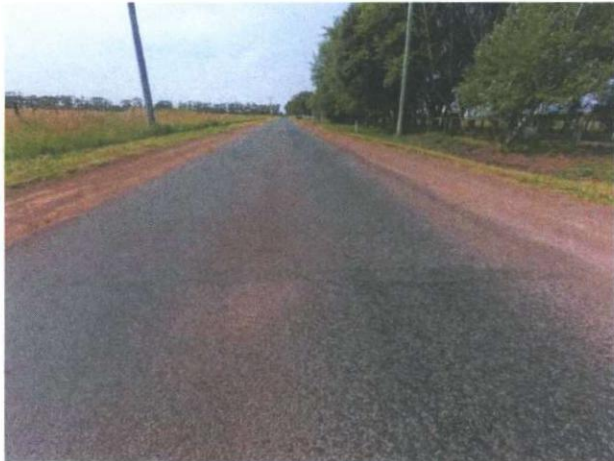
**Photo 55 'GOPR7073.JPG' - (-38.2457288, 142.8911365)**

**Noogee Rd - CH 1.363**

- 
- Change in seal

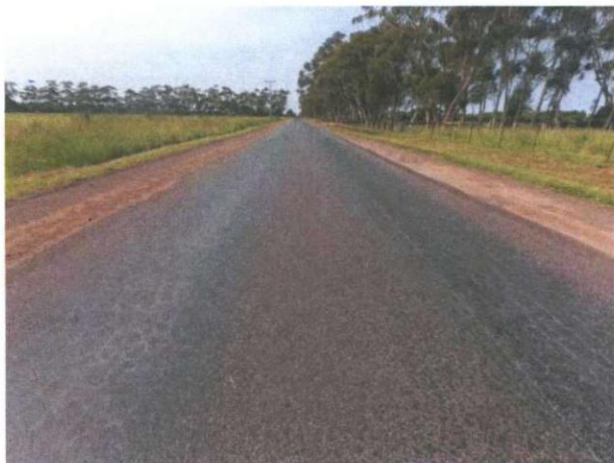
**Photo 57 'GOPR7075.JPG' - (-38.2422493, 142.8917869)**

**Noogee Rd - CH 1.75**

- 
- General view of pavement, moderate crocodile cracking throughout.

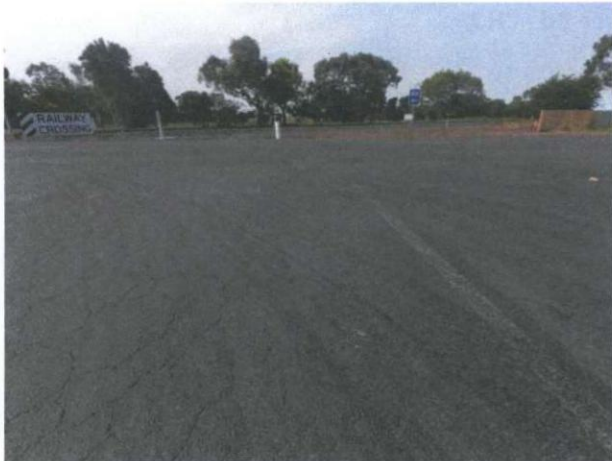
**Photo 61** 'GOPR7079.JPG' - (-38.2371236, 142.8933595)

**Noogee Rd - CH 2.345**

-  
View at Terang-Framlingham Rd Intersection.  
Crocodile cracking through left turn of Noogee Rd

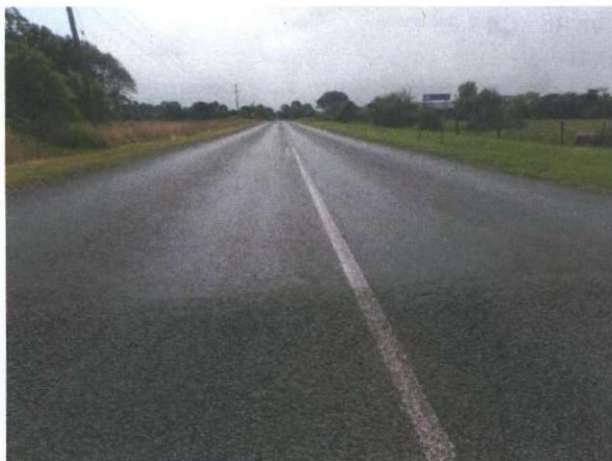
**Photo 63** 'GOPR7081.JPG' - (-38.2369843, 142.8926126)

**Terang – Framlingham Rd - CH 2.409**

-  
Change in seal, moderate flushing all wheel paths.

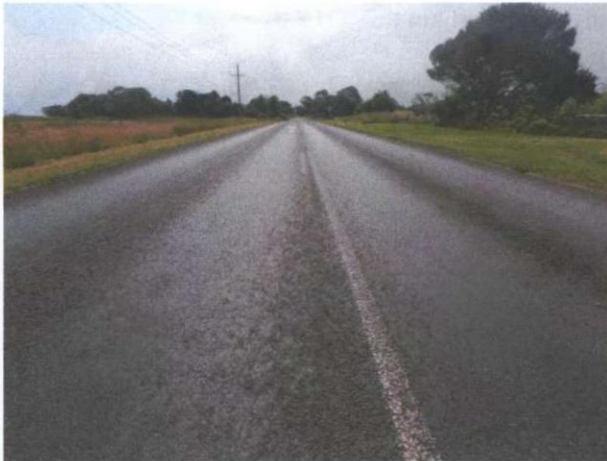
**Photo 64 'GOPR7082.JPG' - (-38.2368819, 142.8915724)**

**Terang – Framlingham Rd - CH 2.5**  
Facing W

-  
Moderate rutting, flushing and crocodile cracking.

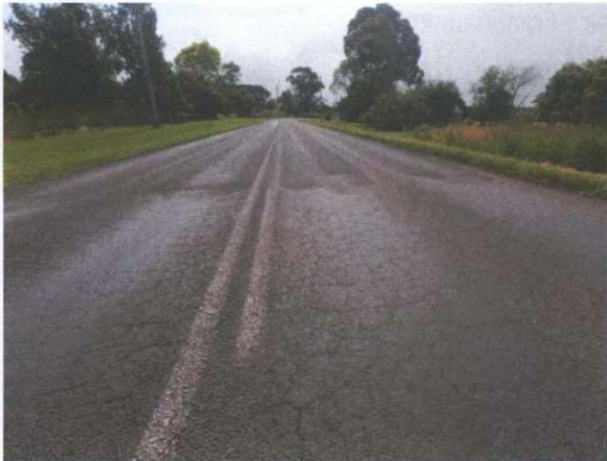
**Photo 65 'GOPR7083.JPG' - (-38.2366055, 142.8893919)**

**Terang – Framlingham Rd - CH 2.696**  
Facing W

-  
Wheel ruts profiled and filled to CH 2.778

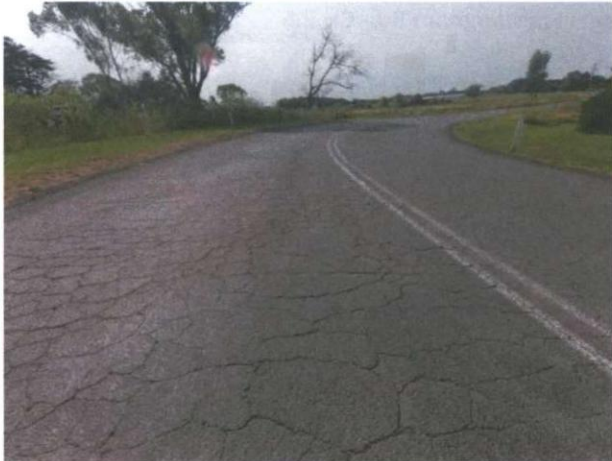
**Photo 67** 'GOPR7085.JPG' - (-38.2364172, 142.888113)

**Terang – Framlingham Rd - CH 2.81**  
Facing W

-  
Extensive crocodile cracking in curve.

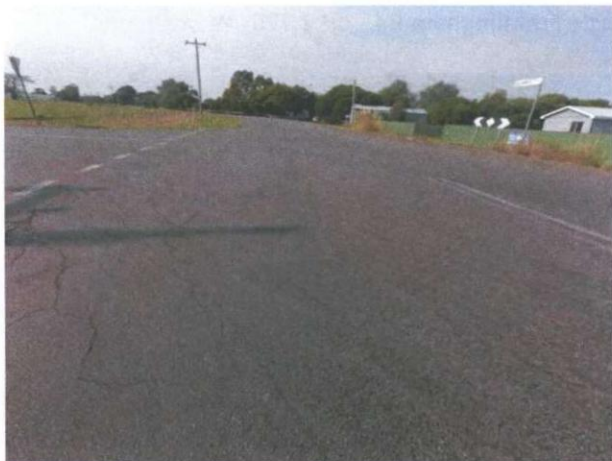
**Photo 69** 'GOPR7087.JPG' - (-38.2349929, 142.8879319)

**Keilambete Rd - CH 2.965**  
Facing N

-  
Terang-Framlingham Rd intersection with crocodile cracking on west side. Guide post knocked over on east side.

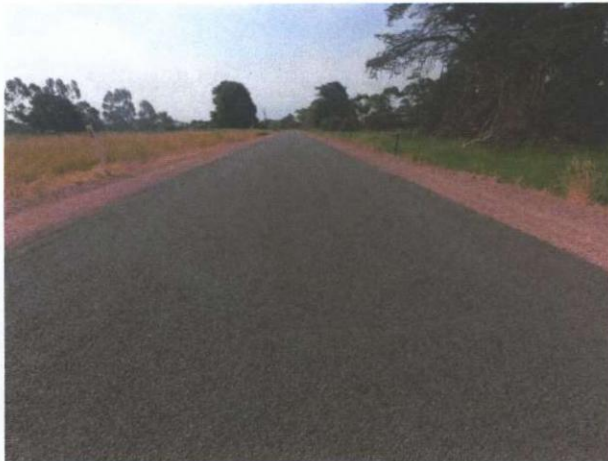
**Photo 76** 'GOPR7094.JPG' - (-38.2255169, 142.8809439)

**Keilambete Rd - CH 4.192**

Guide post missing

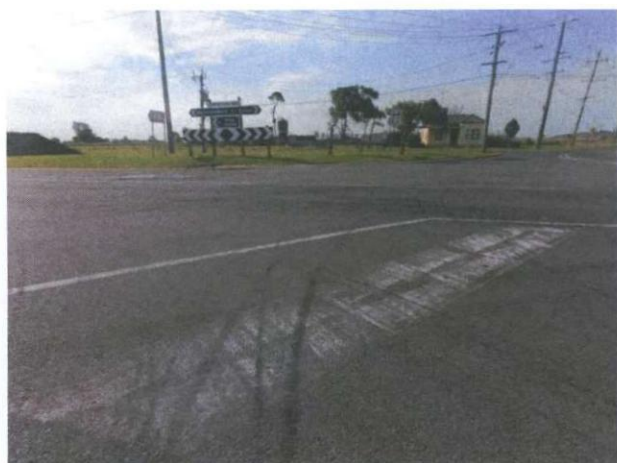
**Photo 87** 'GOPR7107.JPG' - (-38.2367206, 142.9304757)

**Cosgrove and Little Street - CH 0**

-  
View at Princes Hwy Intersection. Crocodile cracking through eastbound lane through intersection.

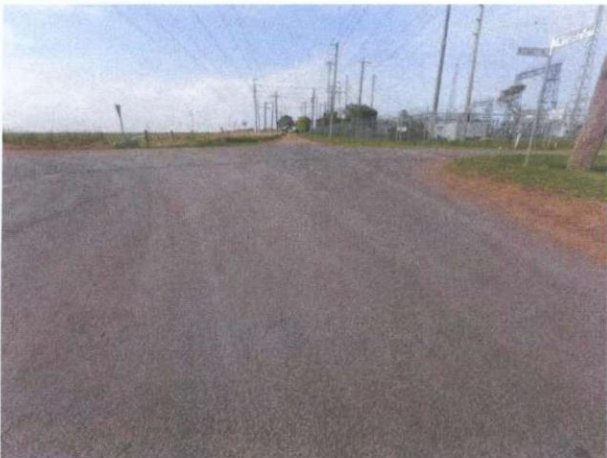
**Photo 90** 'GOPR7110.JPG' - (-38.233778, 142.9309394)

**Cosgrove and Little Street - CH 0.348**  
Facing N

View at McRae St intersection to end of seal

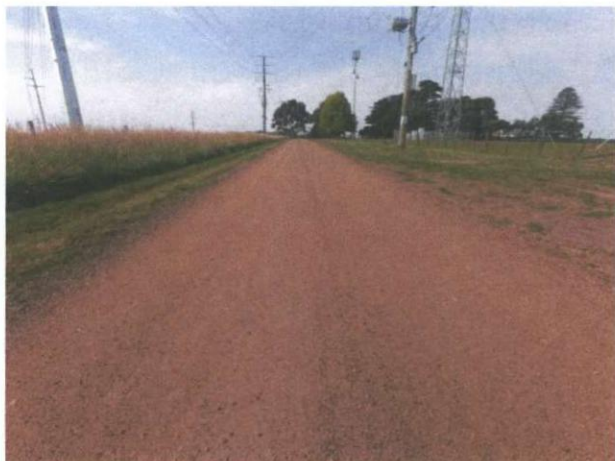
**Photo 91** 'GOPR7111.JPG' - (-38.2322818, 142.9312397)

**Cosgrove and Little Street - CH 0.5**  
Facing N

-  
General view of pavement.

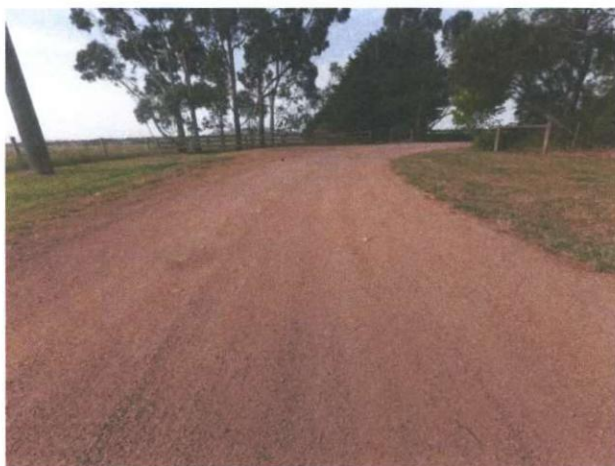
**Photo 92** 'GOPR7112.JPG' - (-38.2311066, 142.9314645)

**Cosgrove and Little Street - CH 0.93**  
Facing N

-  
General view of pavement near end of segment.

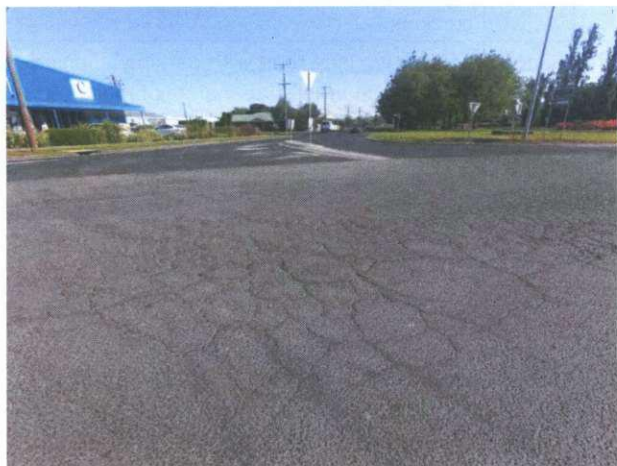
**Photo 93** 'GOPR7114.JPG' - (-38.2408116, 142.9202256)

**Terang – Mortlake Rd - CH 0**  
Facing N

-  
Crocodile cracking through intersection particularly  
east bound lane with seal breaking out

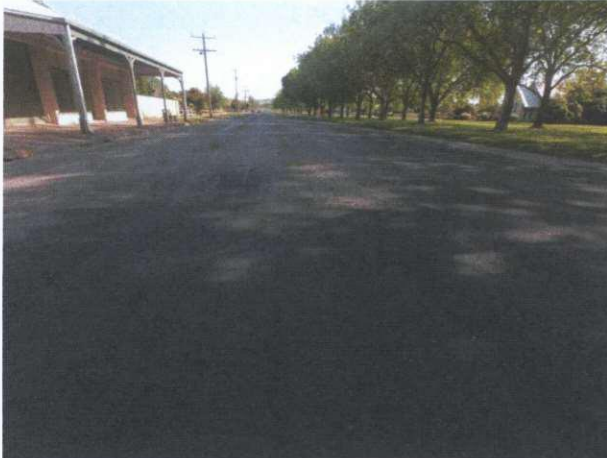
**Photo 95 'GOPR7116.JPG' - (-38.2399974, 142.9203601)**

**Terang – Mortlake Rd - CH 0.093**  
Facing N

-  
Change in seal

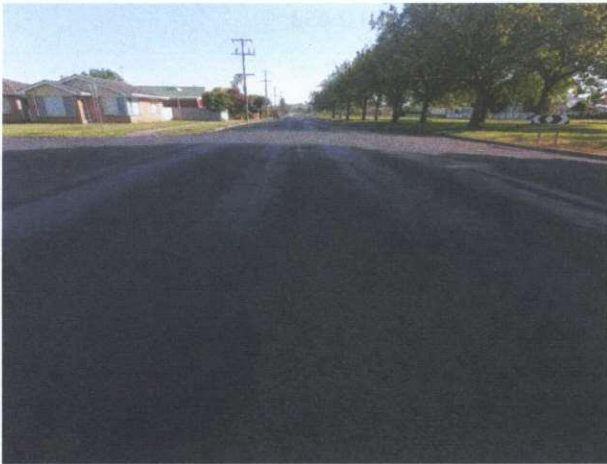
**Photo 96 'GOPR7117.JPG' - (-38.2391591, 142.9205331)**

**Terang – Mortlake Rd - CH 0.197**  
Facing N

-  
General view of intersection with Grey Street

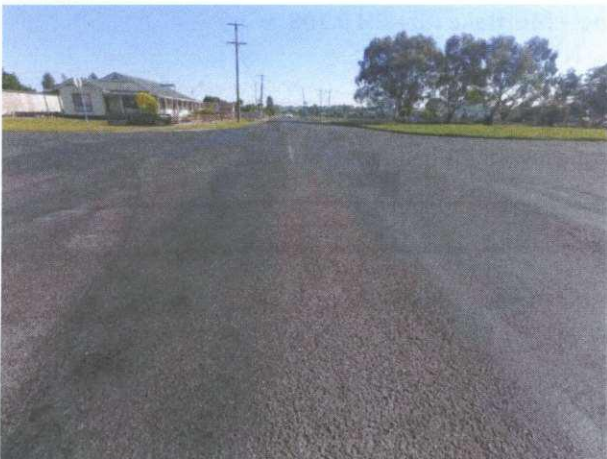
**Photo 97 'GOPR7118.JPG' - (-38.2380279, 142.9207705)**

**Terang – Mortlake Rd - CH 0.325**  
Facing N

-  
General view of intersection with Swanston Street

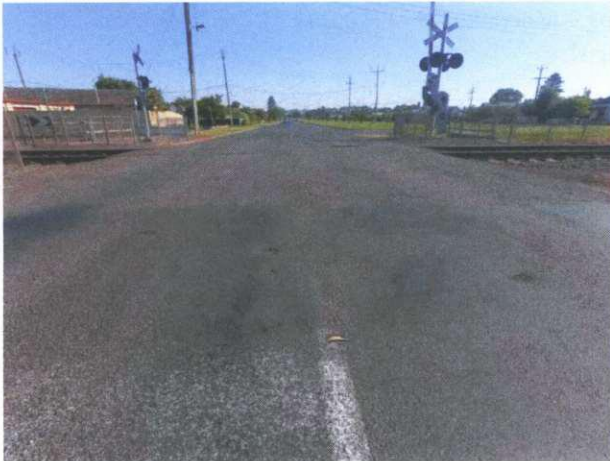
**Photo 98** 'GOPR7119.JPG' - (-38.237378, 142.9208824)

**Terang – Mortlake Rd - CH 0.393**

General view of railway crossing, crocodile cracking both sides

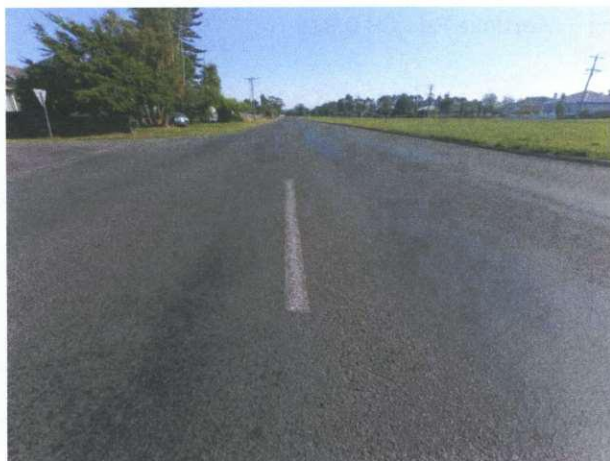
**Photo 100** 'GOPR7121.JPG' - (-38.2345834, 142.9214374)

**Terang – Mortlake Rd - CH 0.708**

General view of intersection with Blackiston Street

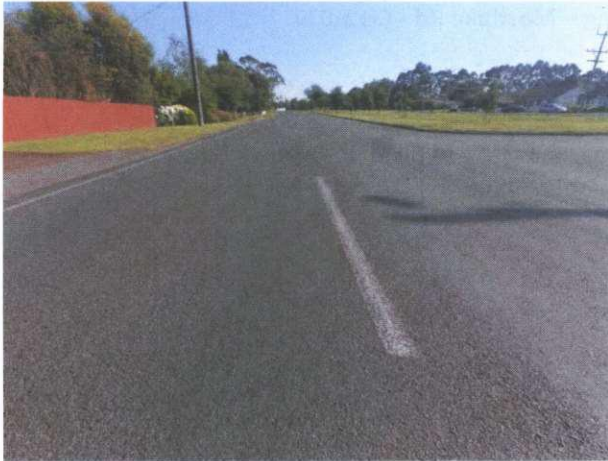
**Photo 101** 'GOPR7122.JPG' - (-38.232616, 142.9218081)

**Terang – Mortlake Rd - CH 0.926**  
Facing N

-  
General view of intersection with McRae

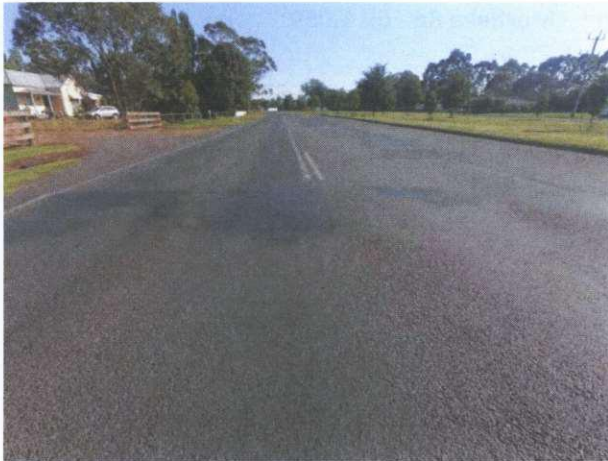
**Photo 102** 'GOPR7123.JPG' - (-38.2321762, 142.9218806)

**Terang – Mortlake Rd - CH 0.967**  
Facing N

-  
Change in seal

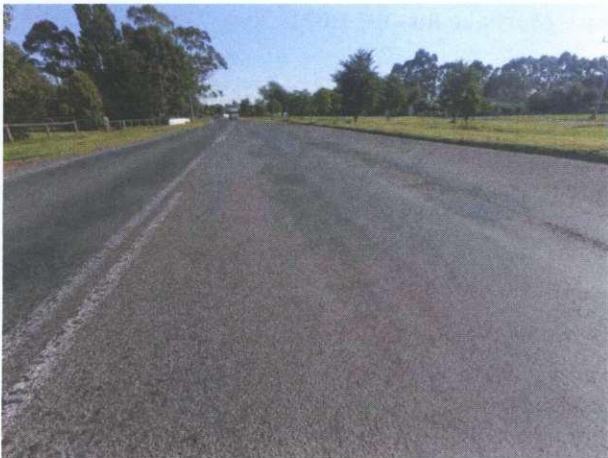
**Photo 103** 'GOPR7124.JPG' - (-38.2320472, 142.921925)

**Terang – Mortlake Rd - CH 0.983**  
Facing N

-  
Wheel rutting and filled potholes breaking open, south bound lane

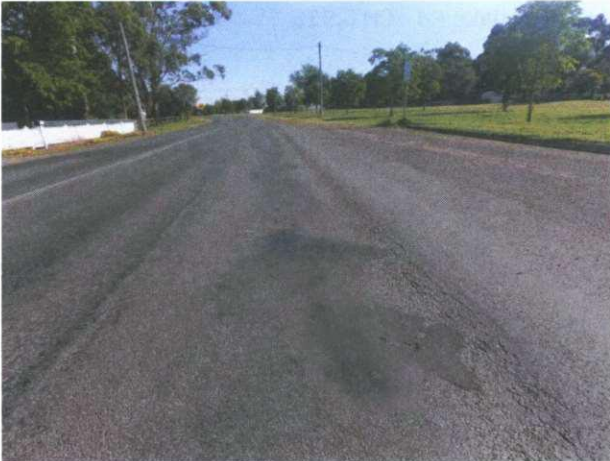
**Photo 104** 'GOPR7125.JPG' - (-38.2316866, 142.9219846)

**Terang – Mortlake Rd - CH 1.017**

-  
Rutting, shoving and filled potholes breaking out in south bound lane

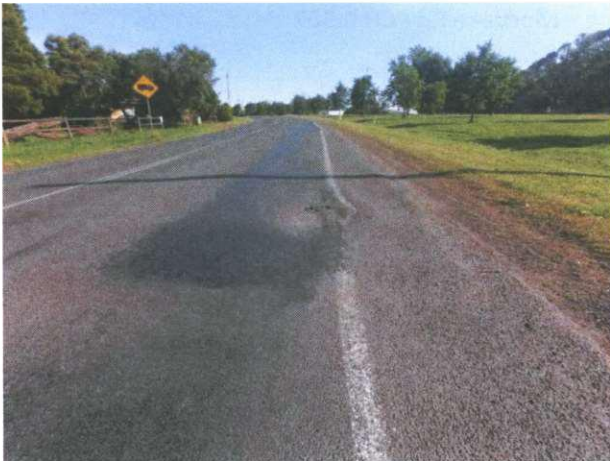
**Photo 105** 'GOPR7126.JPG' - (-38.2313587, 142.9220494)

**Terang – Mortlake Rd - CH 1.059**

-  
Shoving, seal breaking out, and edge line tracking southbound lane

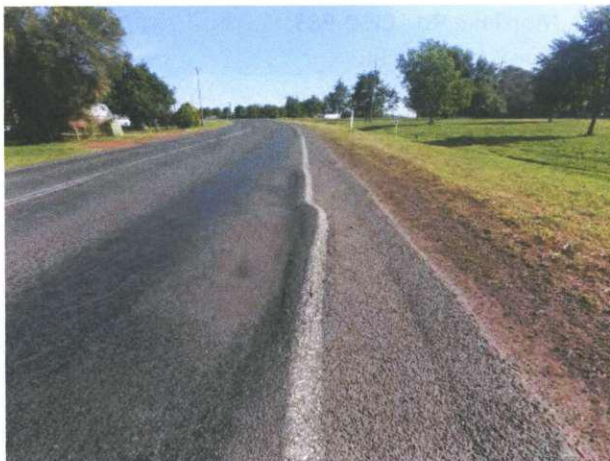
**Photo 106** 'GOPR7127.JPG' - (-38.2312287, 142.9220577)

**Terang – Mortlake Rd - CH 1.071**

-  
Shoving, seal breaking out, and edge line tracking southbound lane.

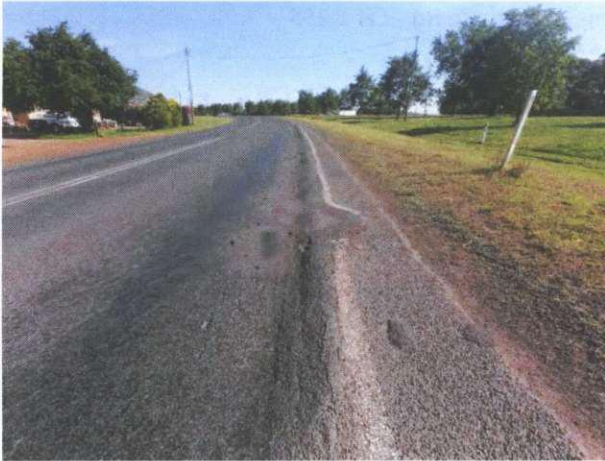
**Photo 107** 'GOPR7128.JPG' - (-38.2311278, 142.9220544)

**Terang – Mortlake Rd - CH 1.080 - 1.115**

-  
Shoving, rutting, seal breaking out, and edge line tracking southbound lane.

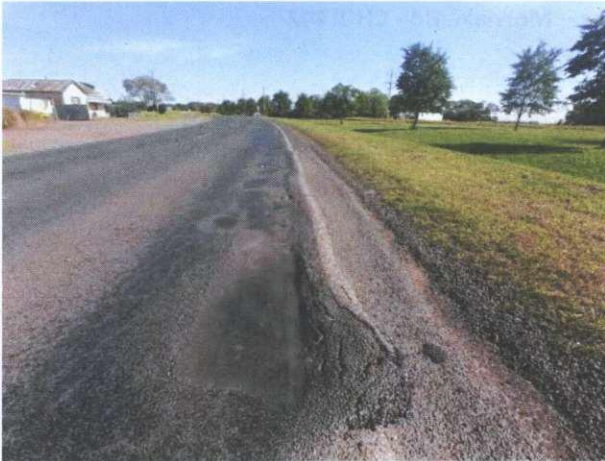
**Photo 108** 'GOPR7129.JPG' - (-38.2306137, 142.9219579)

**Terang – Mortlake Rd - CH 1.141 - 1.149**

-  
Shoving, rutting, seal breaking out, and edge line tracking southbound lane.

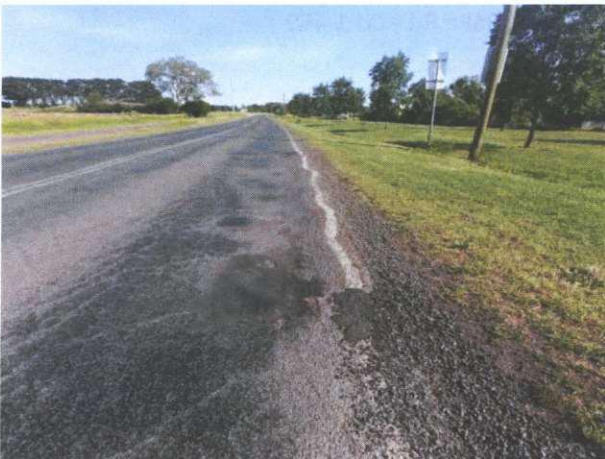
**Photo 109** 'GOPR7130.JPG' - (-38.2300422, 142.9216783)

**Terang – Mortlake Rd - CH 1.207 - 1.231**

-  
Shoving, rutting, seal breaking out, and edge line tracking southbound lane. Crocodile cracking both lanes.

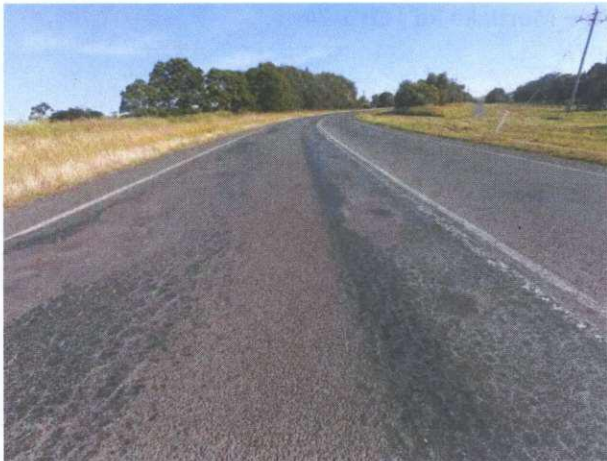
**Photo 113** 'GOPR7134.JPG' - (-38.2276103, 142.9198035)

**Terang – Mortlake Rd - CH 1.525**  
Facing N

-  
Crocodile cracking, rutting, shoving, flushing, filled potholes and seal breaking out to north bound lane.

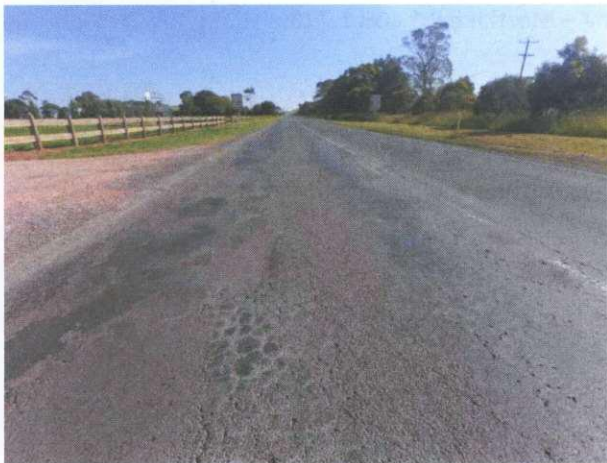
**Photo 114** 'GOPR7135.JPG' - (-38.2261695, 142.9196328)

**Terang – Mortlake Rd - CH 1.688**  
Facing N

-  
Crocodile cracking, rutting, shoving, flushing, filled potholes and seal breaking out to north bound lane.

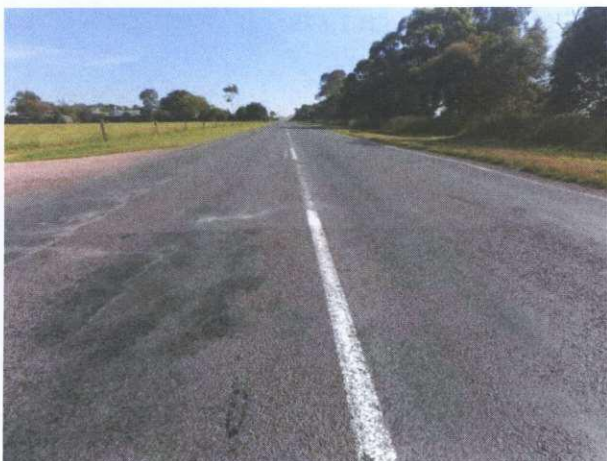
**Photo 115** 'GOPR7136.JPG' - (-38.225783, 142.9197237)

**Terang – Mortlake Rd - CH 1.73**  
Facing N

-  
Change in seal just after 100km/h sign
