**Acciona Energy Australia Global Pty Ltd**

Mortlake South Wind Farm Transmission Line  
Traffic Management Plan  
Final Report Version 3

**INITIAL DILAPIDATION REPORT**

## MORTLAKE SOUTH WIND FARM LOCAL UPGRADED ROADS ORIGINAL CONDITION DILAPIDATION REPORT

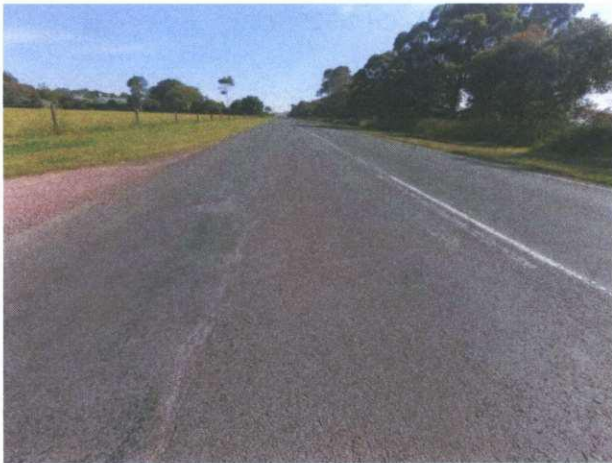
**Photo 116** 'GOPR7137.JPG' - (-38.2257501, 142.9197258)

**Terang – Mortlake Rd - CH 1.74**

-  
General view of pavement with flushing, crocodile cracking, rutting and filled potholes.

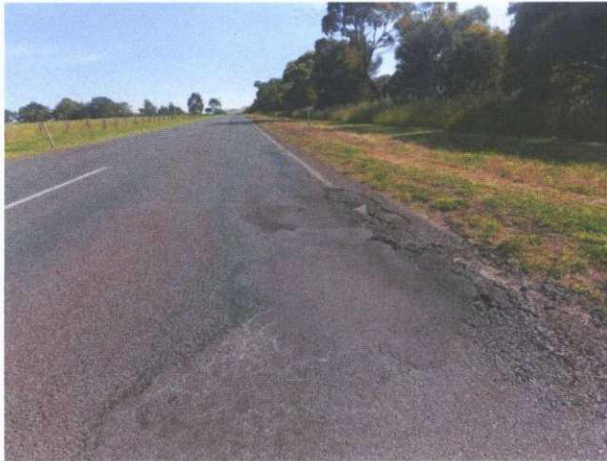
**Photo 119** 'GOPR7140.JPG' - (-38.22418, 142.9200648)

**Terang – Mortlake Rd - CH 1.911**

-  
Shoving, rutting, filled potholes and seal breaking out in both lanes.

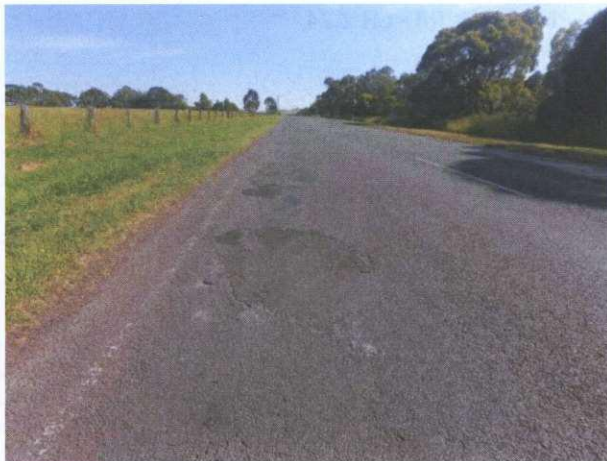
**Photo 120** 'GOPR7141.JPG' - (-38.2239607, 142.920038)

**Terang – Mortlake Rd - CH 1.935**

-  
General view of pavement with flushing, crocodile cracking, rutting, filled potholes and seal breaking out.

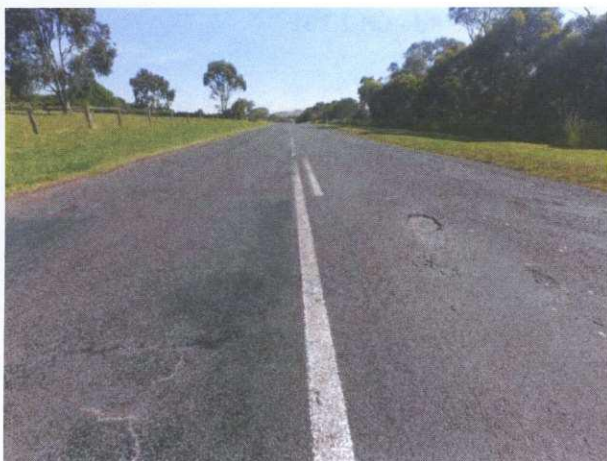
**Photo 121** 'GOPR7142.JPG' - (-38.2222766, 142.920404)

**Terang – Mortlake Rd - CH 2.184**

-  
Change in seal

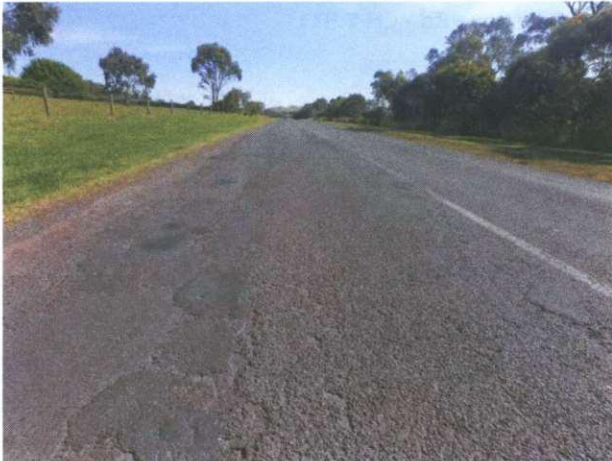
**Photo 122** 'GOPR7143.JPG' - (-38.2221655, 142.9204097)

**Terang – Mortlake Rd - CH 2.195**

-  
General view of pavement with flushing, crocodile cracking, rutting, filled potholes and seal breaking out both lanes.

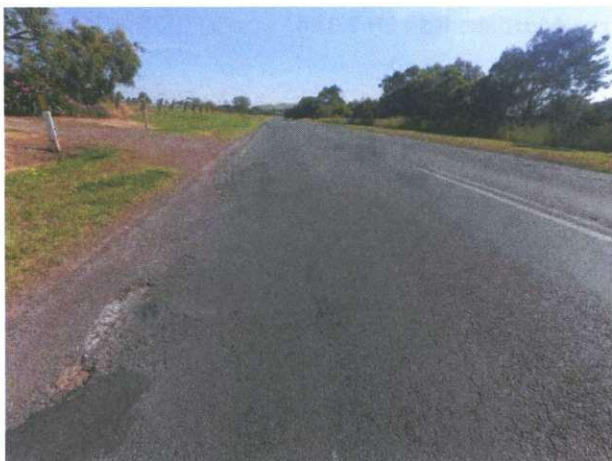
**Photo 124** 'GOPR7145.JPG' - (-38.2215787, 142.9205022)

**Terang – Mortlake Rd - CH 2.261**

-  
General view of pavement with flushing, crocodile cracking, rutting, filled potholes and seal breaking out both lanes.

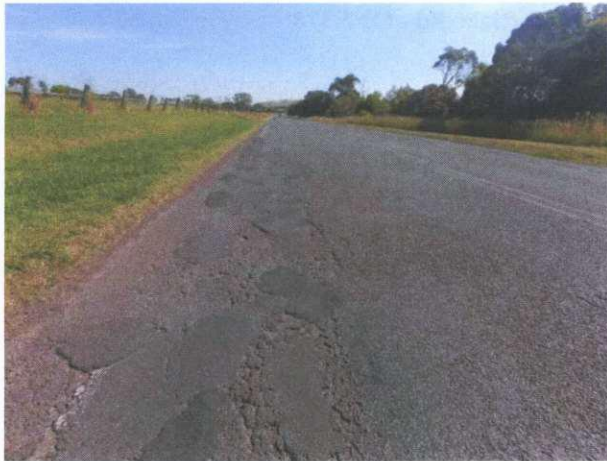
**Photo 125** 'GOPR7146.JPG' - (-38.2213557, 142.9205484)

**Terang – Mortlake Rd - CH 2.285**

-  
General view of pavement with flushing, crocodile cracking, rutting, filled potholes and seal breaking out both lanes.

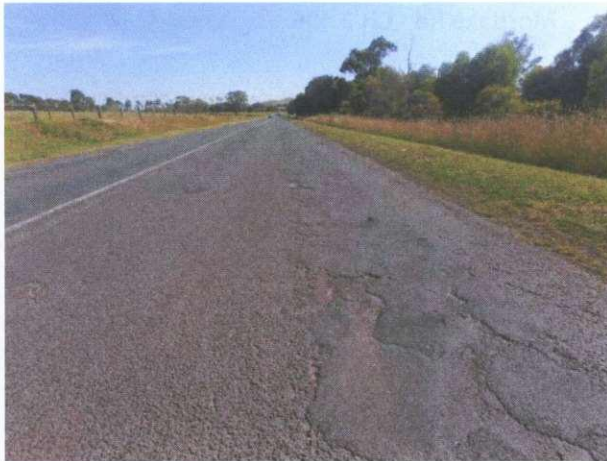
**Photo 126** 'GOPR7147.JPG' - (-38.2210128, 142.9206565)

**Terang – Mortlake Rd - CH 2.325**

-  
General view of pavement with flushing, crocodile cracking, rutting, filled potholes and seal breaking out both lanes.

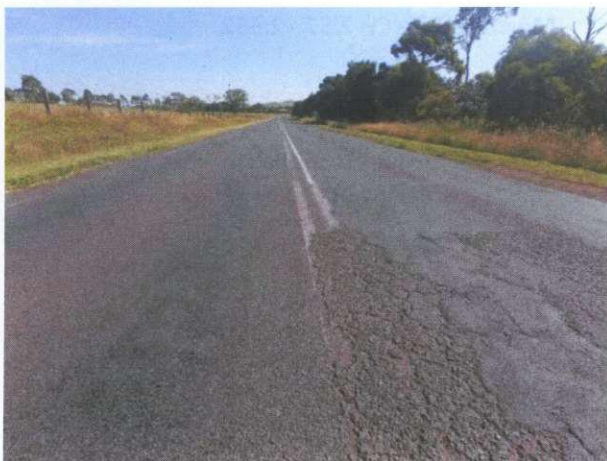
**Photo 127** 'GOPR7148.JPG' - (-38.2207905, 142.9206724)

**Terang – Mortlake Rd - CH 2.351**

-  
General view of pavement

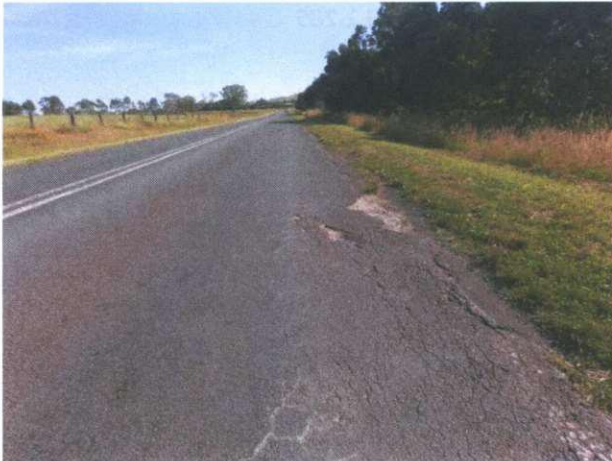
**Photo 128** 'GOPR7149.JPG' - (-38.2205747, 142.9207469)

**Terang – Mortlake Rd - CH 2.378**

-  
Edge of seal breaking out, crocodile cracking and flushing to south bound lane

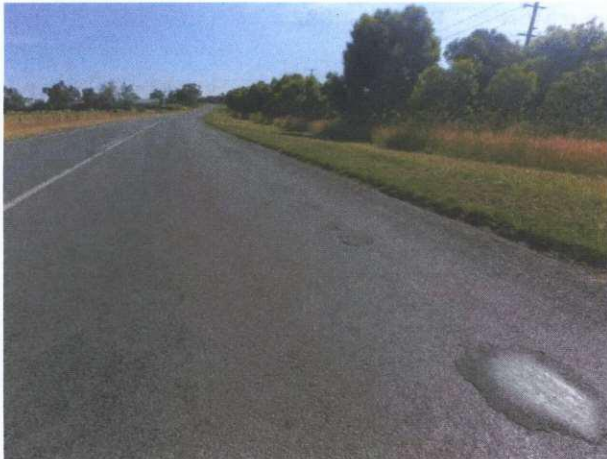
**Photo 131** 'GOPR7152.JPG' - (-38.2181569, 142.9212167)

**Terang – Mortlake Rd - CH 2.645 - 2.685**

-  
Rutting, flushing, filled potholes and seal breaking out  
south bound lane.

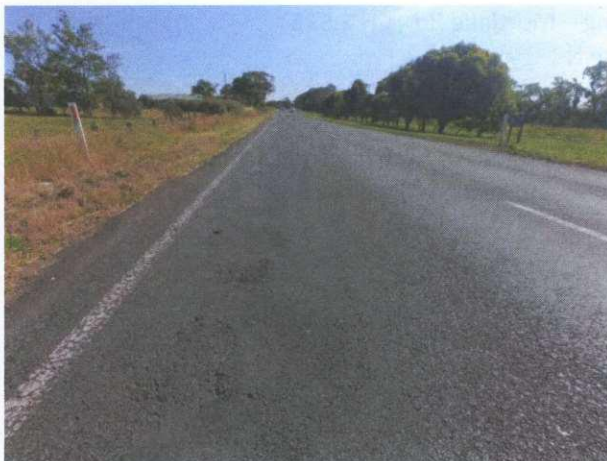
**Photo 132** 'GOPR7153.JPG' - (-38.2173478, 142.9214652)

**Terang – Mortlake Rd - CH 2.737**

-  
Rutting, flushing, filled potholes and seal breaking out  
north bound lane

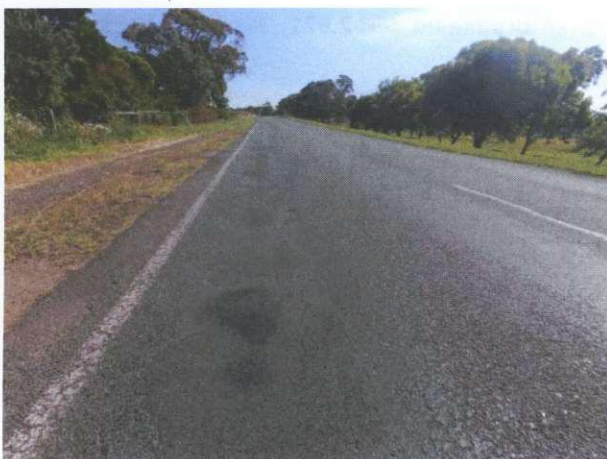
**Photo 133** 'GOPR7154.JPG' - (-38.2167533, 142.9217782)

**Terang – Mortlake Rd - CH 2.811**

-  
Rutting, flushing, filled potholes north bound lane

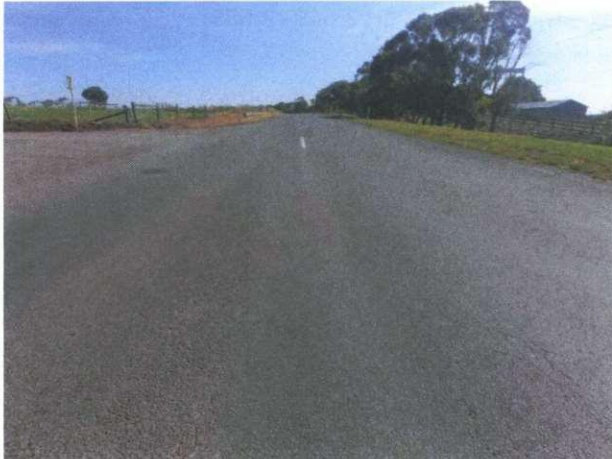
**Photo 134** 'GOPR7155.JPG' - (-38.2162258, 142.9220587)

**Terang – Mortlake Rd - CH 2.882**

-  
General view of Le Couteur Road with crocodile cracking and filled potholes to north bound lane

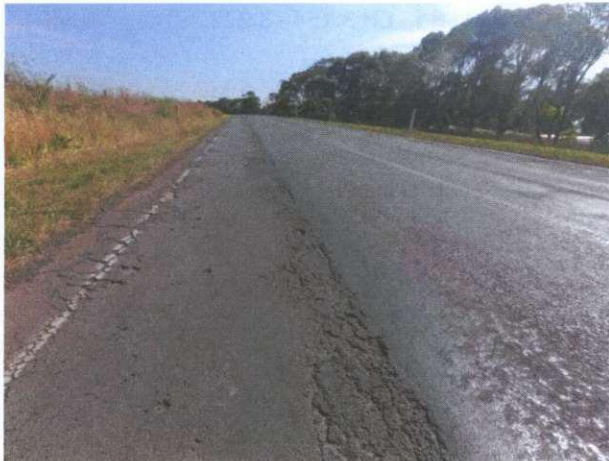
**Photo 137** 'GOPR7158.JPG' - (-38.2156517, 142.9223327)

**Terang – Mortlake Rd - CH 2.945**  
Facing N

-  
Rutting, flushing, shoving, crocodile cracking filled potholes and seal breaking out both lanes.

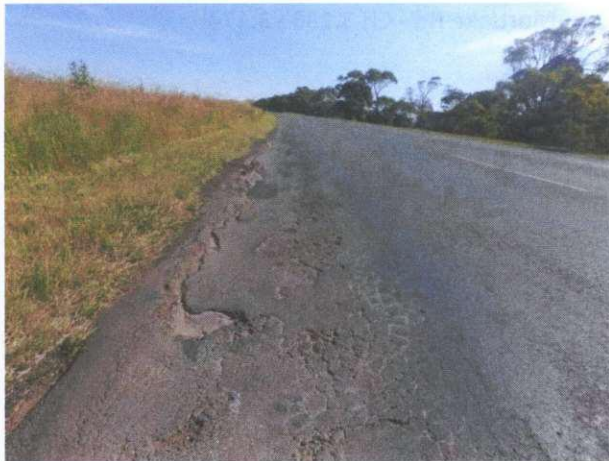
**Photo 138** 'GOPR7159.JPG' - (-38.2147389, 142.9227576)

**Terang – Mortlake Rd - CH 3.051**  
Facing N

-  
Rutting, flushing, shoving, crocodile cracking filled potholes and seal breaking out north bound lane.

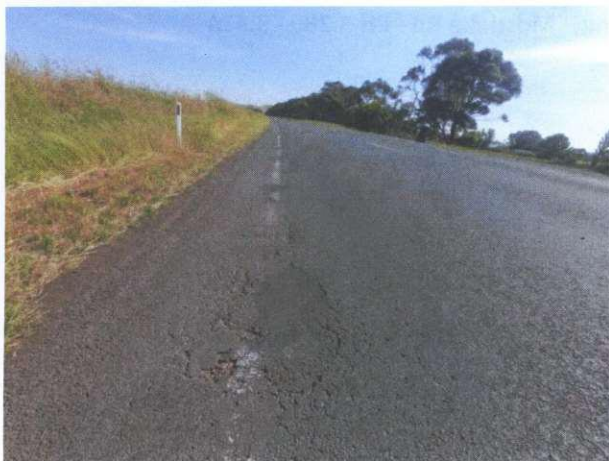
**Photo 139** 'GOPR7160.JPG' - (-38.2142717, 142.9229174)

**Terang – Mortlake Rd - CH 3.107 - 3.231**  
Facing N

-  
Rutting, flushing, shoving, crocodile cracking filled  
potholes and seal breaking out south bound lane

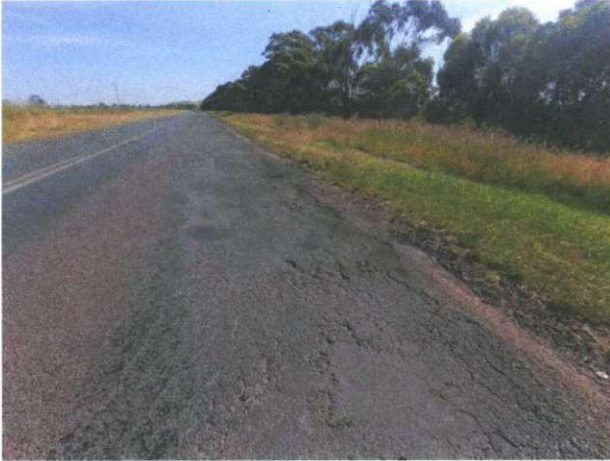
**Photo 140** 'GOPR7161.JPG' - (-38.2138021, 142.9230796)

**Terang – Mortlake Rd - CH 3.154 - 3.222**  
Facing N

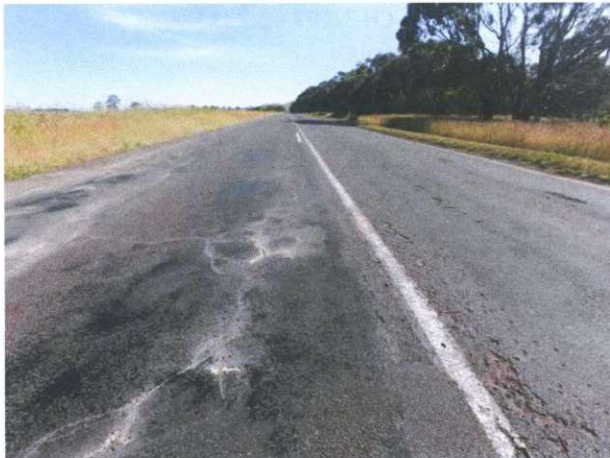
**Photo 142** 'GOPR7163.JPG' - (-38.2126839, 142.9232444)

**Terang – Mortlake Rd - CH 3.280 - 3.474**  
Facing N

-  
General view of pavement showing crocodile cracking,  
flushing, filled potholes and seal breaking out both  
lanes

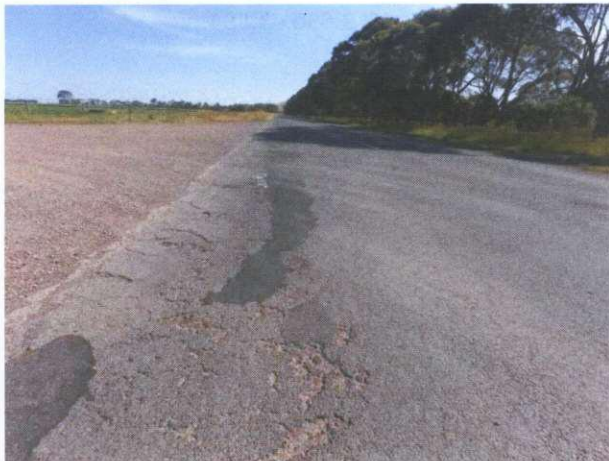
**Photo 143** 'GOPR7164.JPG' - (-38.2109677, 142.9235414)

**Terang – Mortlake Rd - CH 3.475**

-  
Filled potholes, crocodile cracking and seal breaking  
out north bound lane

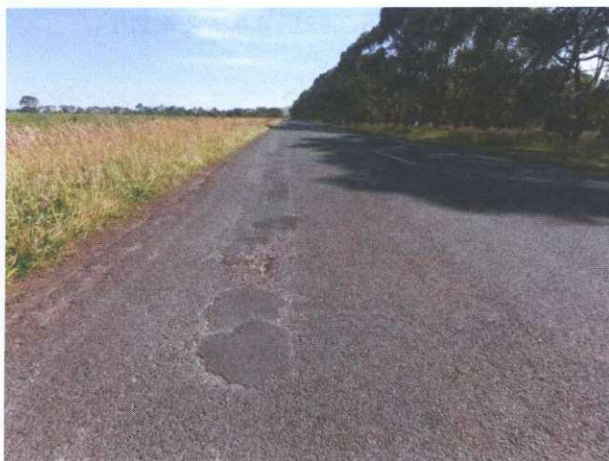
**Photo 145** 'GOPR7166.JPG' - (-38.2102405, 142.9236836)

**Terang – Mortlake Rd - CH 3.554 - 3.622**

-  
Filled potholes, crocodile cracking and seal breaking  
out north bound lane

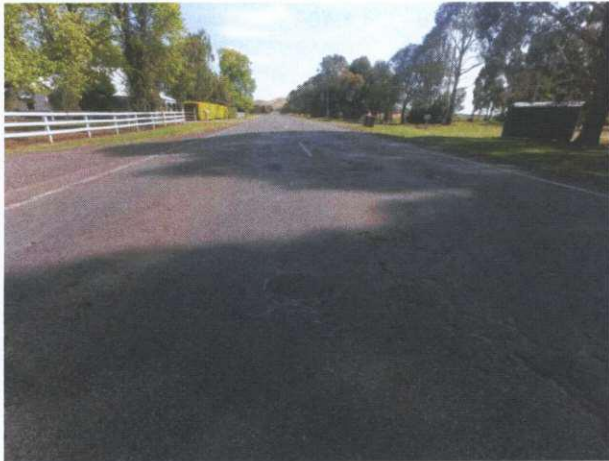
**Photo 149** 'GOPR7170.JPG' - (-38.2047135, 142.9247455)

**Terang – Mortlake Rd - CH 4.176 - 4.246**

- Numerous filled potholes, minor rutting, flushing, crocodile cracking and small breakouts in seal.

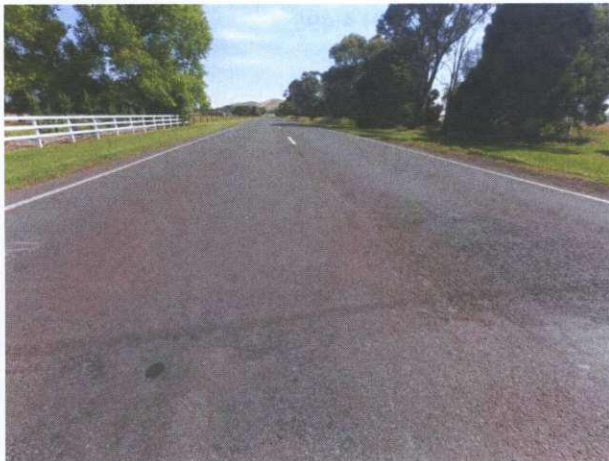
**Photo 150** 'GOPR7171.JPG' - (-38.2041125, 142.9248675)

**Terang – Mortlake Rd - CH 4.246**

- Change in seal

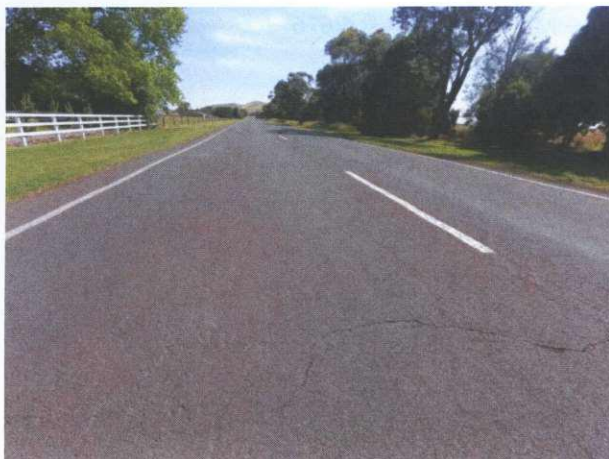
**Photo 151** 'GOPR7172.JPG' - (-38.2040211, 142.924876)

**Terang – Mortlake Rd - CH 4.252**

- Lateral crack in north bound lane typical of segment

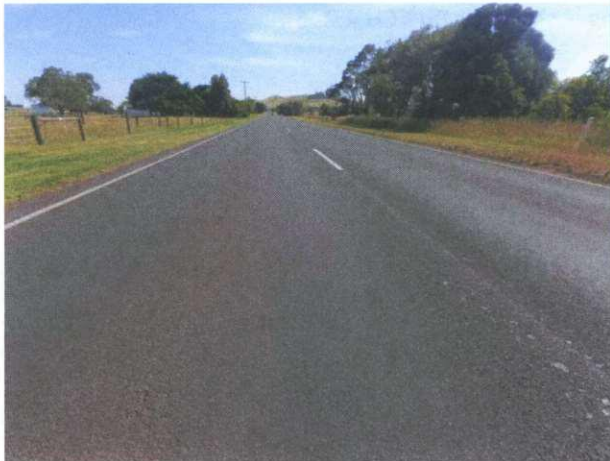
**Photo 153** 'GOPR7174.JPG' - (-38.2019071, 142.9252692)

**Terang – Mortlake Rd - CH 4.495**

Missing guide post west side

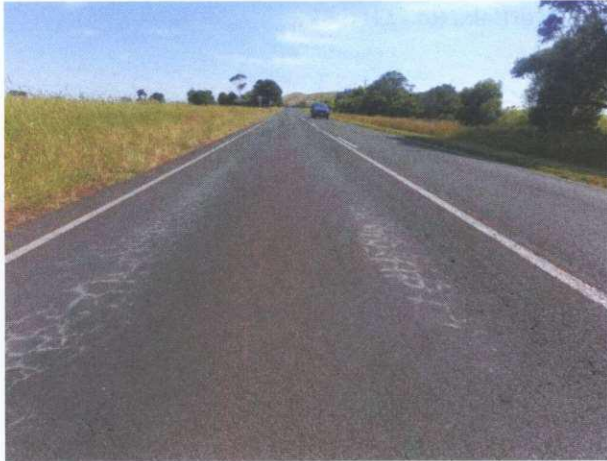
**Photo 155 'GOPR7176.JPG' - (-38.1988605, 142.9258488)**

**Terang – Mortlake Rd - CH 4.83**

-  
Crocodile cracking and pumping of fines prominent in north bound lane but some in south bound lane

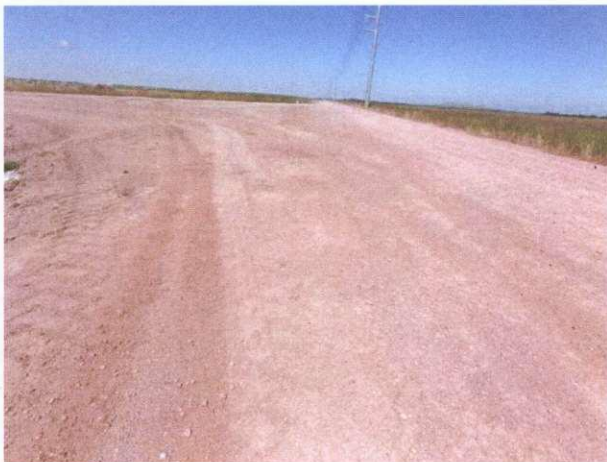
**Photo 2 (GOPR6902.JPG) - E-38.1304325, N142.8323481**

**Grinters Lane - CH 1796**

Some minor rutting and potholing at wind tower entry road

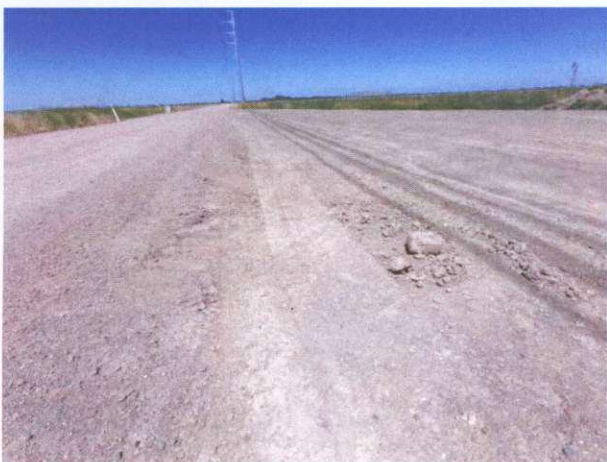
**Photo 3 (GOPR6903.JPG) - E-38.1311638, N142.838036**

**Grinters Lane - CH 2300**

Some minor rutting and potholing at wind tower entry road

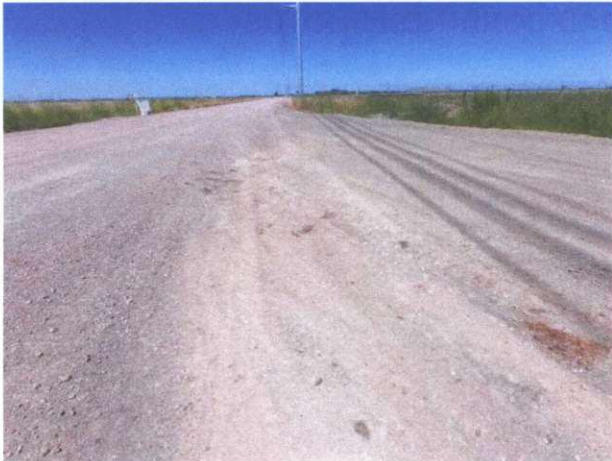
**Photo 4** (GOPR6904.JPG) - E-38.1312016, N142.8383182

**Grinters Lane - CH 2320**

Some minor rutting and potholing at wind tower entry road

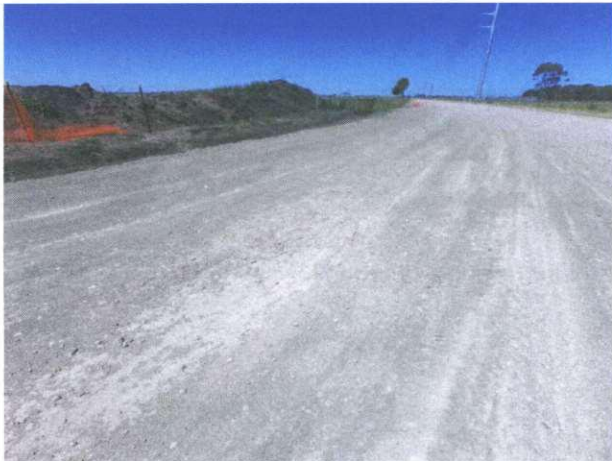
**Photo 5** (GOPR6905.JPG) - E-38.1320121, N142.845988

**Grinters Lane - CH 2997**

Some minor rutting and potholing at wind tower entry road

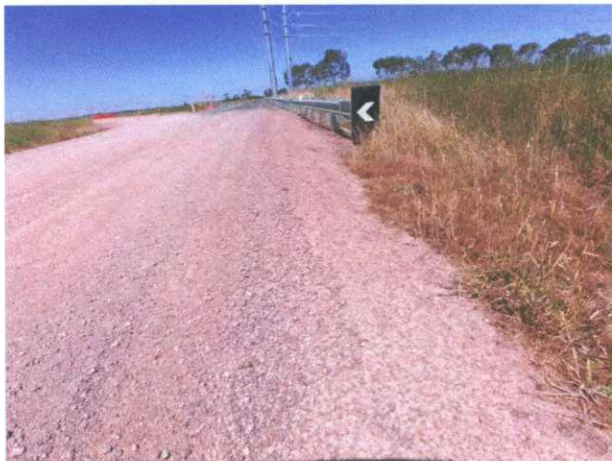
**Photo 6** (GOPR6906.JPG) - E-38.133238, N142.8556295

**Grinters Lane - CH 3880**

Chevron sign replaced on guard rail terminal

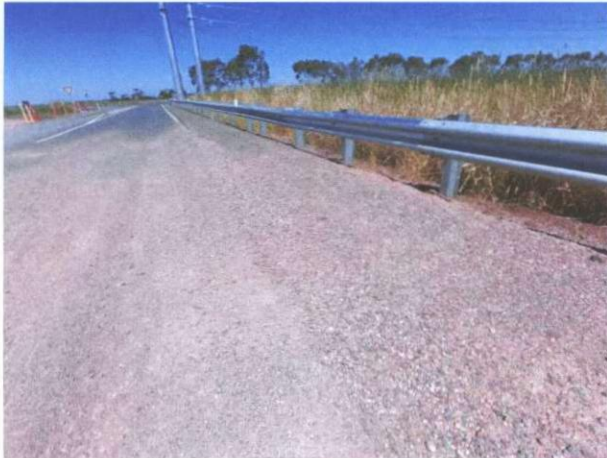
**Photo 7 (GOPR6907.JPG) - E-38.1332539, N142.8557998**

**Grinters Lane - CH 3895**

Section of damaged guard rail has been replaced.

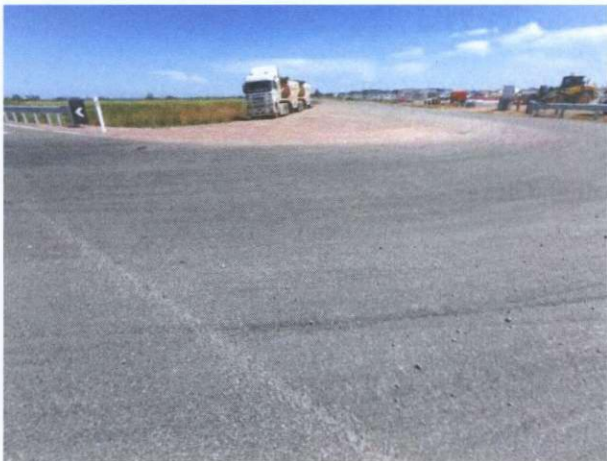
**Photo 8 (GOPR6908.JPG) - E-38.1274236, N142.8577828**

**Tapps Lane - CH 15**

Three guide posts missing at intersection with Terang-Mortlake Rd

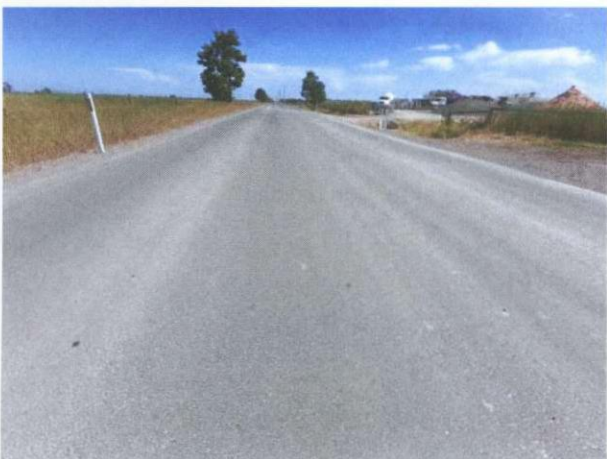
**Photo 9 (GOPR6909.JPG) - E-38.1296541, N142.8572219**

**Tapps Lane - CH 268**

Guide post missing on west side and line marking faded.

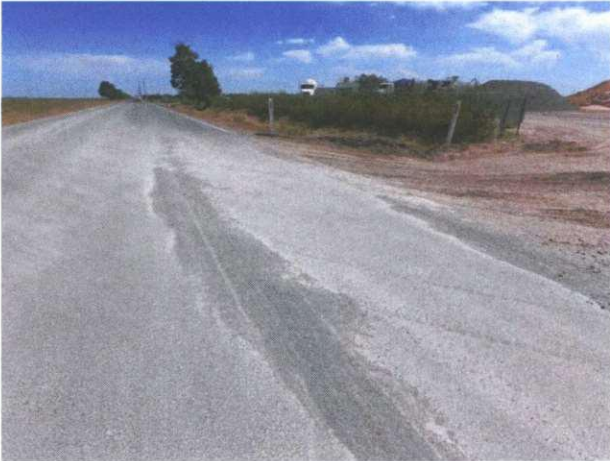
**Photo 10** (GOPR6910.JPG) - E-38.1299168, N142.857151

**Tapps Lane - CH 298**

Shoulder shove through turn into materials compound

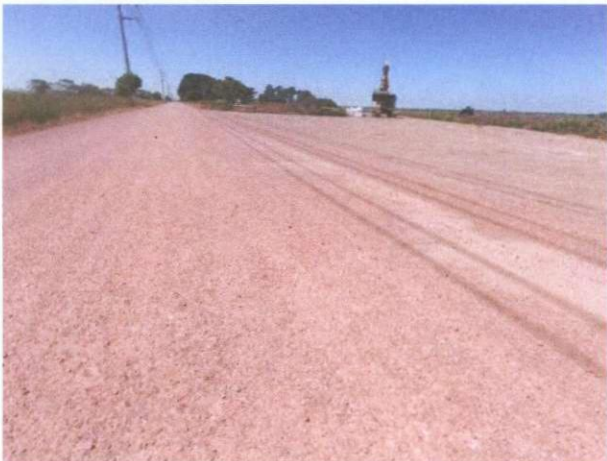
**Photo 14** (GOPR6914.JPG) - E-38.1720423, N142.8490685

**Tapps Lane - CH 5035**  
Facing N

Table drain being formed at tower entrance road intersection with Tapps Lane

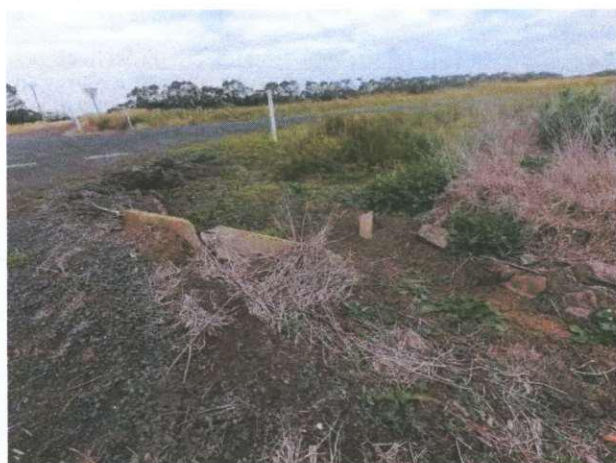
**Photo 9 'GOPR7475.JPG'** (-38.22608, 142.89482)

**Riley Road - CH 1.250**

Head wall damaged on south side of road

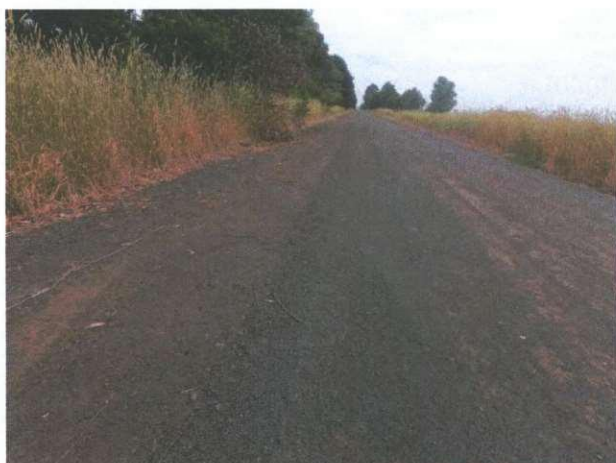
**Photo 1 'GOPR7467.JPG' (-38.22431, 142.88009)**

General view at intersection with Keilambete Rd.

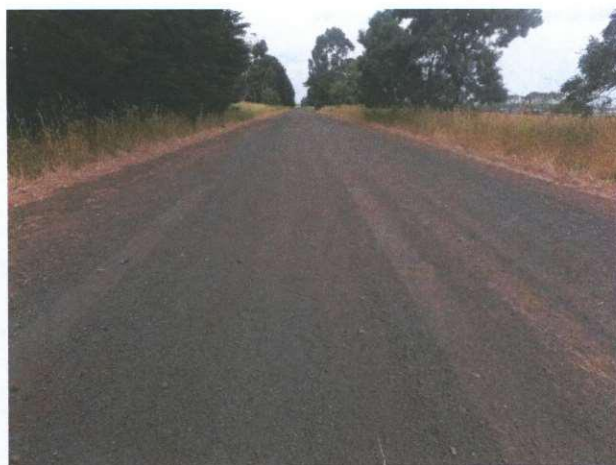
**Photo 2 'GOPR7468.JPG' (-38.22441, 142.88123)**

Tree branch on shoulder.

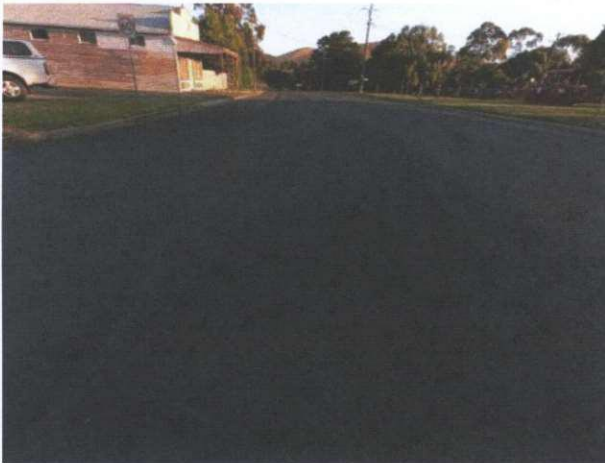
**Photo 1** 'GOPR7840.JPG' - (-38.19162, 142.92719)

Crocodile cracking through intersection

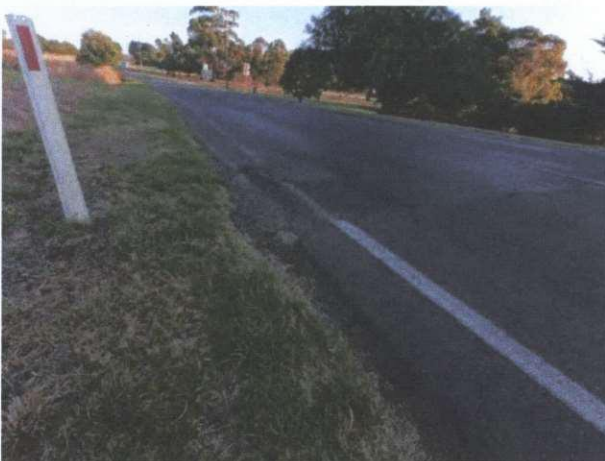
**Photo 2** 'GOPR7841.JPG' - (-38.19054, 142.92722)

Shoving of patch on west side, guide post missing on east side.

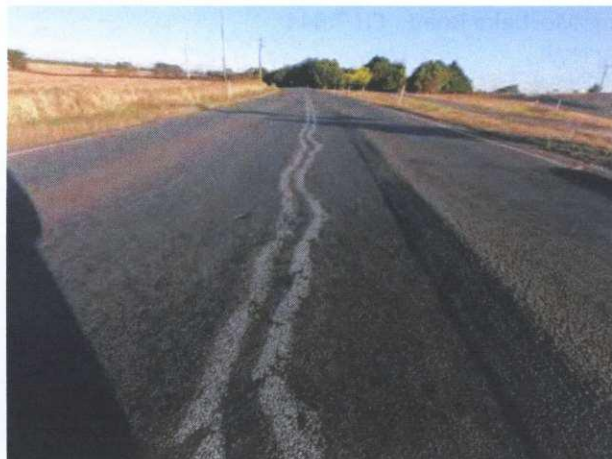
**Photo 7** 'GOPR7846.JPG' - (-38.17457, 142.92083)

Centre line tracking

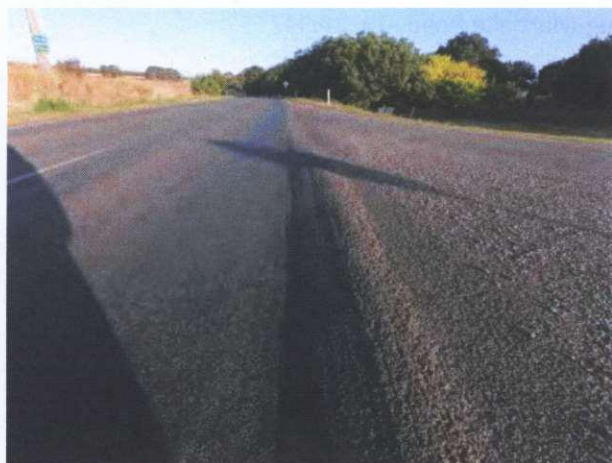
**Photo 8** 'GOPR7847.JPG' - (-38.17393, 142.92037)

Shove at intersection

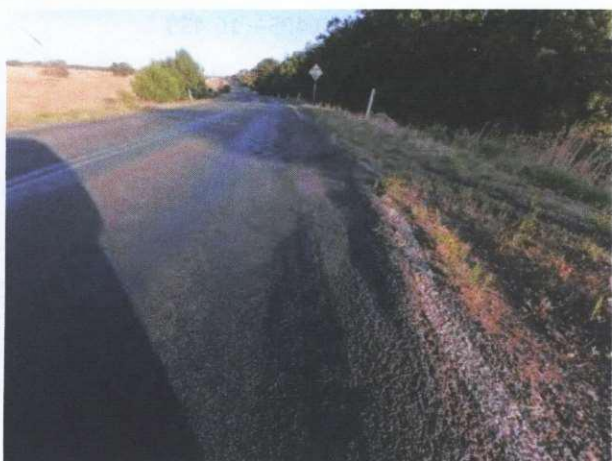
**Photo 9** 'GOPR7848.JPG' - (-38.1737, 142.92018)

Flushing, shoving, edge line tracking, rutting and seal breaking out south bound lane

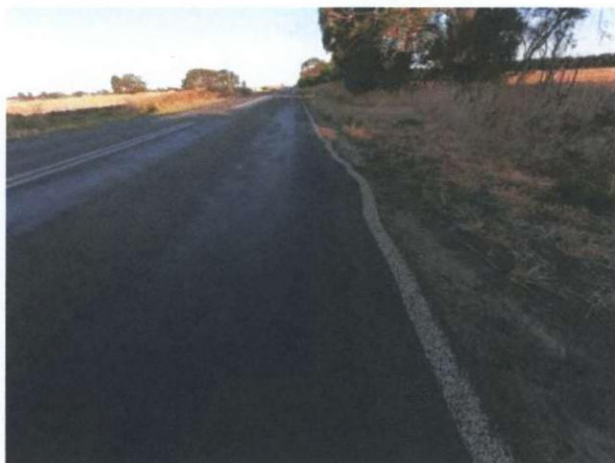
Photo 10 'GOPR7849.JPG' - (-38.17256, 142.9187)

Flushing, shoving and edge line tracking south bound lane

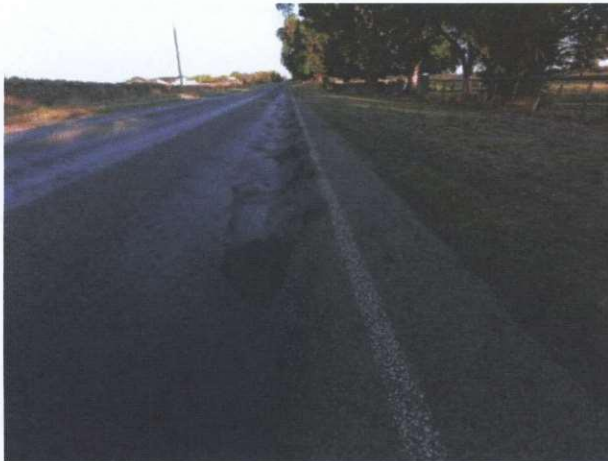
**Photo 13** 'GOPR7852.JPG' - (-38.15687, 142.89601)

Rutting, shoving and seal breaking out south bound lane

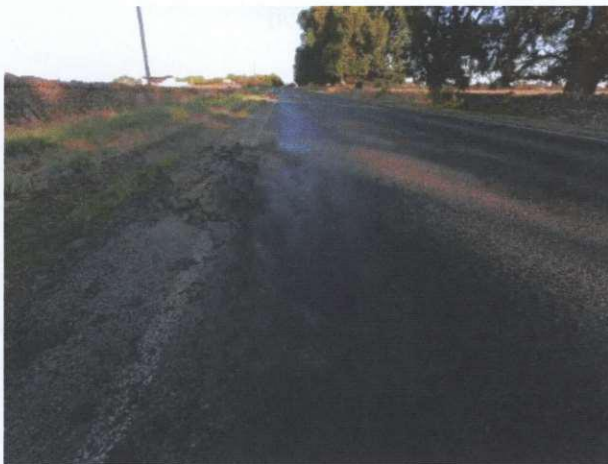
**Photo 14** 'GOPR7853.JPG' - (-38.15676, 142.89573)

Potholes patched but shoving out, crocodile cracking north bound lane

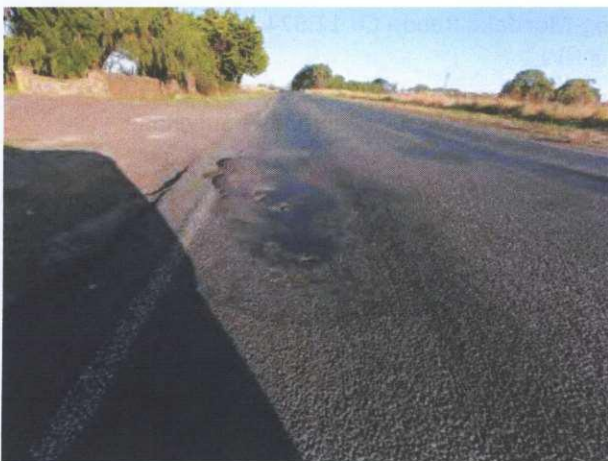
**Photo 15** 'GOPR7854.JPG' - (-38.15256, 142.88999)

Potholes patched but shoving out, crocodile cracking north bound lane

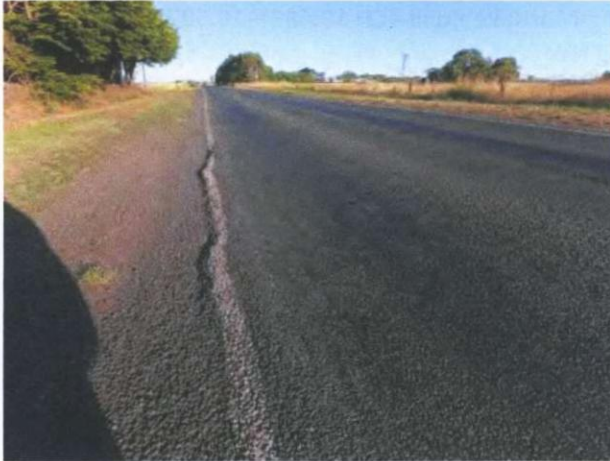
**Photo 16** 'GOPR7855.JPG' - (-38.15243, 142.8898)

Rutting, shoving, edge line tracking and seal breaking out

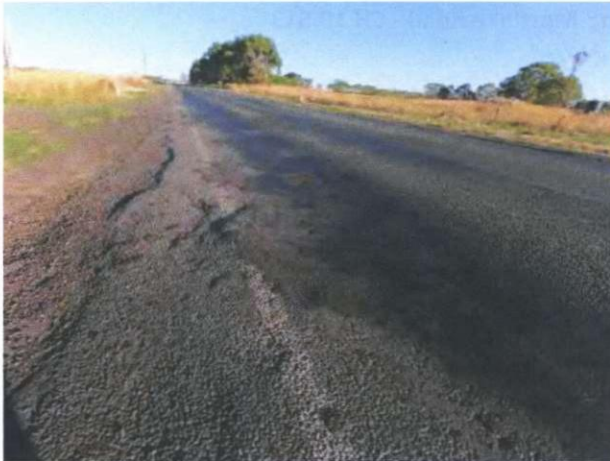
**Photo 17** 'GOPR7856.JPG' - (-38.15213, 142.88939)

Major pavement failure full width with rutting, flushing, large areas of seal breaking out and shoving

In general, repairs should be performed to many sections of both roads to improve conditions. Several asphalt overlays conducted recently have started to fail, indicating that this treatment method is inadequate and reconstruction of the pavement in failed areas is necessary for a mid to long term solution.

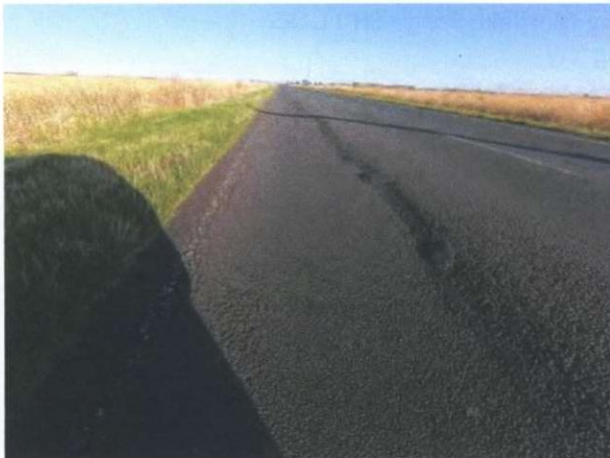
**Photo 18** 'GOPR7857.JPG' - (-38.14428, 142.87907)

Typical view of heavy rutting in north bound lane.

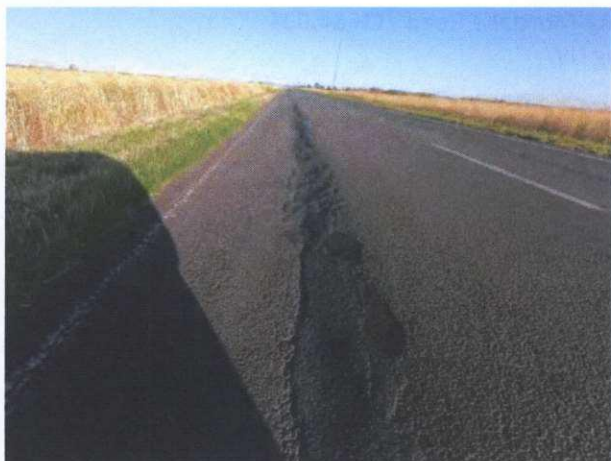
**Photo 19** 'GOPR7858.JPG' - (-38.14391, 142.87859)

Typical view of heavy rutting in north bound lane.

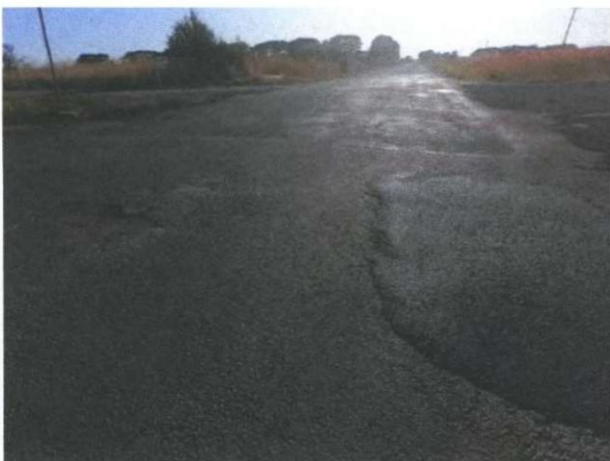
Photo 30 'GOPR7869.JPG' - (-38.19664, 142.84436)

Patch failure repaired. New area cracking and breaking up in crown.

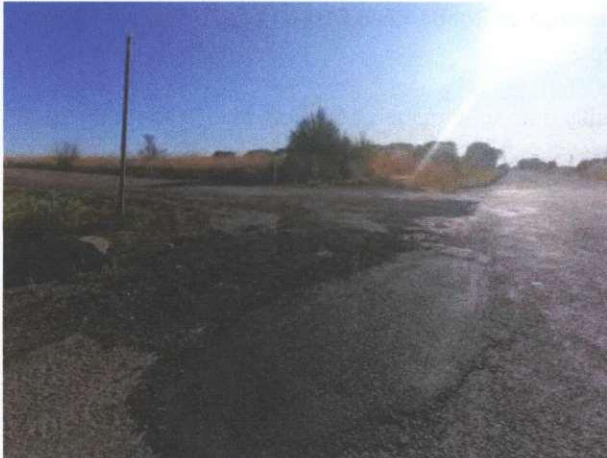
**Photo 31 'GOPR7870.JPG' - (-38.19659, 142.84443)**

Patched pothole, breaking out and shoving at intersection of Tapps Lane. Finger sign (road name sign) missing off pole.

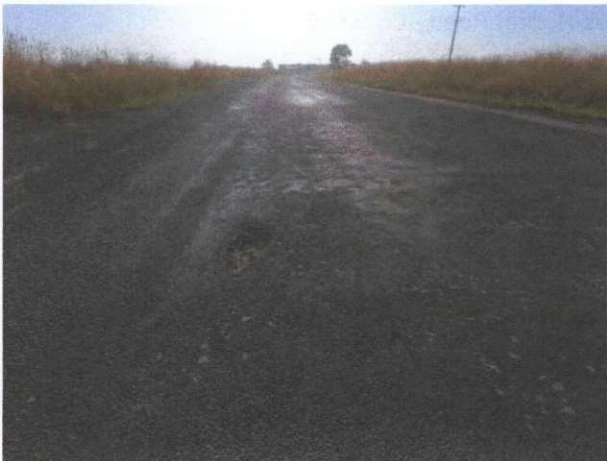
**Photo 32 'GOPR7871.JPG' - (-38.19736, 142.85251)**

Patch breaking open

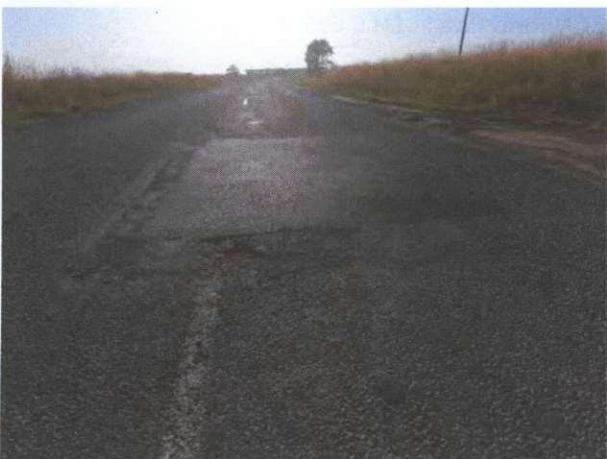
**Photo 33 'GOPR7872.JPG' - (-38.1974, 142.85274)**

Patch repaired but breaking open again either side and crocodile cracking beyond.

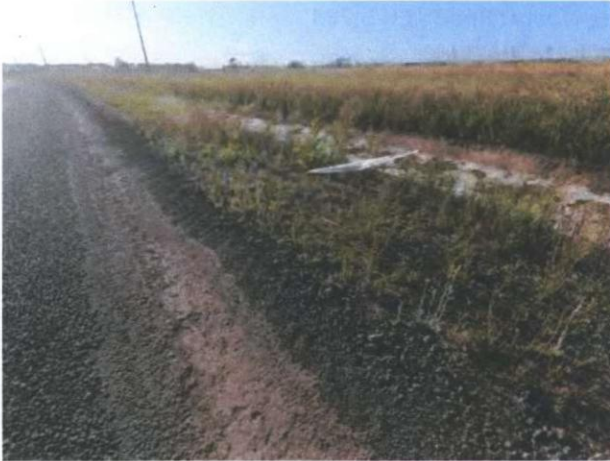
Photo 34 'GOPR7873.JPG' - (-38.19764, 142.85406)

Recently damaged guide post south side of road.

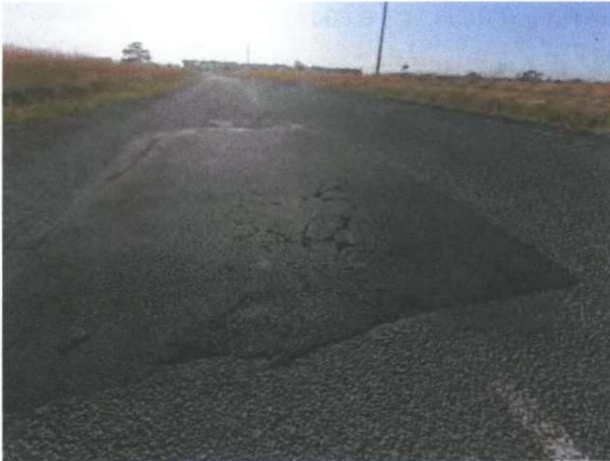
Photo 35 'GOPR7874.JPG' - (-38.19767, 142.85444)

Recent patch breaking open.

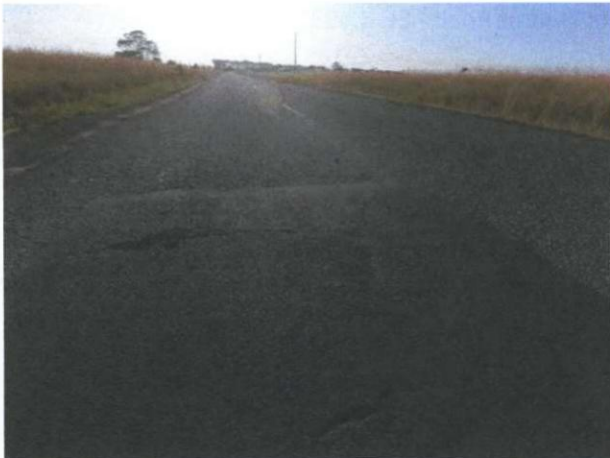
Photo 36 'GOPR7875.JPG' - (-38.19778, 142.85511)

Recent patches breaking out.

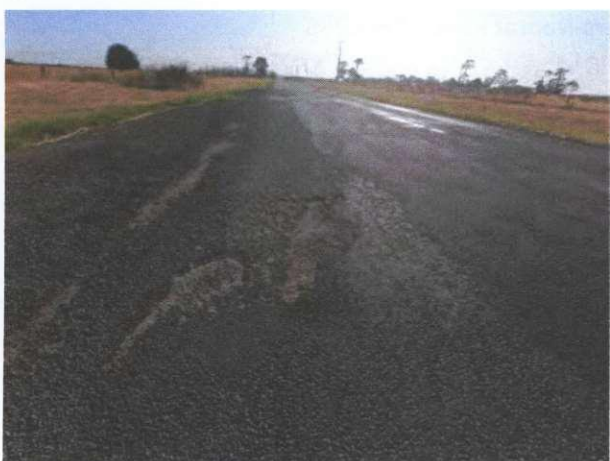
**Photo 39** 'GOPR7878.JPG' - (-38.19708, 142.86451)

Recent patches in pavement, large rectangular patches have very thin seal stripping off

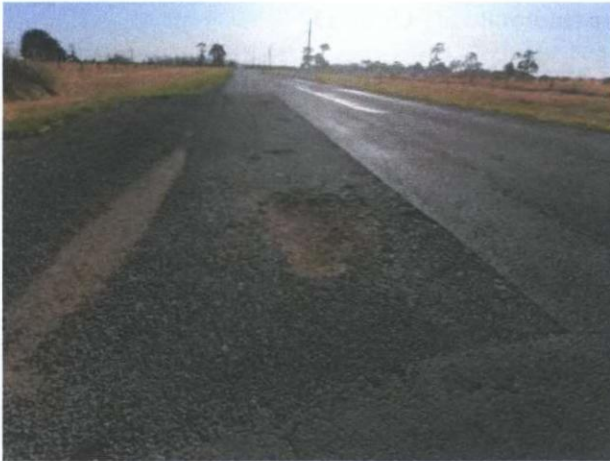
**Photo 40** 'GOPR7879.JPG' - (-38.19704, 142.86471)

Recent patches in pavement. Large rectangular patches have very thin seal stripping off and potholing.

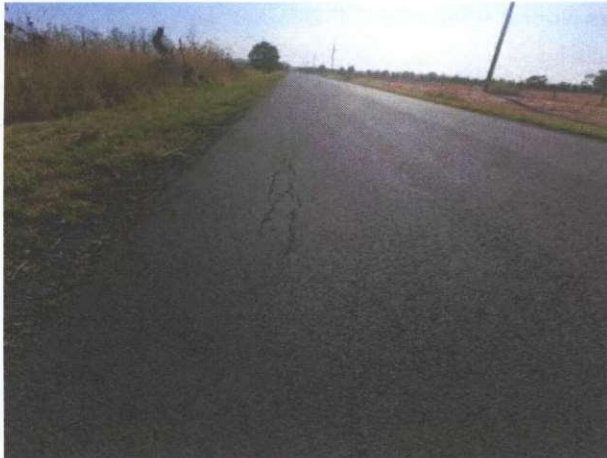
**Photo 43 'GOPR7882.JPG' - (-38.19628, 142.86869)**

Longitudinal cracking in major patch.

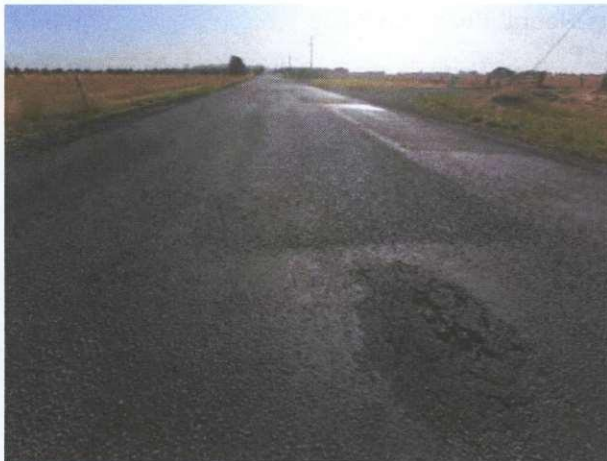
**Photo 44 'GOPR7883.JPG' - (-38.19595, 142.87047)**

Recent patches starting to break open.

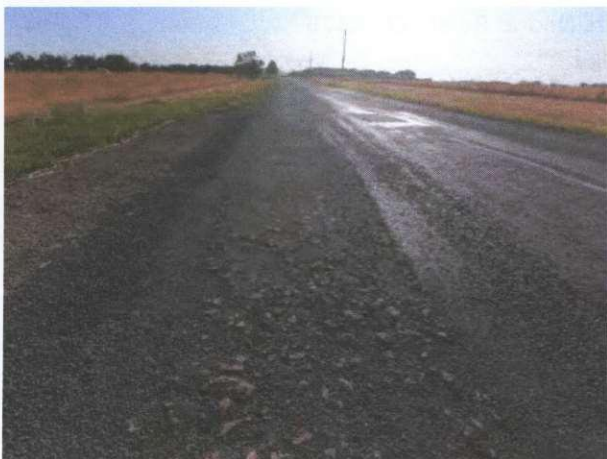
**Photo 45 'GOPR7884.JPG' - (-38.19529, 142.87377)**

Thin seal on patch stripping

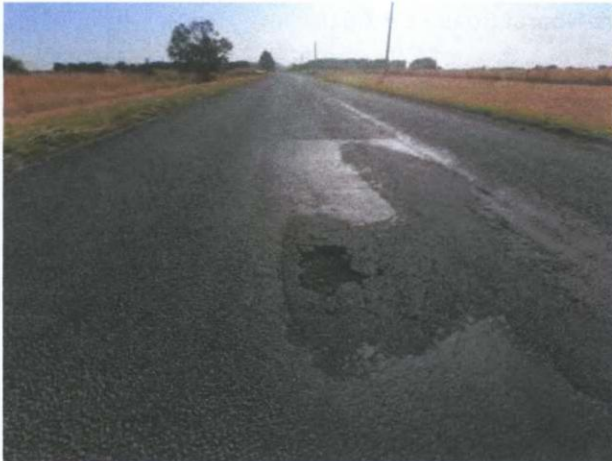
Photo 46 'GOPR7885.JPG' - (-38.19519, 142.87438)

Patch in crown reopening.

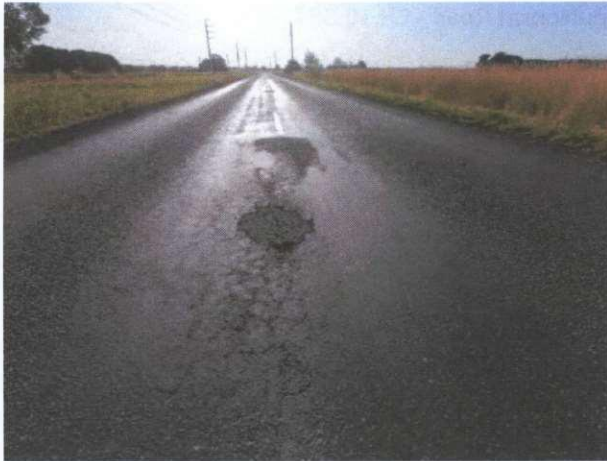
**Photo 49** 'GOPR7888.JPG' - (-38.19456, 142.89352)

Recent patch breaking out.

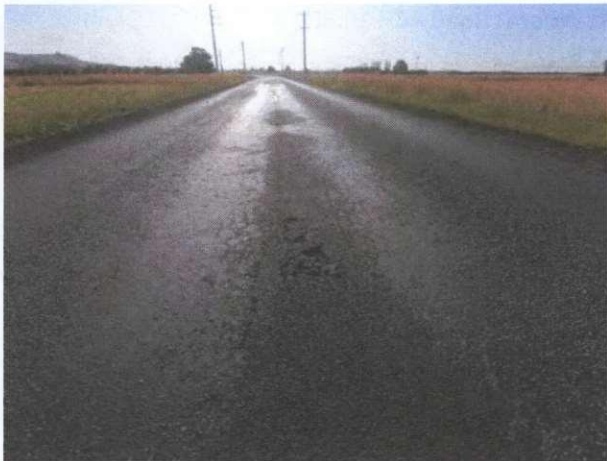
**Photo 50** 'GOPR7889.JPG' - (-38.19475, 142.89536)

Recent patches breaking out in crown.

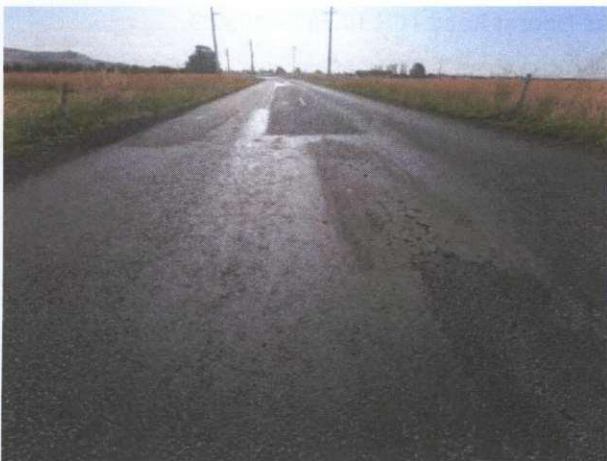
**Photo 51** 'GOPR7890.JPG' - (-38.19478, 142.89563)

Crocodile cracking around recent patches.

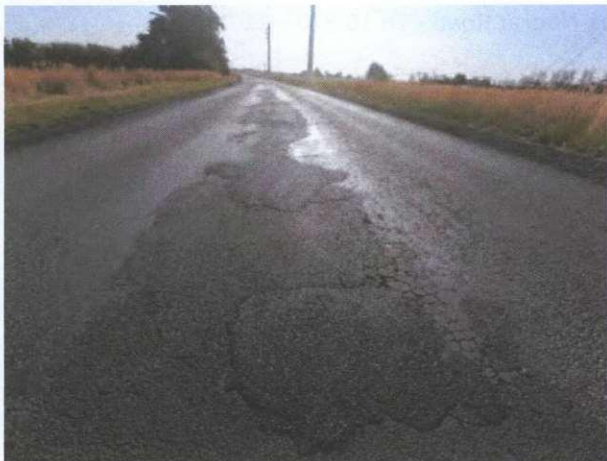
Photo 56 'GOPR7895.JPG' - (-38.19488, 142.89772)

Recent patches breaking out have been repaired, but cracking around repairs.

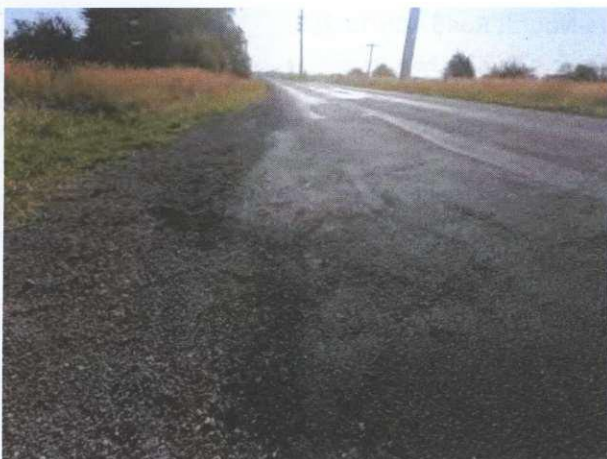
Photo 57 'GOPR7896.JPG' - (-38.19481, 142.8982)

Edge break out repaired.

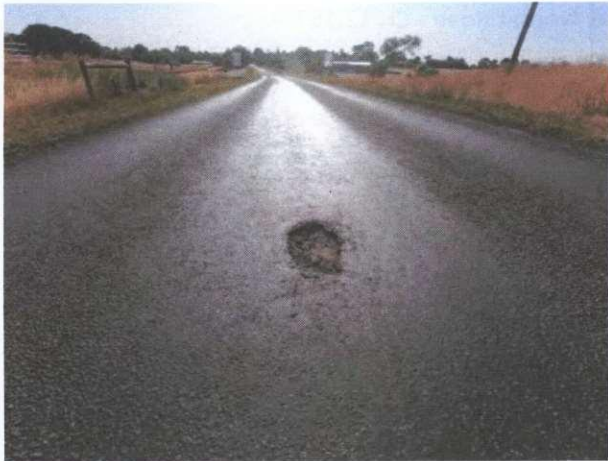
Photo 61 'GOPR7900.JPG' - (-38.19203, 142.92244)

Seal breaking out

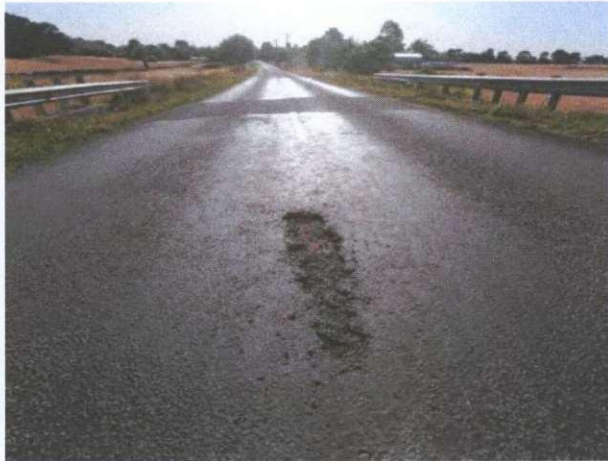
Photo 62 'GOPR7901.JPG' - (-38.19203, 142.92301)

Seal breaking out
