**Acciona Energy Australia Global Pty Ltd**

Mortlake South Wind Farm Transmission Line  
Traffic Management Plan  
Final Report Version 3

**INITIAL DILAPIDATION REPORT**

## MORTLAKE SOUTH WIND FARM LOCAL UPGRADED ROADS ORIGINAL CONDITION DILAPIDATION REPORT

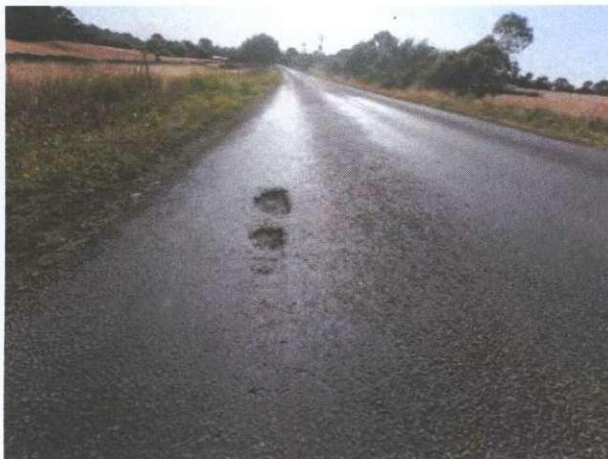
Photo 63 'GOPR7902.JPG' - (-38.192, 142.92321)

Seal breaking out and crocodile cracking.
