Mortlake South Wind Farm Transmission Line

Traffic Management Plan

Final Report Version 3

18 February 2020

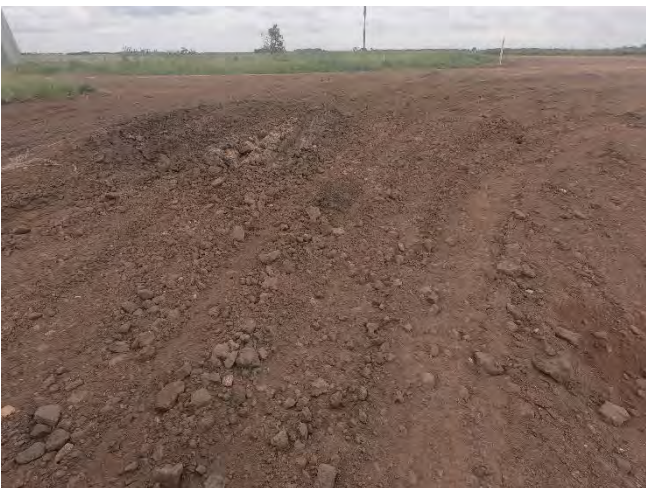
TAPPS LANE - CH 5482

GOOD

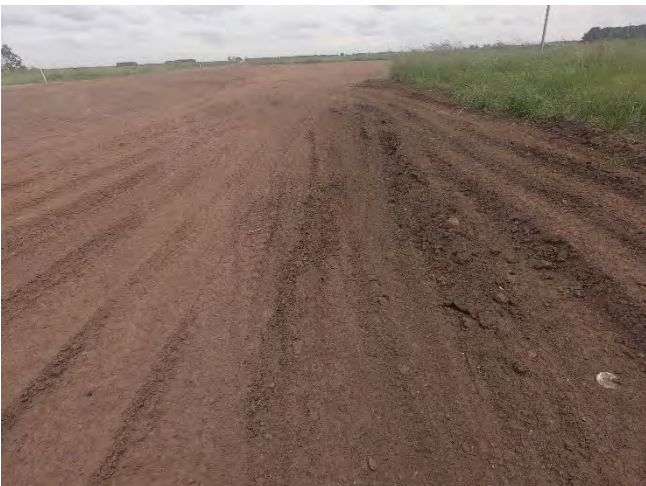
TAPPS LANE - CH 5477

FAIR

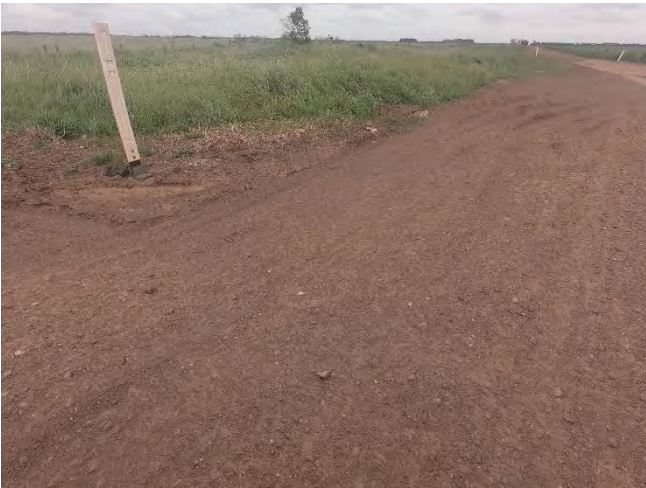
TAPPS LANE - CH 5499

Wheel rutting on south-east corner of Cliffords Lane (Londrigans Lane) intersection due to U-turn movements. Soft edges.

FAIR

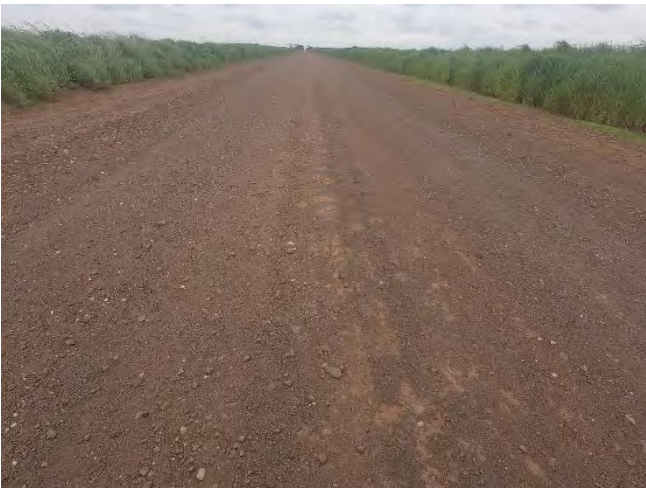
TAPPS LANE - CH 5625

General view of pavement

GOOD

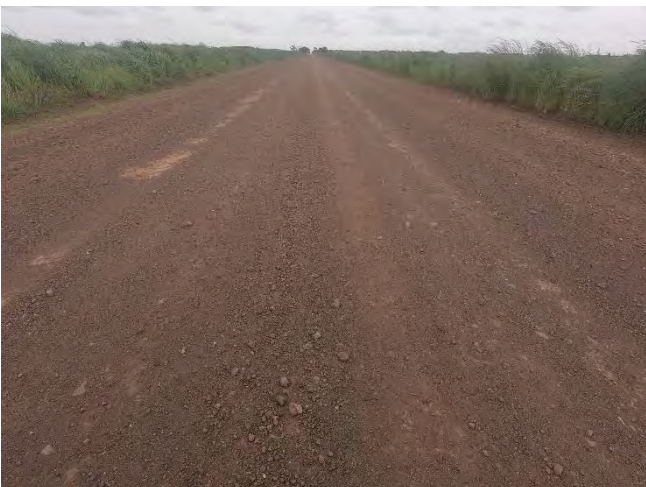
TAPPS LANE - CH 5908

General view of pavement

GOOD

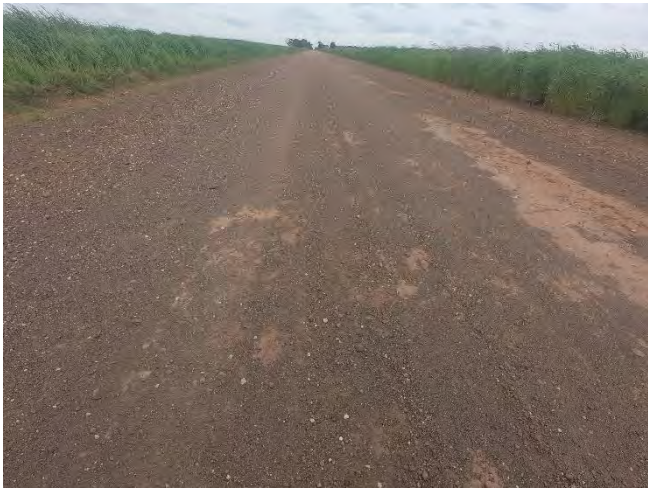
TAPPS LANE - CH 6229

GOOD

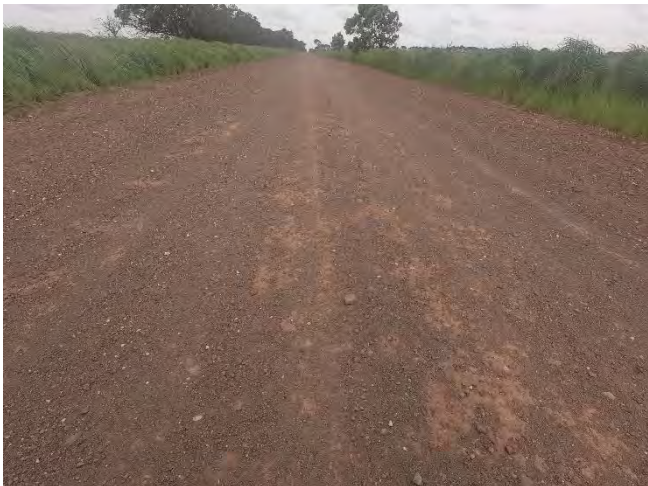
TAPPS LANE - CH 6534

GOOD

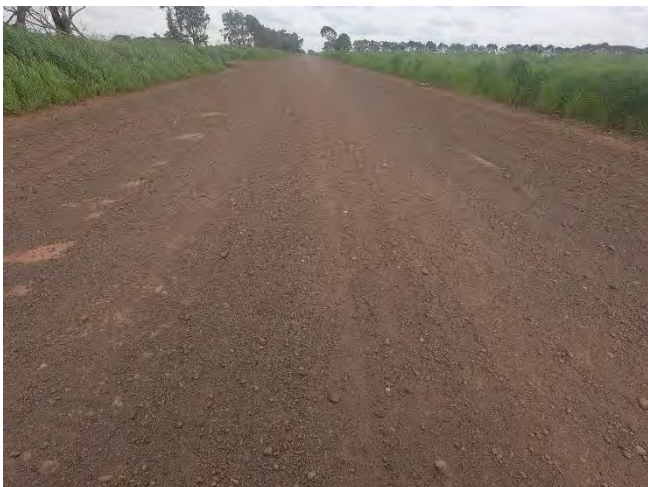
TAPPS LANE - CH 6825

GOOD

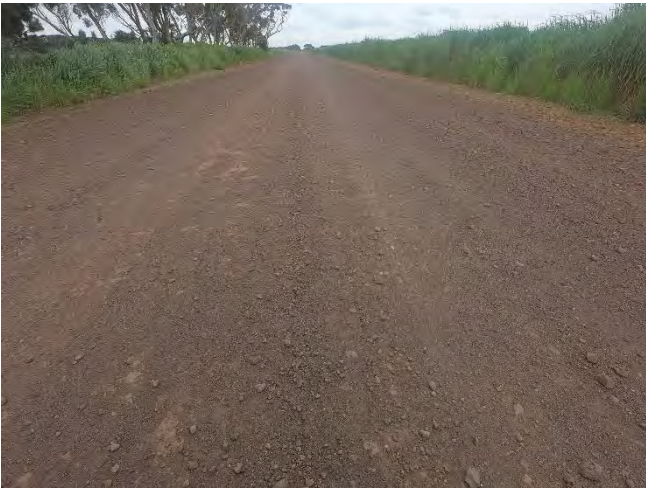
TAPPS LANE - CH 7123

GOOD

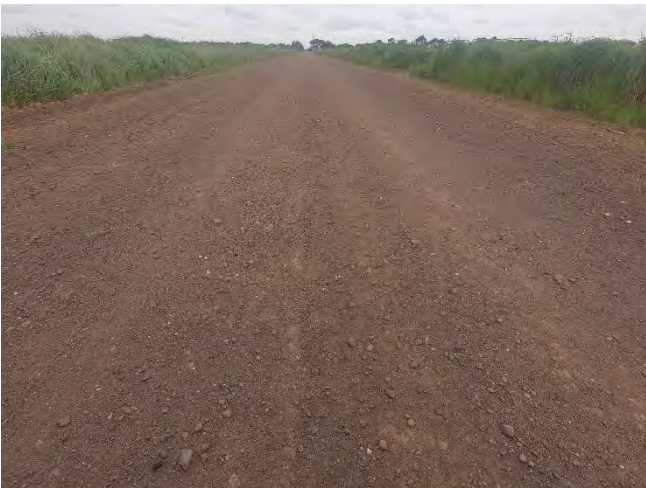
TAPPS LANE - CH 7426

GOOD

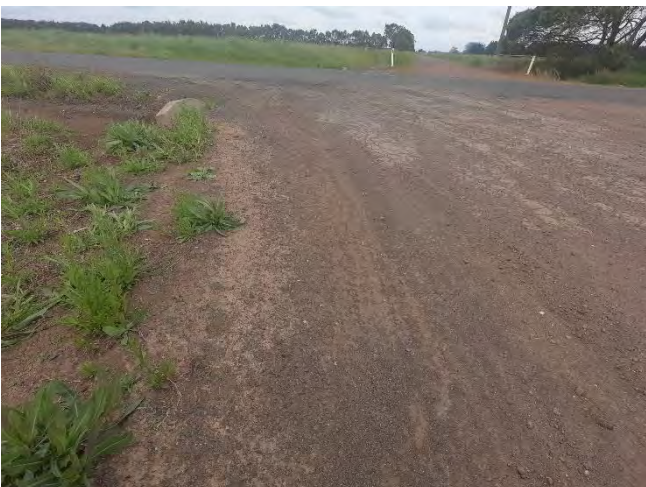
TAPPS LANE - CH 7773

GOOD

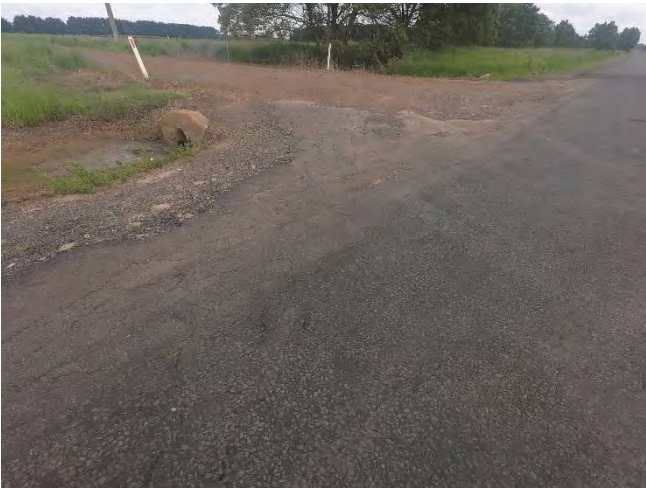
TAPPS LANE - CH 7783

General view of the Sisters-Noorat Rd intersection at south-east side.

GOOD

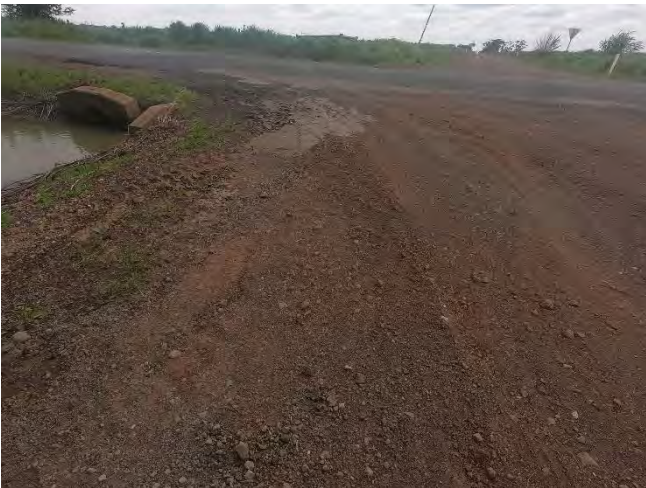
TAPPS LANE - CH 7790

General view of the Sisters-Noorat Rd intersection at south-west side.

GOOD

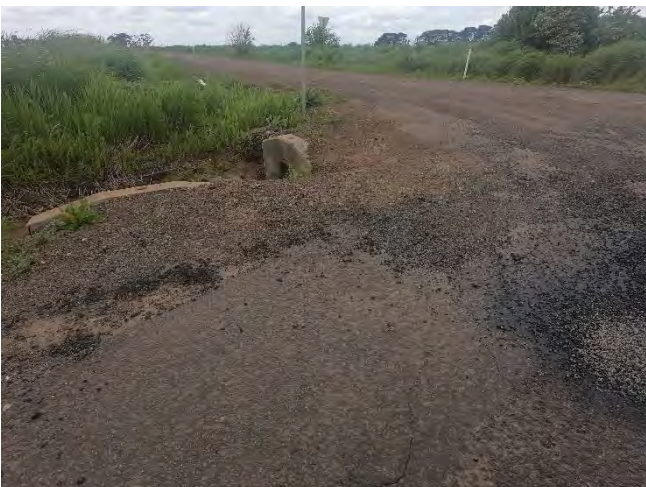
TAPPS LANE - CH 7770

General view of the Sisters-Noorat Rd intersection at north-west side.

GOOD

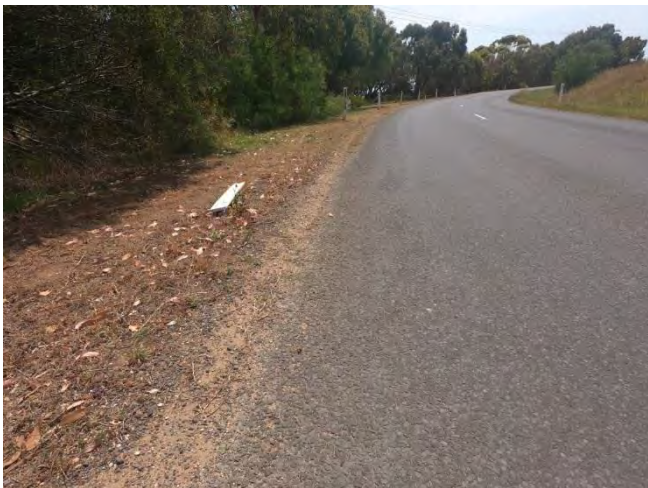
Burkes Rd - CH 1.705

-
Guide posts damaged through curve

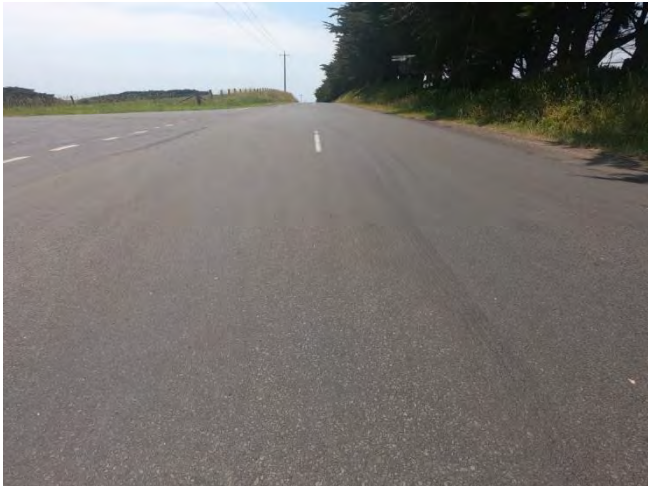
Burkes Rd - CH 1.895

-
Intersection with Hopkins Point Road. Crocodile
Cracking through intersection

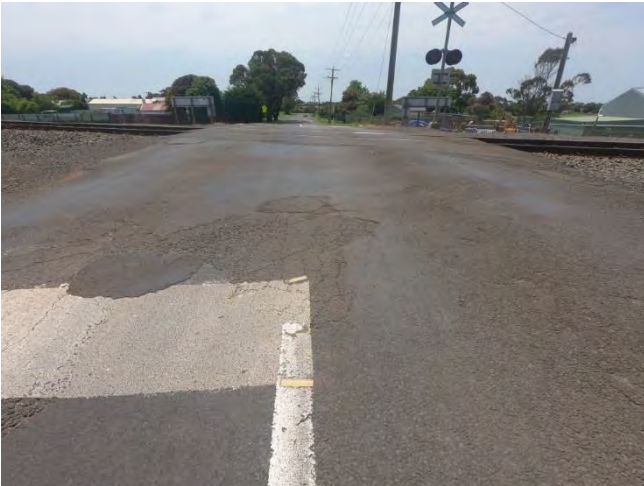
Tooram Rd - CH 4.725

General view at approach to railway line, Seal moderately flush and lateral crack across pavement 1 meter before railway line.

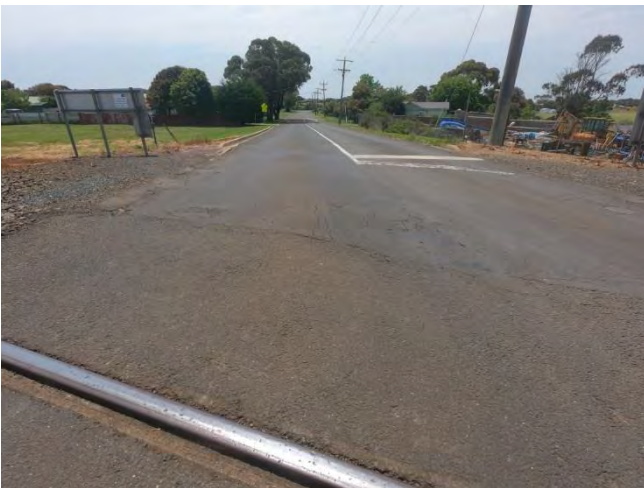
Tooram Rd - CH 4.733

General view at departure from railway line with shove in centre of northbound lane and crocodile cracking in southbound lane

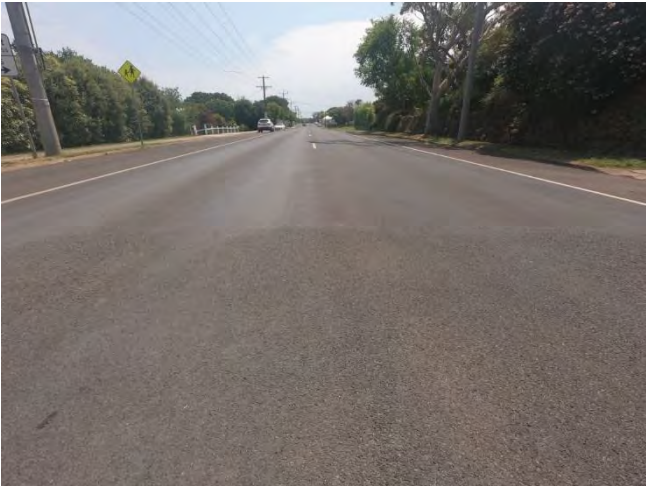
Ziegler Pd - CH 5.19

-
Change in seal, Seal moderately flush

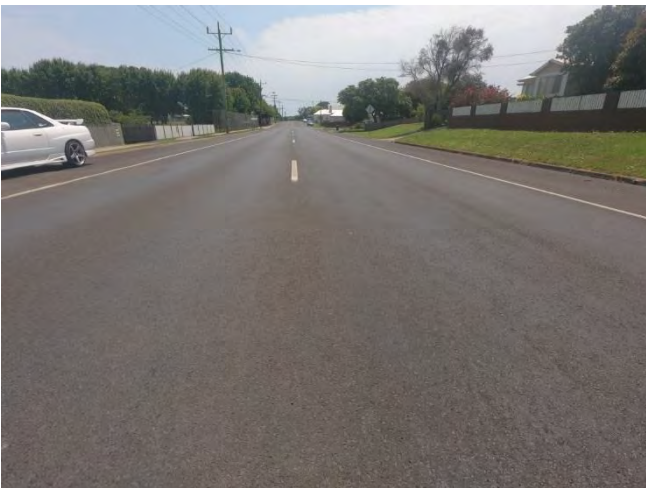
Ziegler Pd - CH 5.25

-
General view of pavement seal moderately flush

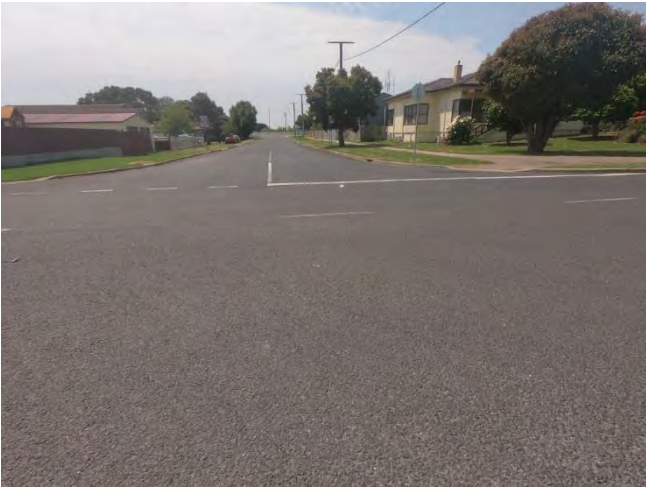
Ziegler Pd - CH 5.346

General view of pavement at intersection Ziegler Parade with minor crocodile cracking throughout.

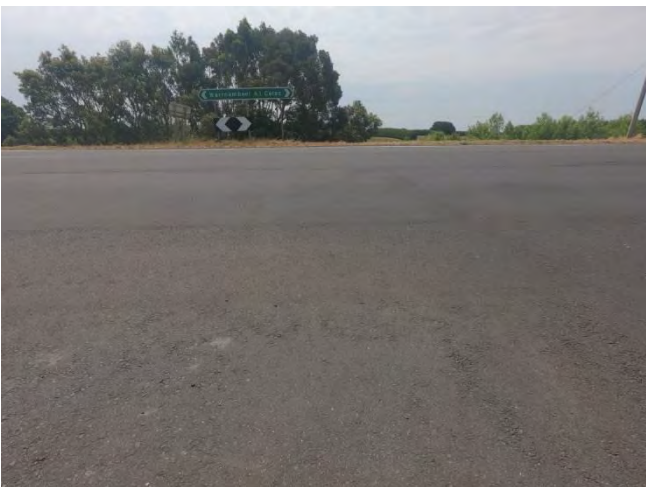
Garabaldi Ln - CH 5.5

General view of pavement at Princes Highway intersection, some lateral cracking through eastbound lane.

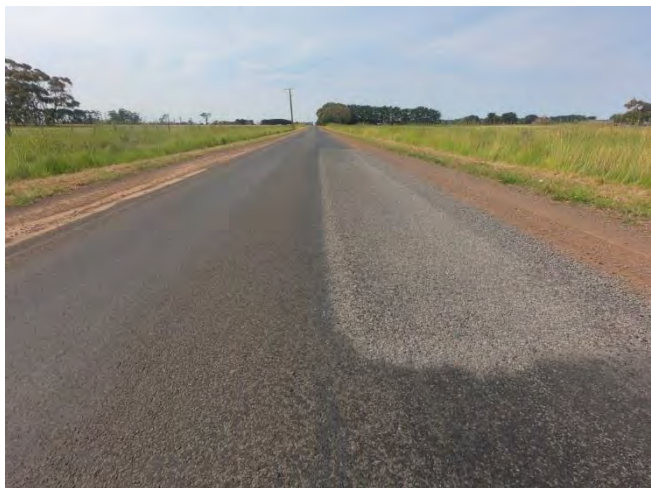
Noogee Rd - CH 0.198

Recent patch east side

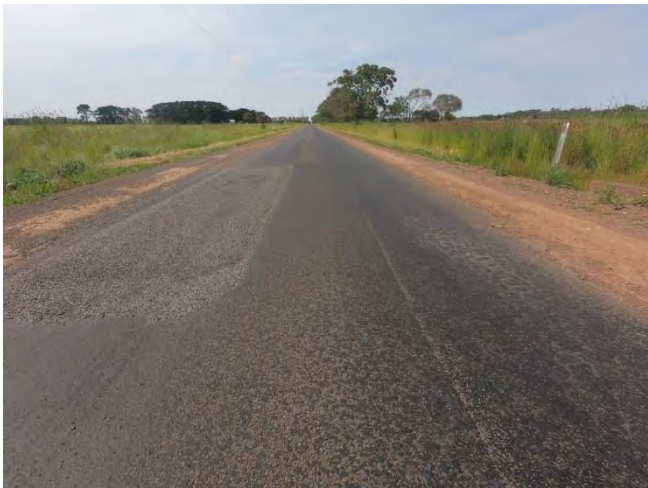
Noogee Rd - CH 0.852

Recent patch west side, crocodile cracking east side, over culvert.

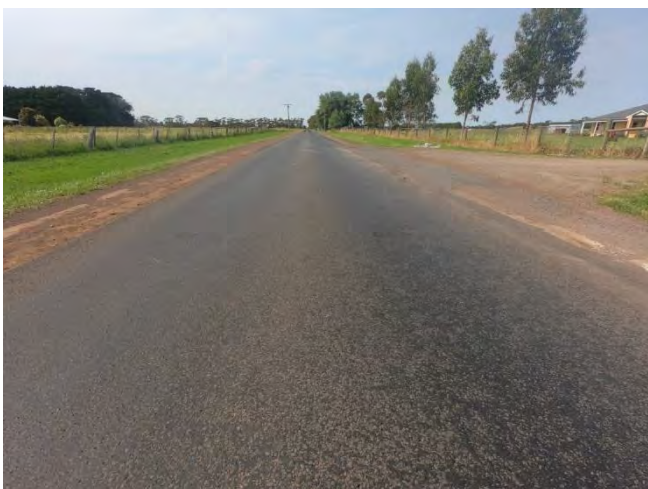
Noogee Rd - CH 1.25

General view of pavement, some crocodile cracking

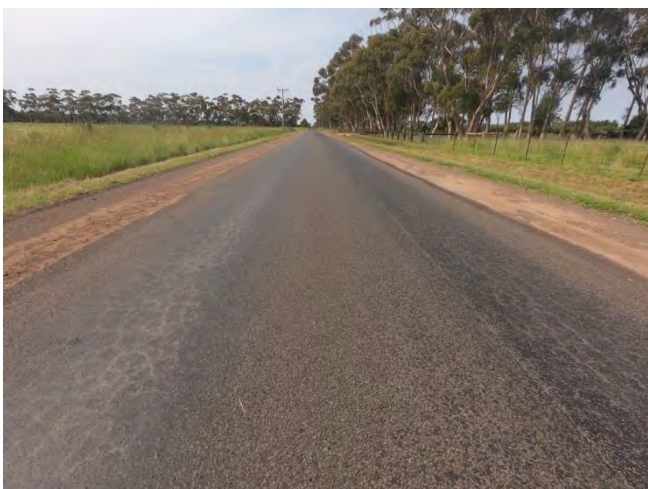
Noogee Rd - CH 1.75

-
General view of pavement, moderate crocodile cracking throughout.

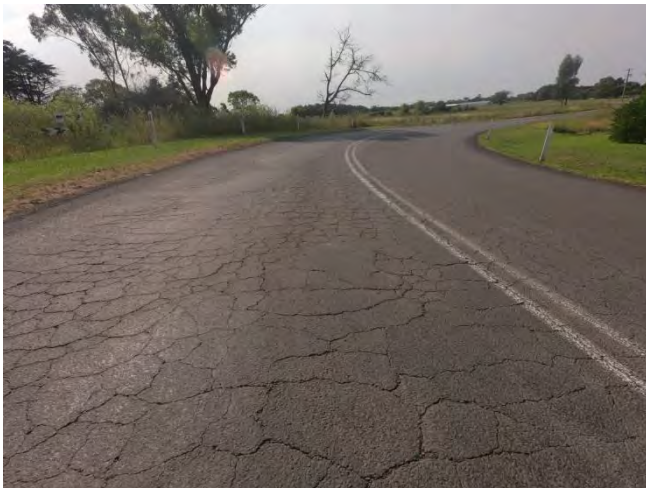
Terang – Framlingham Rd - CH 2.81

Extensive crocodile cracking in curve.

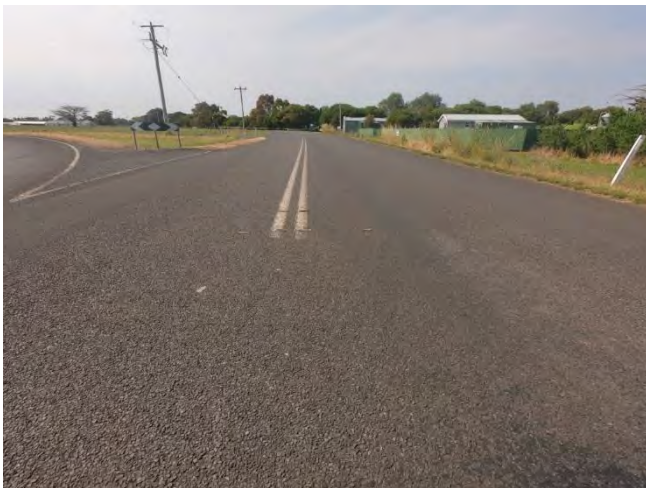
Terang – Framlingham Rd - CH 2.93

Change in seal at Keilambete Rd intersection

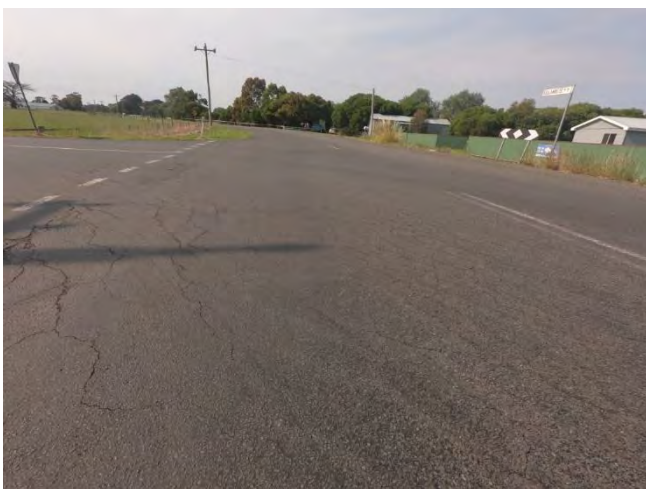
Keilambete Rd - CH 2.965

Terang-Framlingham Rd intersection with crocodile cracking on west side. Guide post knocked over on east side.

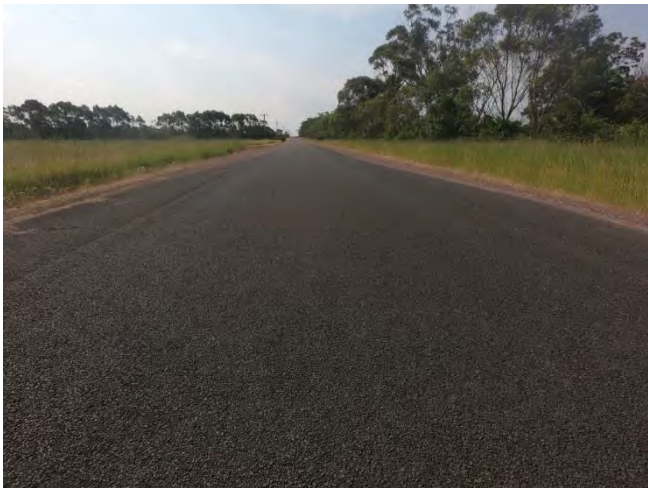
Keilambete Rd - CH 4.52

Seal narrows at end of curve

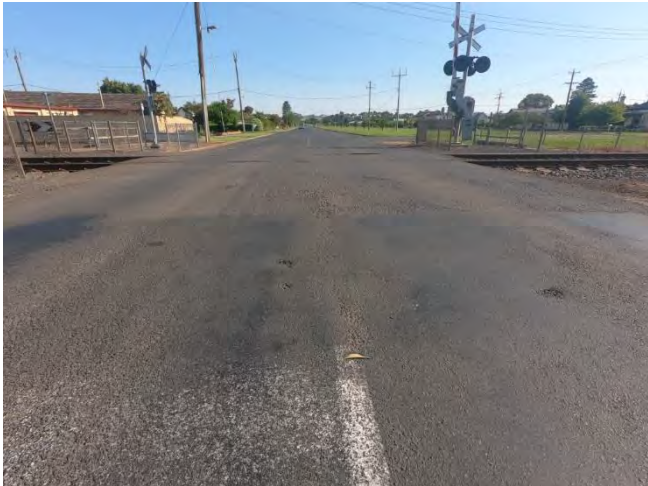
Terang – Mortlake Rd - CH 0.393

General view of railway crossing, crocodile cracking both sides

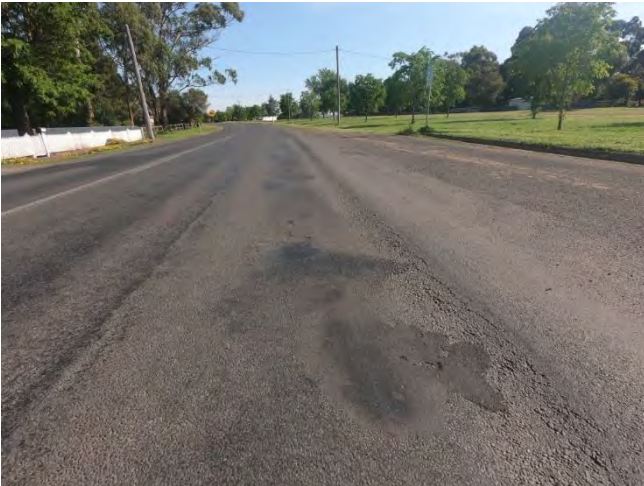
Terang – Mortlake Rd - CH 1.017

Rutting, shoving and filled potholes breaking out in south bound lane

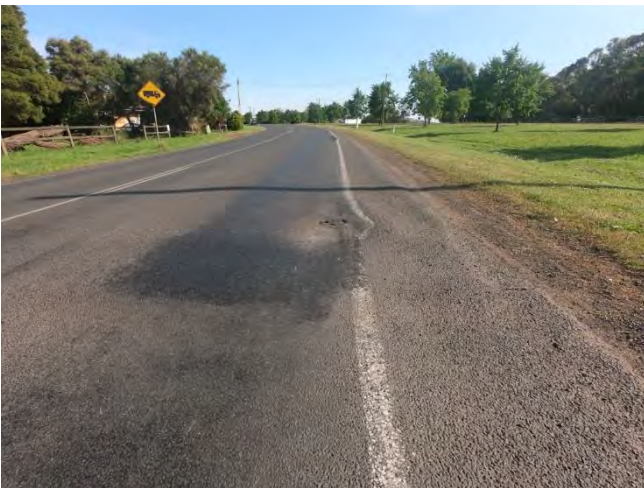
Terang – Mortlake Rd - CH 1.059

Shoving, seal breaking out, and edge line tracking southbound lane

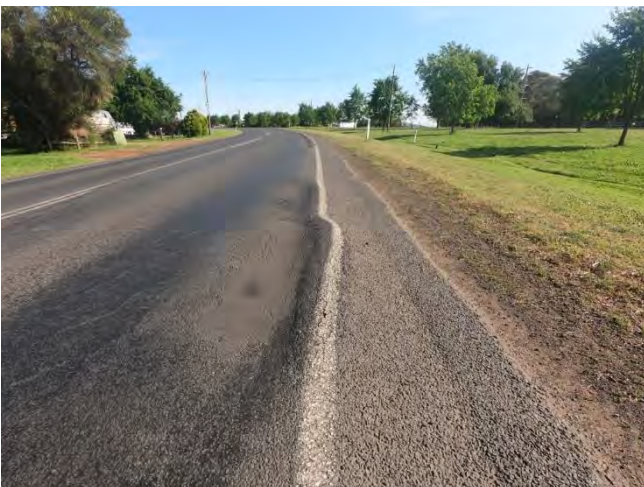
Terang – Mortlake Rd - CH 1.071

Shoving, seal breaking out, and edge line tracking southbound lane.

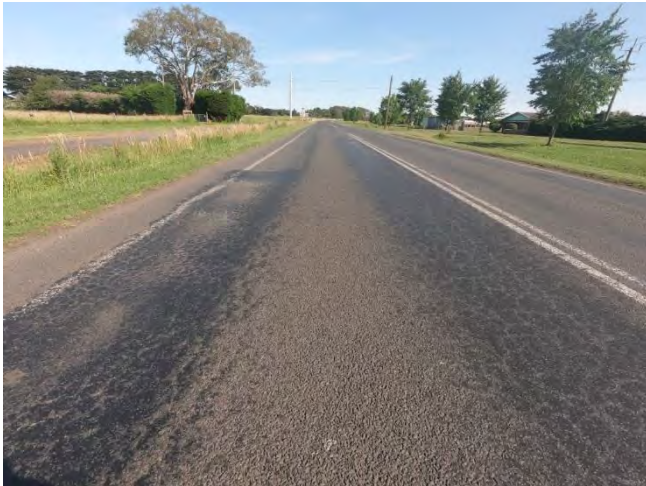
Terang – Mortlake Rd - CH 1.255

-
Crocodile cracking, rutting and flushing to north bound lane

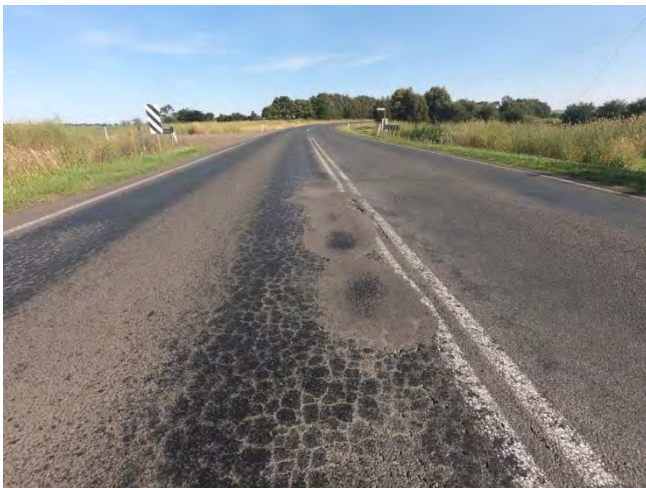
Terang – Mortlake Rd - CH 1.442

-
Crocodile cracking, rutting, flushing and seal breaking out, north bound lane.

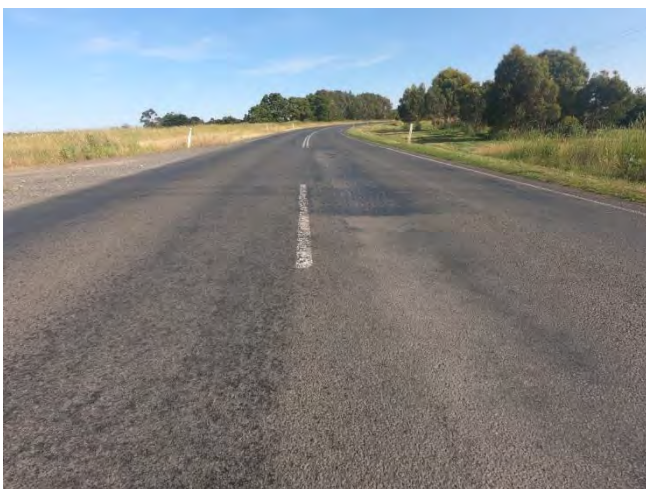
Terang – Mortlake Rd - CH 1.469

-
General view at intersection by Riley Road with crocodile cracking, rutting, flushing and filled potholes in south bound lane

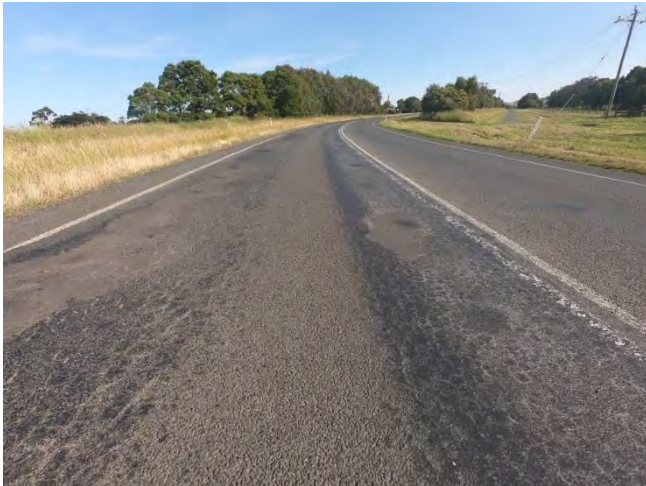
Terang – Mortlake Rd - CH 1.525

Crocodile cracking, rutting, shoving, flushing, filled potholes and seal breaking out to north bound lane.

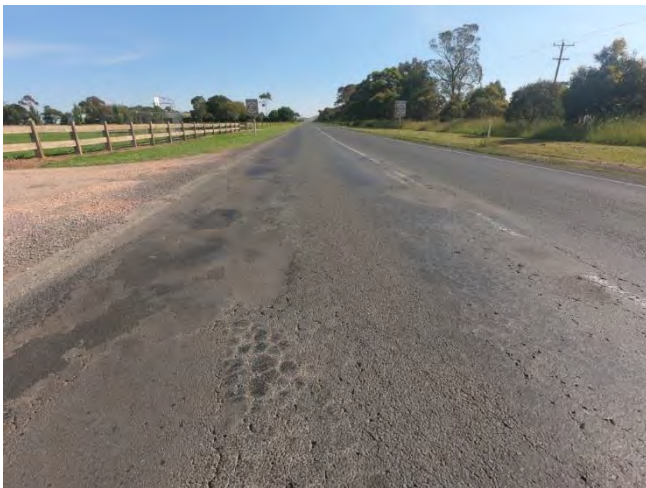
Terang – Mortlake Rd - CH 1.688

Crocodile cracking, rutting, shoving, flushing, filled potholes and seal breaking out to north bound lane.

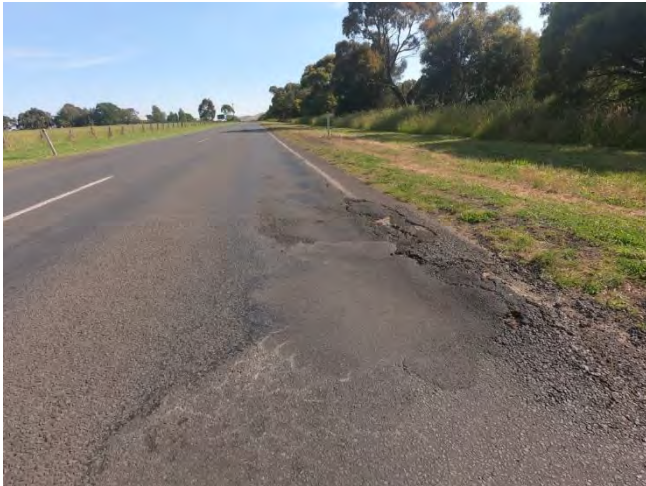
Terang – Mortlake Rd - CH 1.911

Shoving, rutting, filled potholes and seal breaking out in both lanes.

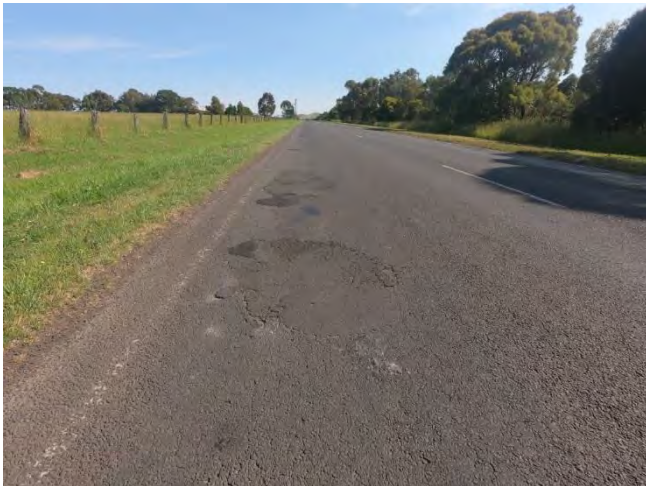
Terang – Mortlake Rd - CH 1.935

General view of pavement with flushing, crocodile cracking, rutting, filled potholes and seal breaking out.

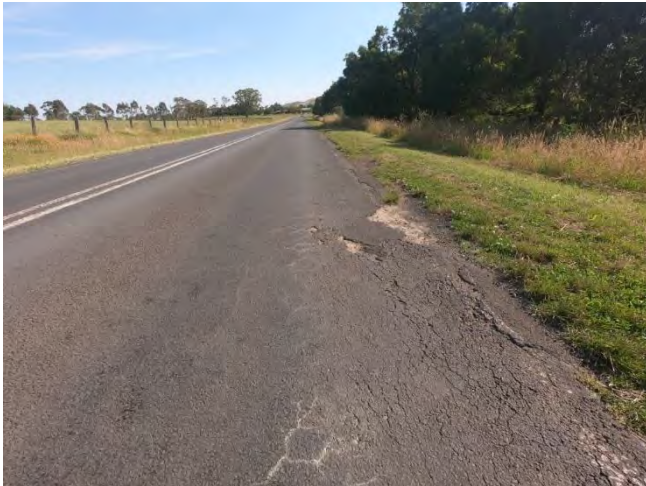
Terang – Mortlake Rd - CH 2.378

Edge of seal breaking out, crocodile cracking and flushing to south bound lane

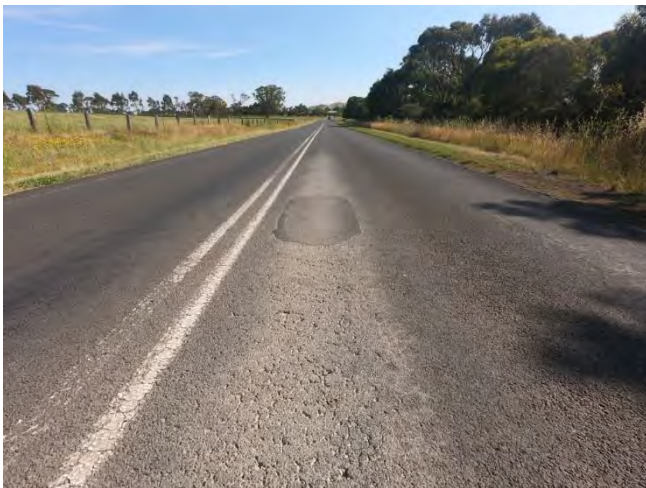
Terang – Mortlake Rd - CH 2.406

Patched pothole with crocodile cracking and minor rutting, south bound lane

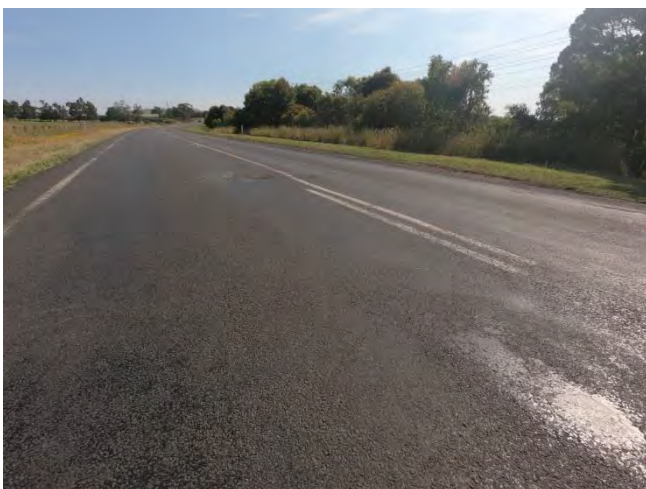
Terang – Mortlake Rd - CH 2.57 - 2.632

Rutting, flushing, shoving, crocodile cracking, filled potholes and seal breaking out to both lanes.

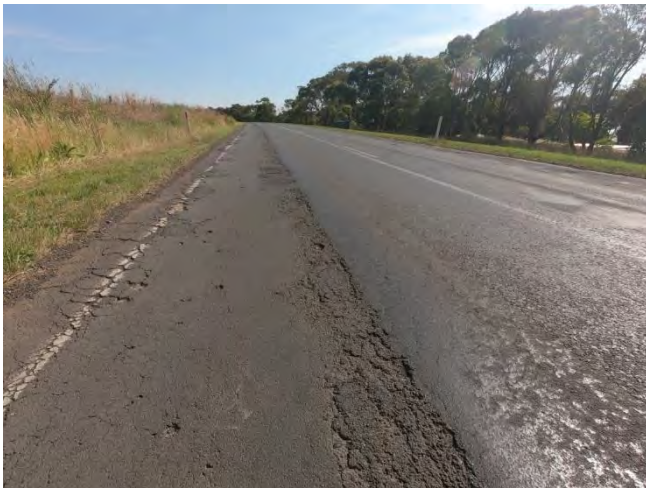
Terang – Mortlake Rd - CH 2.945

Rutting, flushing, shoving, crocodile cracking filled potholes and seal breaking out both lanes.

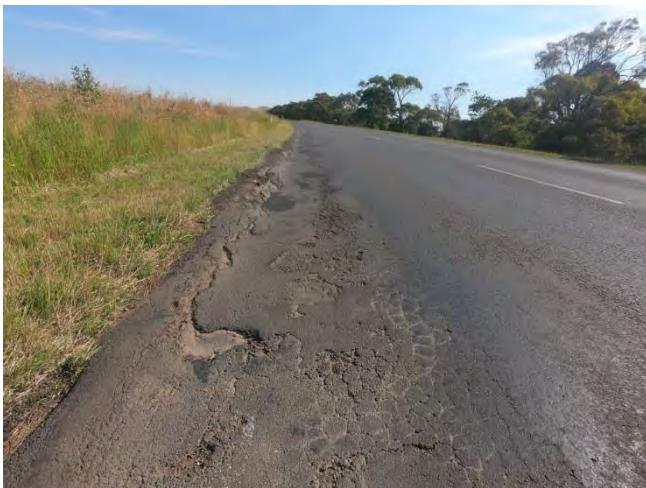
Terang – Mortlake Rd - CH 3.051

Rutting, flushing, shoving, crocodile cracking filled potholes and seal breaking out north bound lane.

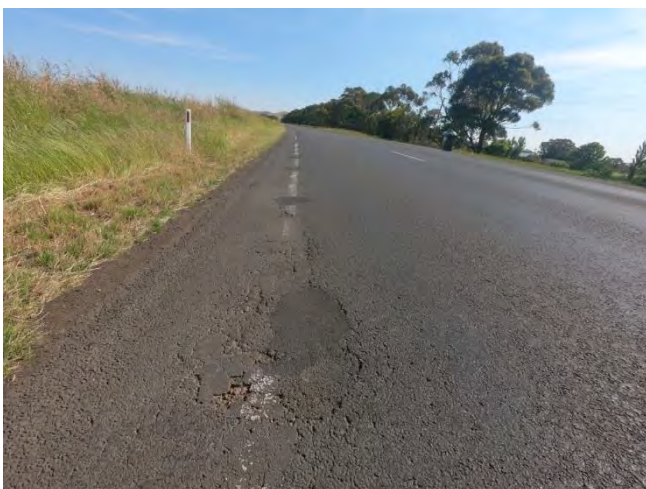
Terang – Mortlake Rd - CH 3.107 - 3.231

Filled potholes, flushing and seal breaking out north bound lane.

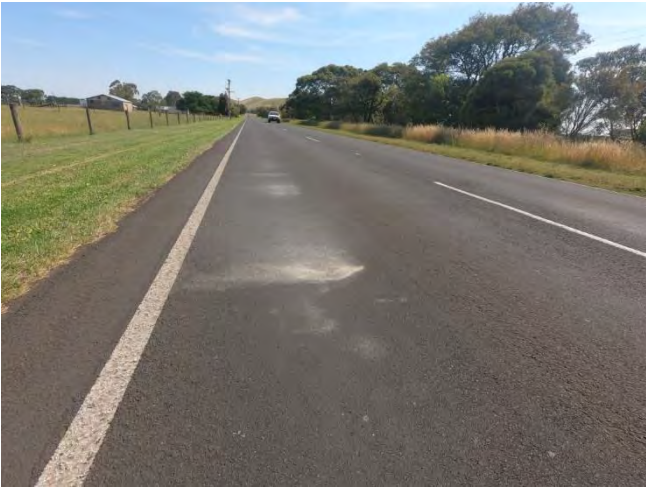
Terang – Mortlake Rd - CH 4.402

-
- Pumping of fines through small cracks in seal

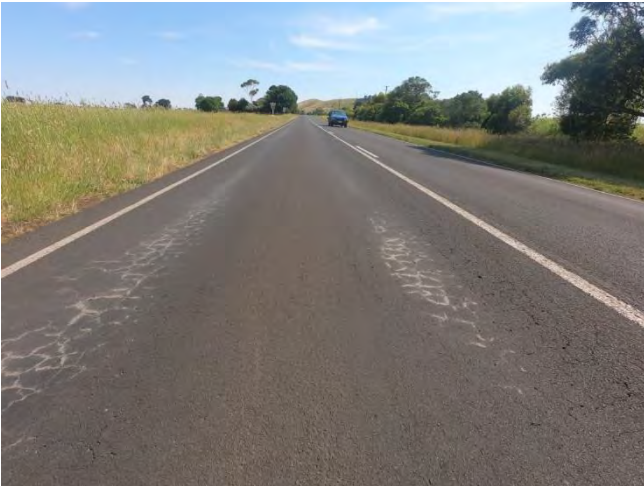
Terang – Mortlake Rd - CH 4.83

-
Crocodile cracking and pumping of fines prominent in north bound lane but some in south bound lane

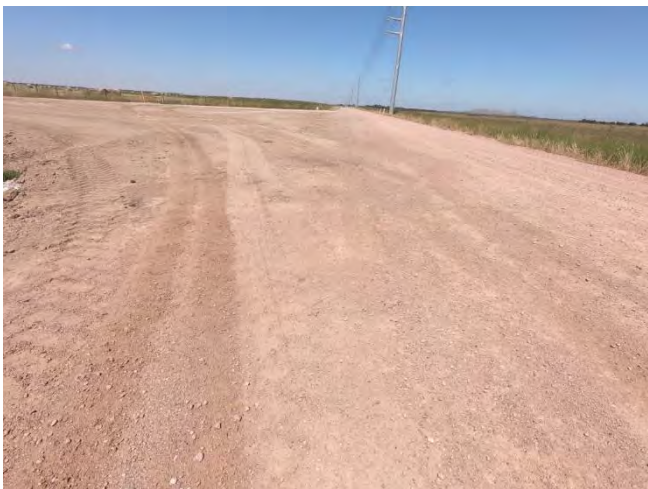
Grinters Lane - CH 1796

Some minor rutting and potholing at wind tower entry road

Location	Item	Finding	Recommendation	Priority
Tapps Lane CH 15, 268	Guide Posts	Guide posts broken, damaged or missing.	Reinstate guide posts	Moderate
Tapps Lane CH 298	Shoulder	Shove at turn into batching compound.	Repair shoulder	Moderate
Tapps Lane CH 615	Road Surface	Loose gravel on surface.	Sweep sealed surface.	Low
Chamallak Lane CH 1950	Shoulder	Rutting in shoulder from errant truck.	Grade shoulder.	Low
Grinters Lane at Tower Entry Roads	Pavement	Potholes at rutting at tower entrance roads.	Grade when problematic.	Low

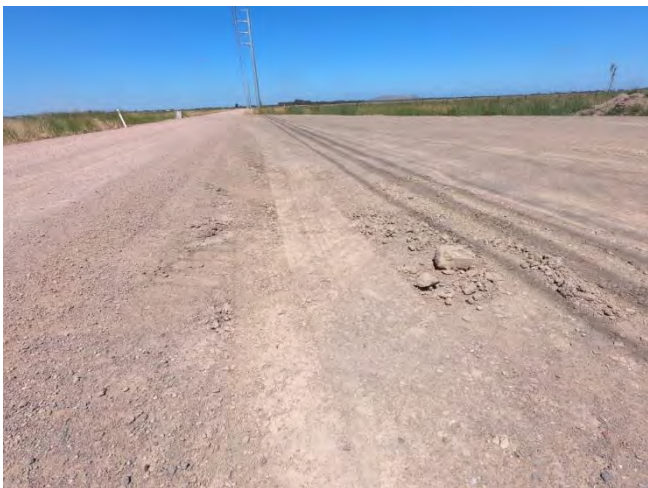
Grinters Lane - CH 2300

Some minor rutting and potholing at wind tower entry road

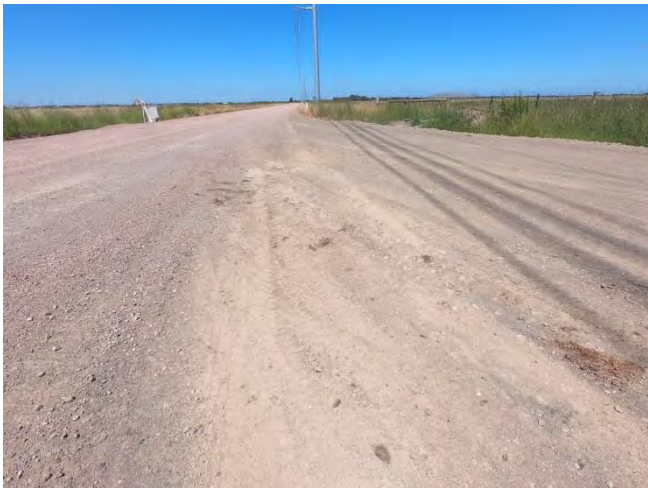
Grinters Lane - CH 2320

Some minor rutting and potholing at wind tower entry road

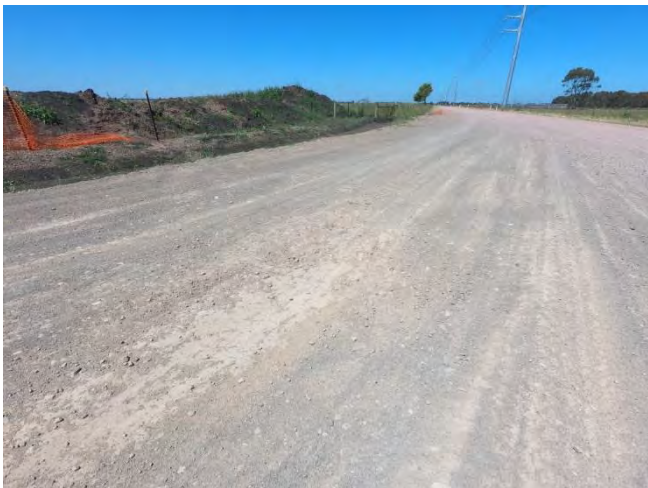
Grinters Lane - CH 2997

Some minor rutting and potholing at wind tower entry road

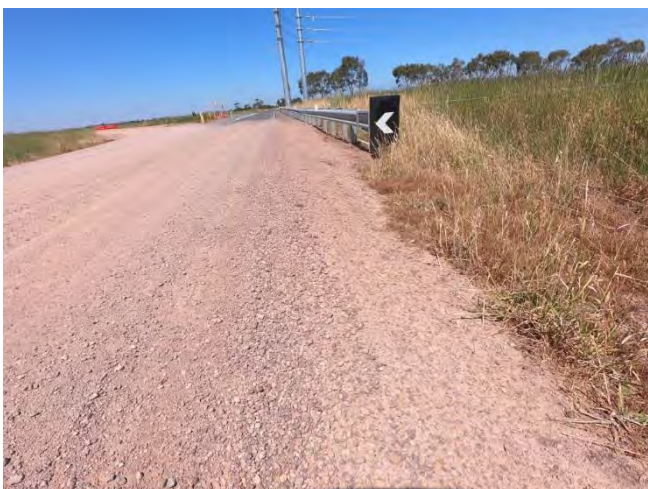
Grinters Lane - CH 3880

Chevron sign replaced on guard rail terminal

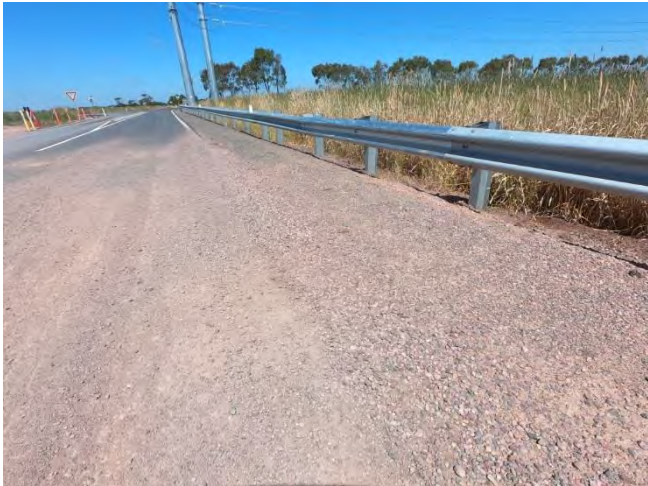
Grinters Lane - CH 3895

Section of damaged guard rail has been replaced.

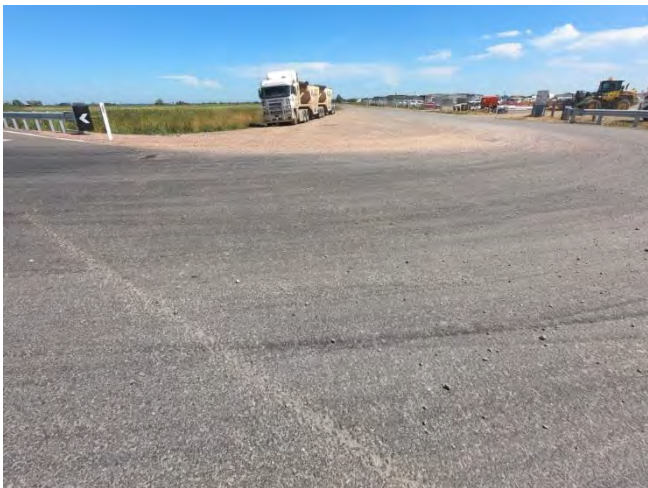
Tapps Lane - CH 15

Three guide posts missing at intersection with Terang-Mortlake Rd

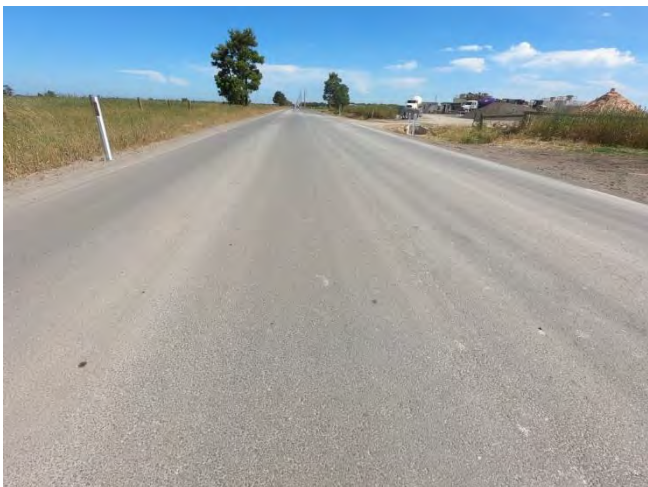
Tapps Lane - CH 268

Guide post missing on west side and line marking faded.

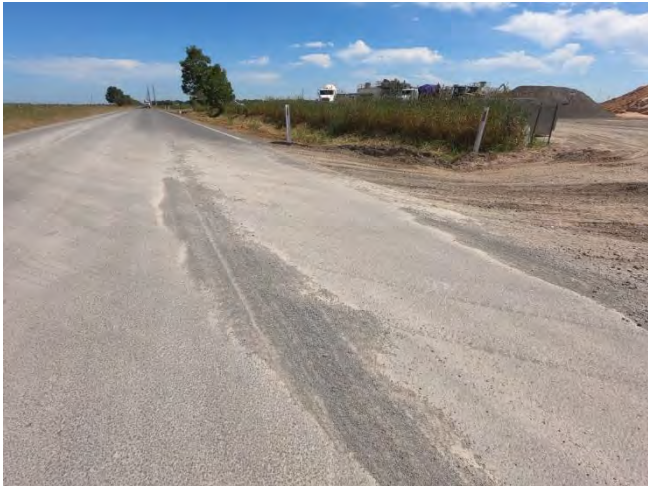
Tapps Lane - CH 298

Shoulder shove through turn into materials compound

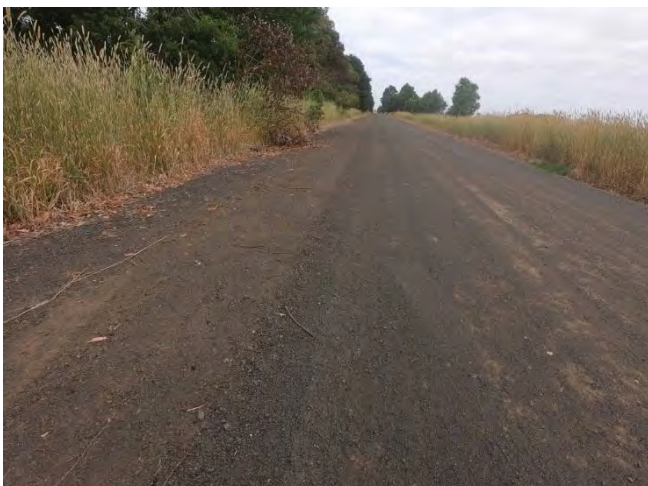
Riley Road - CH 0.110

Tree branch on shoulder.

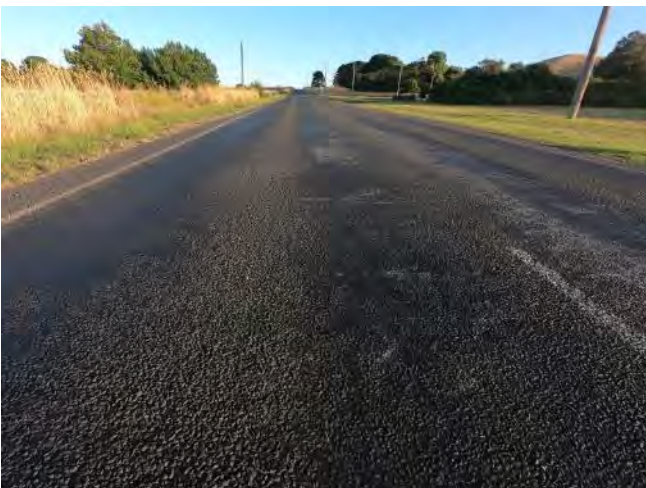
Terang-Mortlake Road - CH 5.993

Edge shove and crocodile cracking through all wheel paths

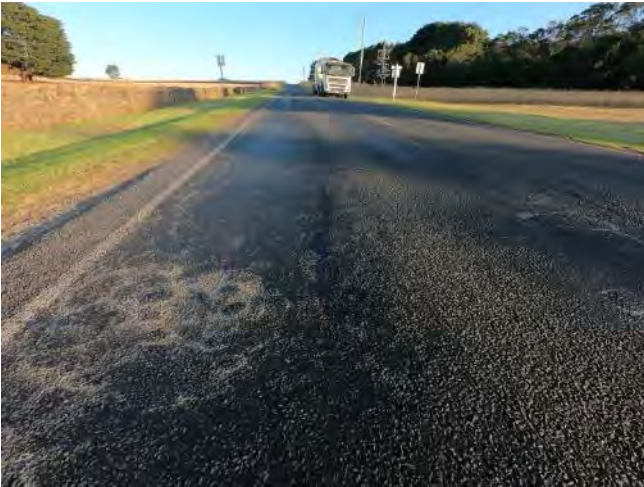
Terang-Mortlake Road - CH 6.095

Rutting and crocodile cracking. Seal flush.

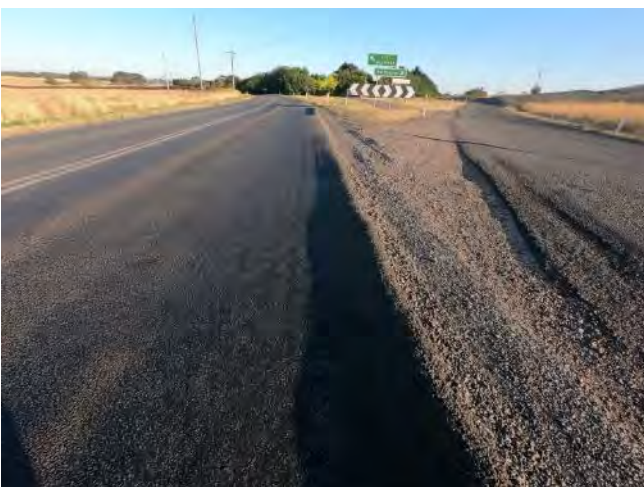
Typical view of crocodile cracking through segment.

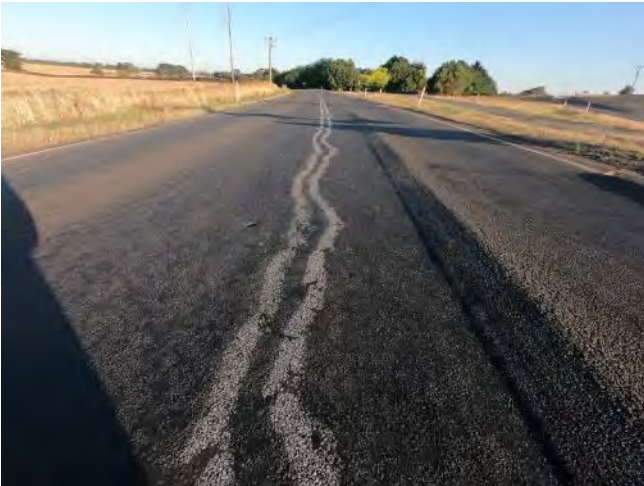
Photo 6 'GOPR7845.JPG' - (-38.1747, 142.92093)

Shoving, rutting and edge line tracking.

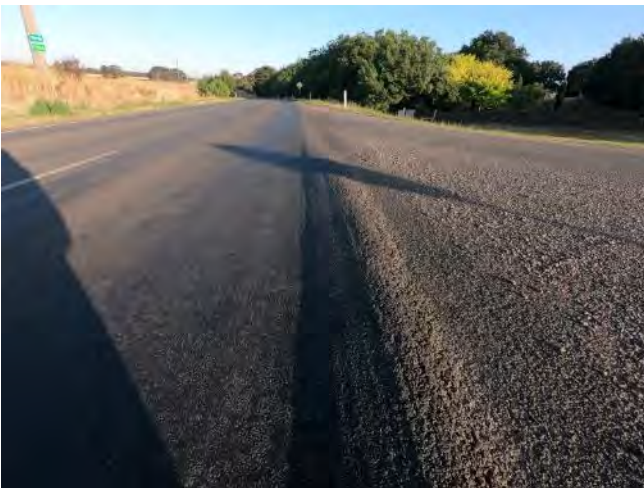
Photo 7 'GOPR7846.JPG' - (-38.17457, 142.92083)

Centre line tracking

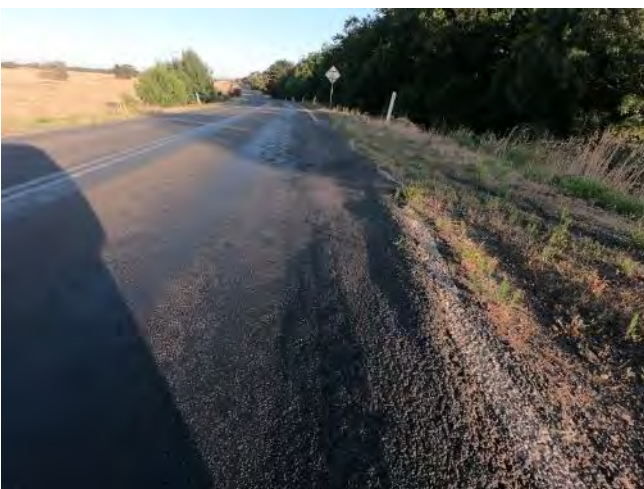
Photo 8 'GOPR7847.JPG' - (-38.17393, 142.92037)

Shove at intersection

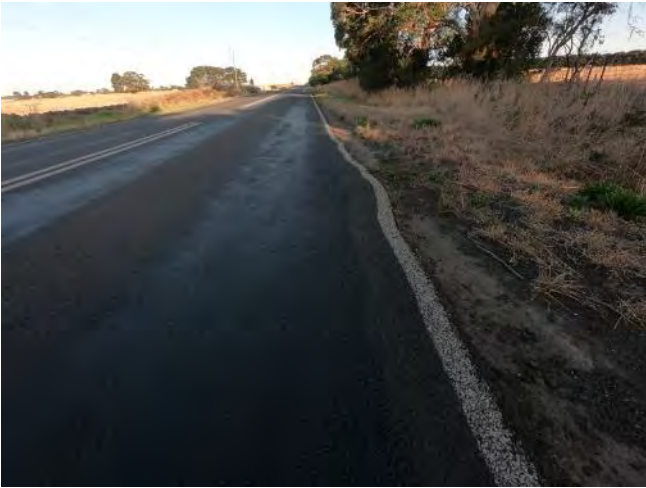
Photo 9 'GOPR7848.JPG' - (-38.1737, 142.92018)

Flushing, shoving, edge line tracking, rutting and seal breaking out south bound lane

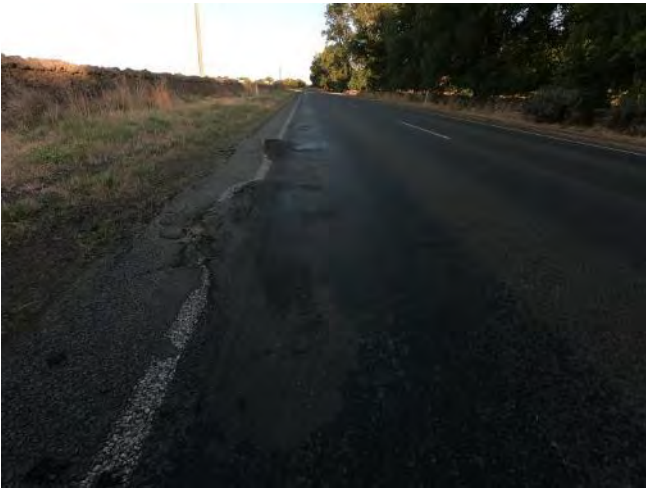
Photo 10 'GOPR7849.JPG' - (-38.17256, 142.9187)

Flushing, shoving and edge line tracking south bound lane

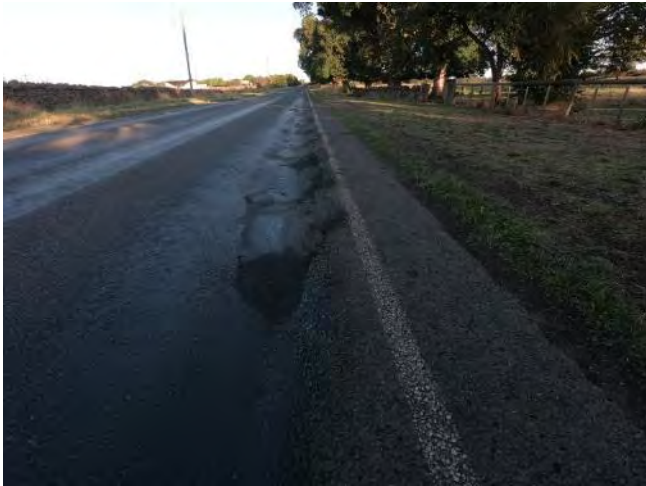
Potholes patched but shoving out, crocodile cracking north bound lane
