Mortlake South Wind Farm Transmission Line

Traffic Management Plan

Final Report Version 3

18 February 2020

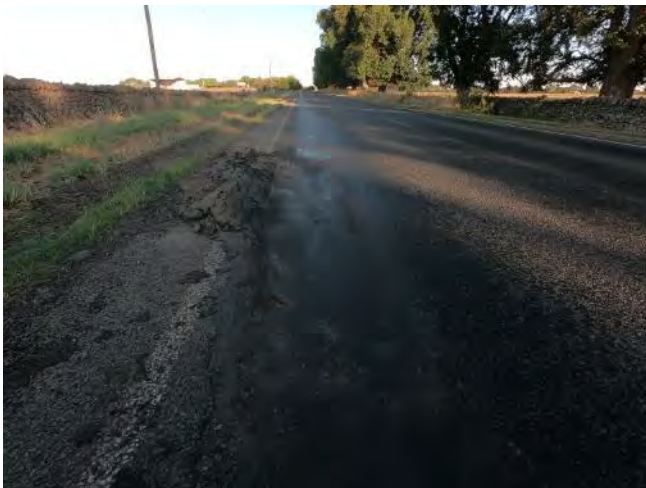
Photo 13 'GOPR7852.JPG' - (-38.15687, 142.89601)

Rutting, shoving and seal breaking out south bound lane

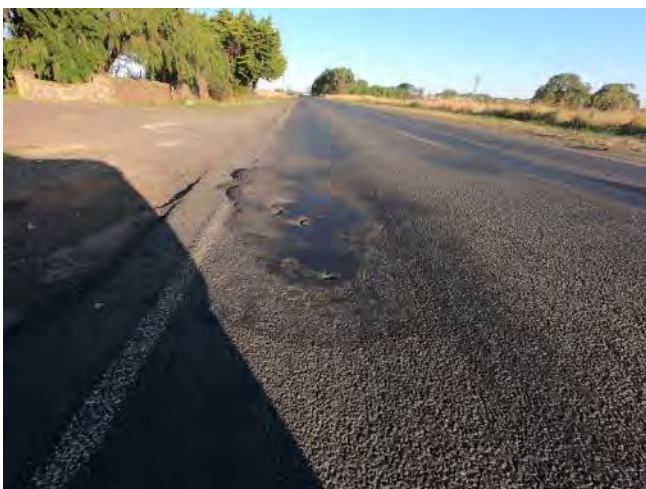
Photo 14 'GOPR7853.JPG' - (-38.15676, 142.89573)

Potholes patched but shoving out, crocodile cracking north bound lane

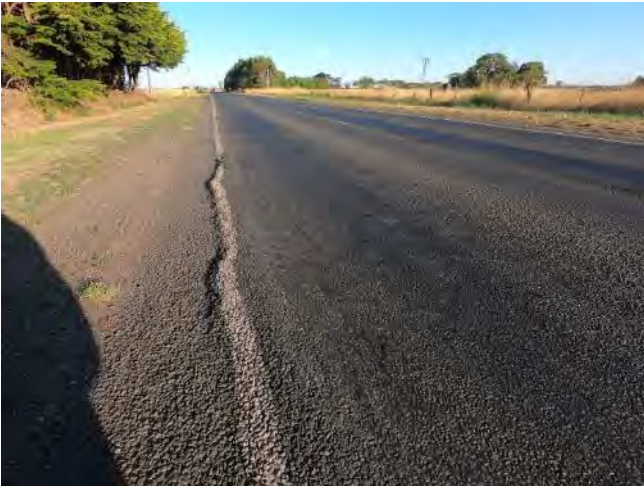
Photo 15 'GOPR7854.JPG' - (-38.15256, 142.88999)

Potholes patched but shoving out, crocodile cracking north bound lane

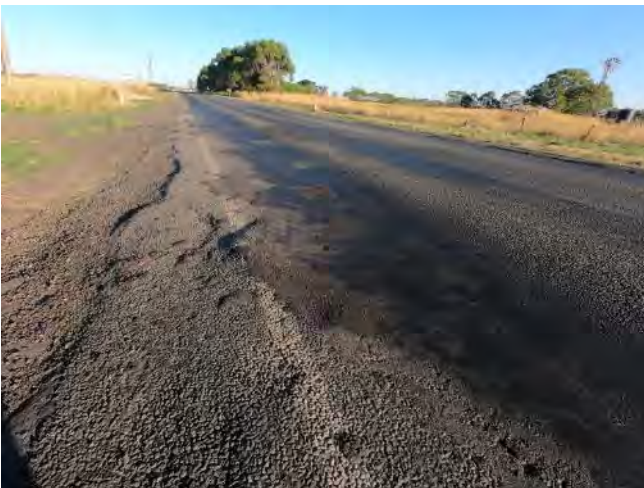
Photo 16 'GOPR7855.JPG' - (-38.15243, 142.8898)

Rutting, shoving, edge line tracking and seal breaking out

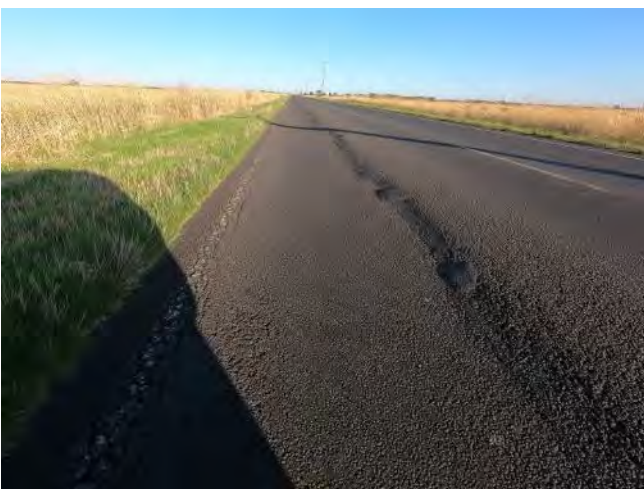
Photo 17 'GOPR7856.JPG' - (-38.15213, 142.88939)

Terang-Mortlake Road is showing signs of distress with large areas of crocodile cracking pavement failures, shoving and seal stripping. Damage is becoming extensive in some segments and it appears as though minimal maintenance has been performed on this road other than the occasional pothole filling. A large failed section at CH 11.27km is particularly prominent and heavy rutting is a concern through chainages 12.52 to 12.80.

Major pavement failure full width with rutting, flushing, large areas of seal breaking out and shoving

In general, repairs should be performed to many sections of both roads to improve conditions. Several asphalt overlays conducted recently have started to fail, indicating that this treatment method is inadequate and reconstruction of the pavement in failed areas is necessary for a mid to long term solution.

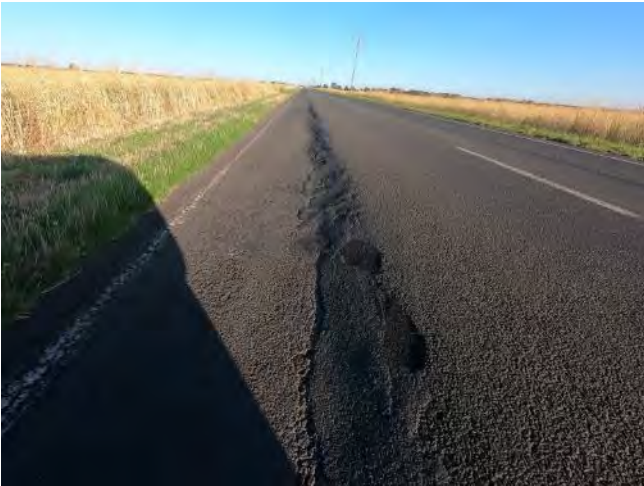
Photo 18 'GOPR7857.JPG' - (-38.14428, 142.87907)

Typical view of heavy rutting in north bound lane.

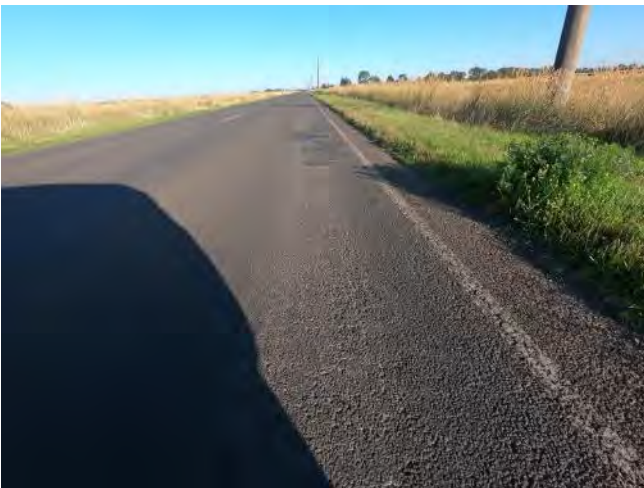
Photo 19 'GOPR7858.JPG' - (-38.14391, 142.87859)

Typical view of heavy rutting in north bound lane.

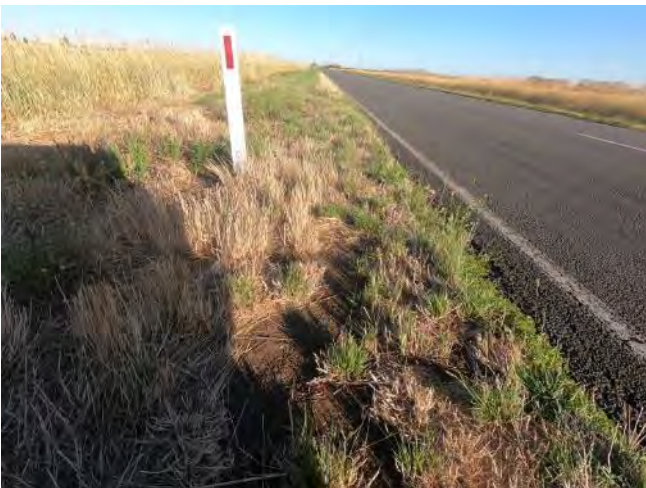
Photo 22 'GOPR7861.JPG' - (-38.13485, 142.86679)

Guide post damaged SW side of road

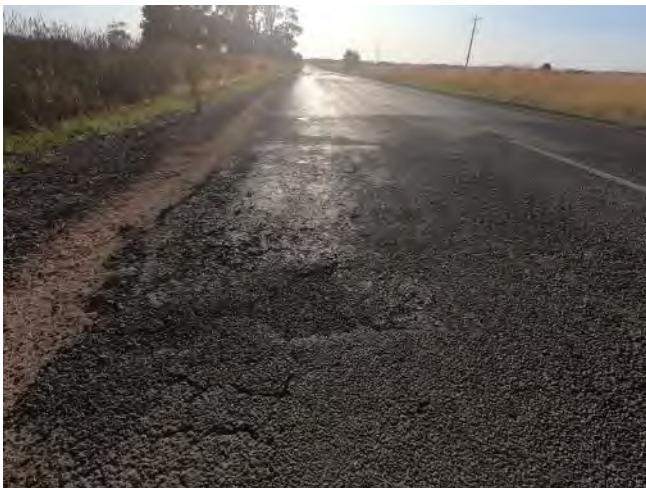
Photo 25 'GOPR7864.JPG' - (-38.1934, 142.817)

Crocodile cracking and edge of seal breaking out at quarry entrance

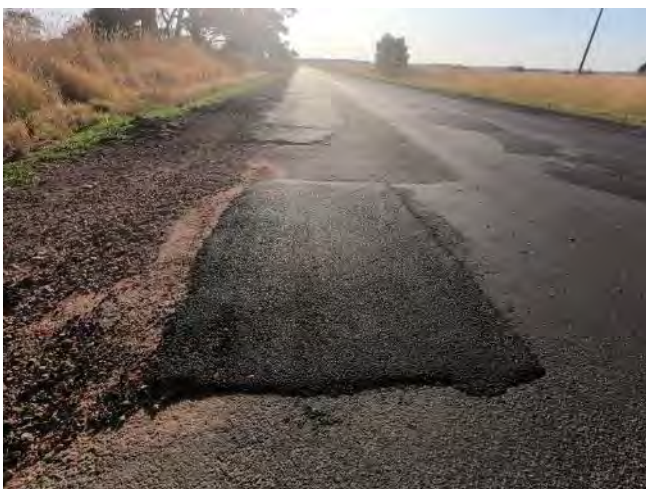
Photo 26 'GOPR7865.JPG' - (-38.19475, 142.82686)

Patch breaking out and shoving

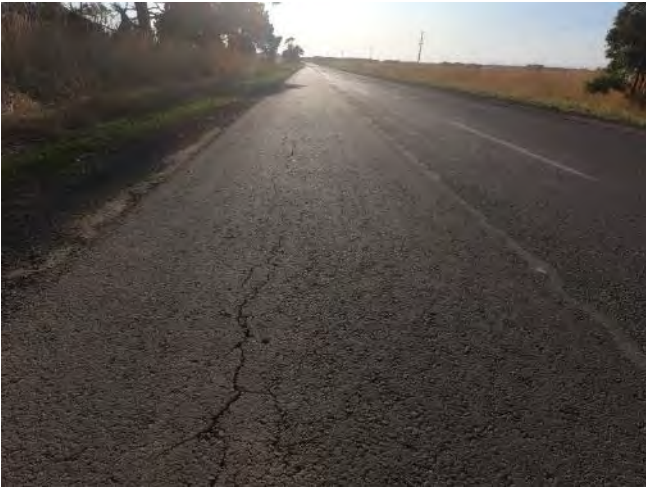
Photo 27 'GOPR7866.JPG' - (-38.19482, 142.82739)

Patching completed. Spoil left on shoulder.

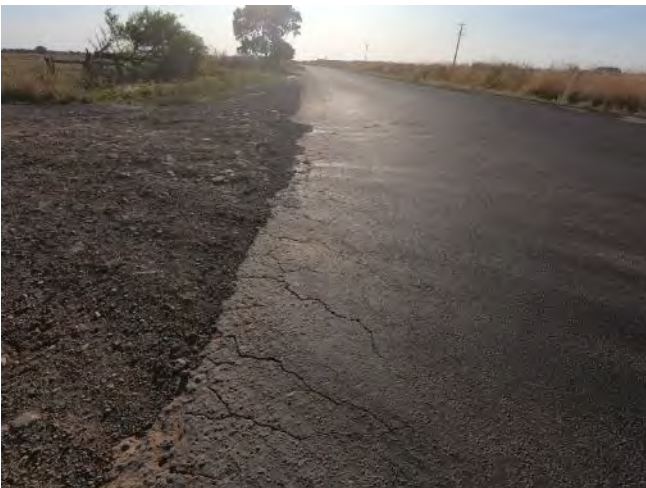
Photo 28 'GOPR7867.JPG' - (-38.19489, 142.82785)

Crocodile cracking through long heavy patch.

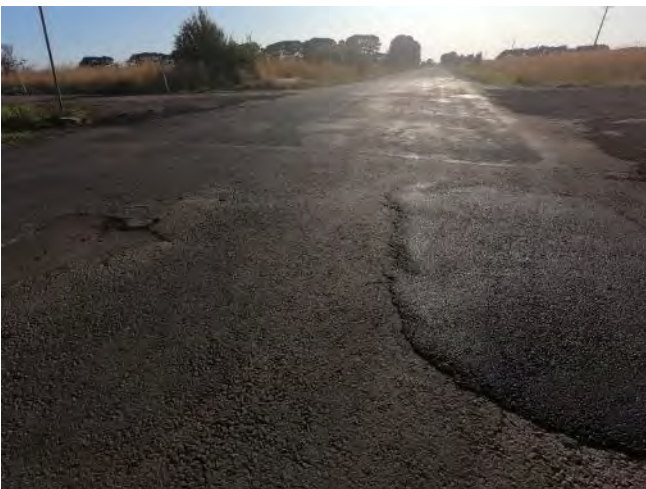
Photo 29 'GOPR7868.JPG' - (-38.19515, 142.82967)

Edge of seal breaking out and crocodile cracking at driveway.

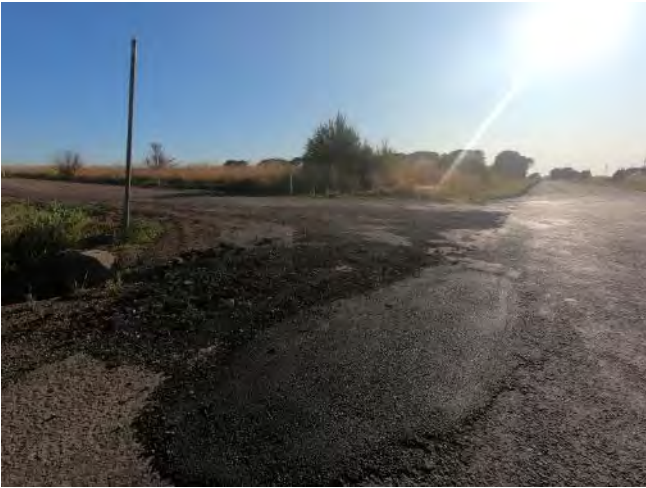
Photo 30 'GOPR7869.JPG' - (-38.19664, 142.84436)

Patch failure repaired. New area cracking and breaking up in crown.

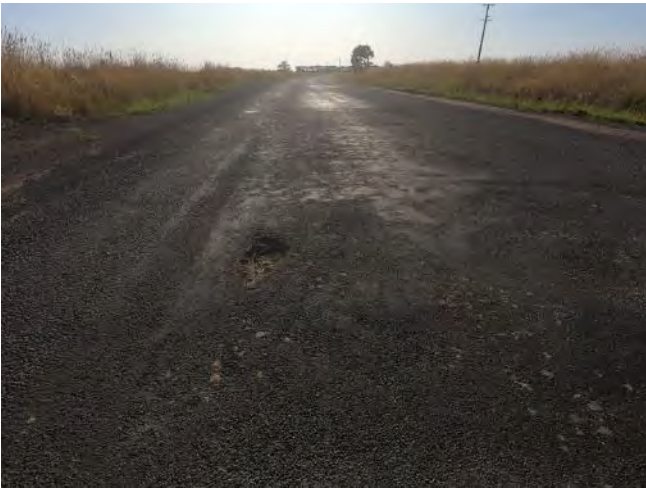
Photo 31 'GOPR7870.JPG' - (-38.19659, 142.84443)

Patched pothole, breaking out and shoving at intersection of Tapps Lane. Finger sign (road name sign) missing off pole.

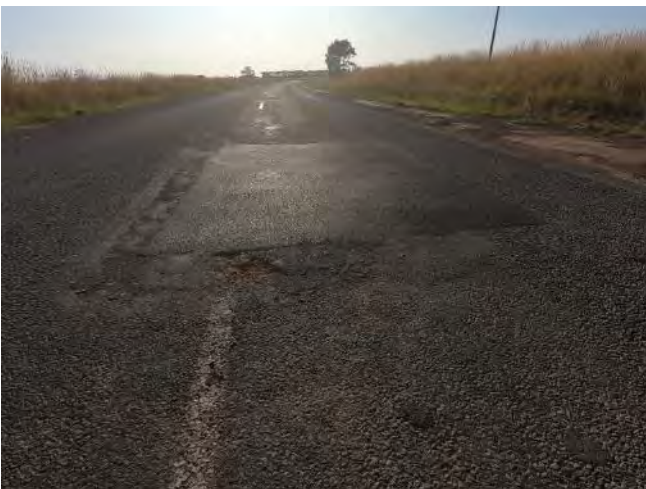
Photo 32 'GOPR7871.JPG' - (-38.19736, 142.85251)

Patch breaking open

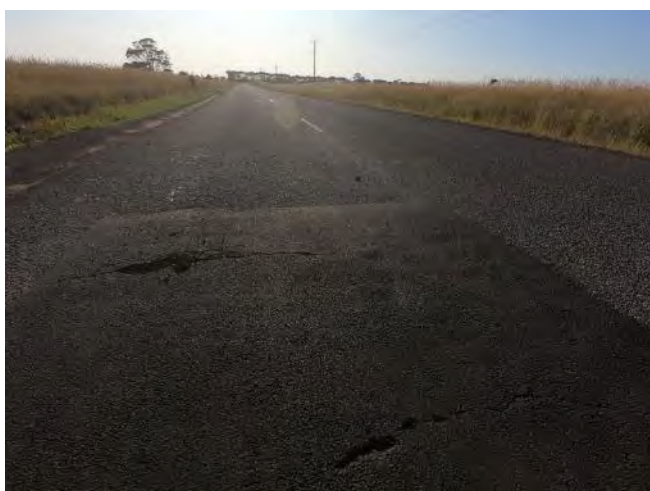
Photo 35 'GOPR7874.JPG' - (-38.19767, 142.85444)

Recent patch breaking open.

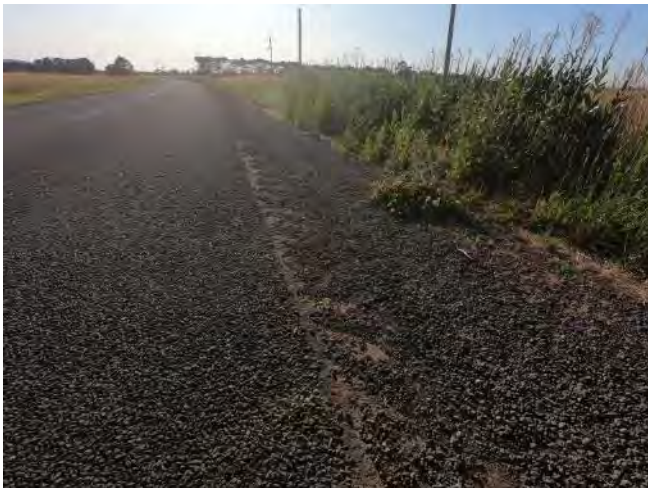
Photo 36 'GOPR7875.JPG' - (-38.19778, 142.85511)

Recent patches breaking out.

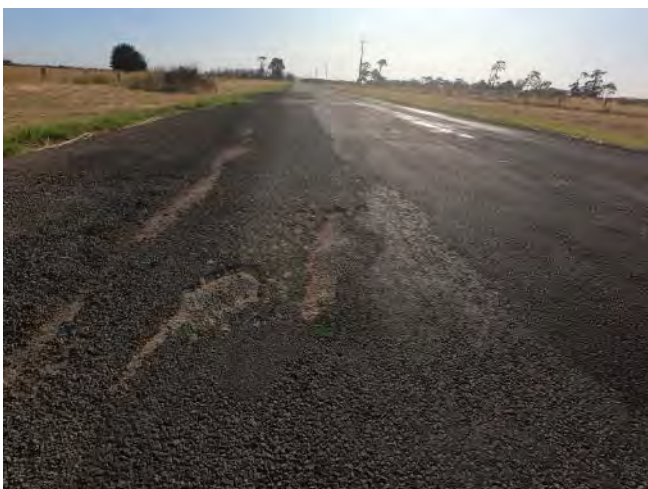
Photo 38 'GOPR7877.JPG' - (-38.19723, 142.86384)

Patch breaking open

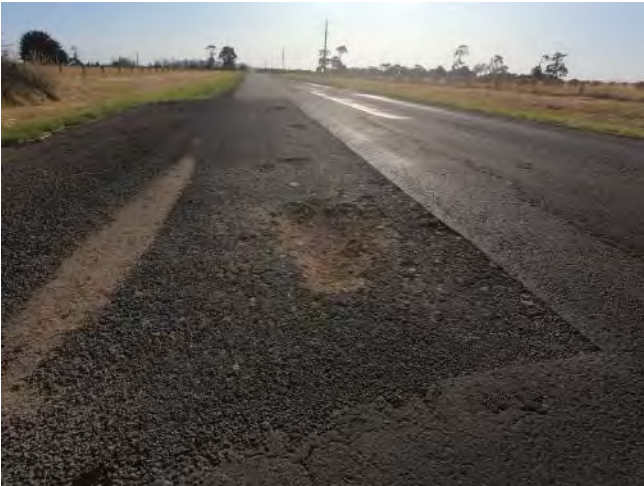
Photo 39 'GOPR7878.JPG' - (-38.19708, 142.86451)

Recent patches in pavement, large rectangular patches have very thin seal stripping off

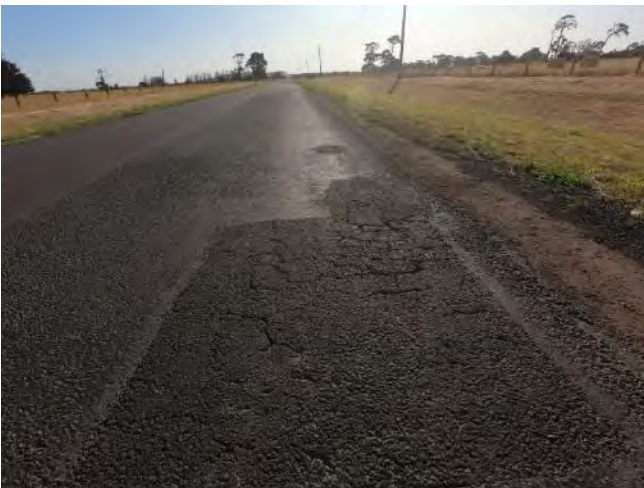
Photo 40 'GOPR7879.JPG' - (-38.19704, 142.86471)

Recent patches in pavement. Large rectangular patches have very thin seal stripping off and potholing.

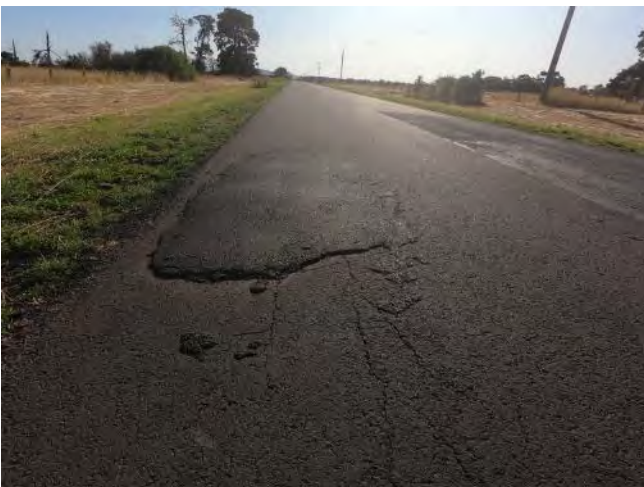
Photo 41 'GOPR7880.JPG' - (-38.19696, 142.86535)

Crocodile cracking and patch breaking up

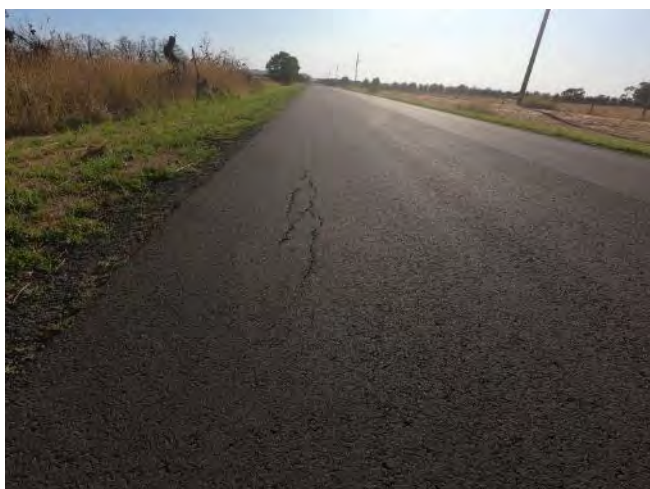
Photo 42 'GOPR7881.JPG' - (-38.19656, 142.8672)

Recent patch repair.

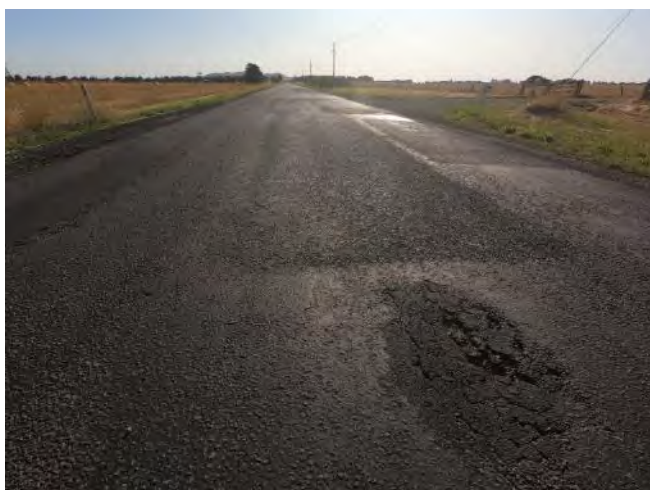
Photo 43 'GOPR7882.JPG' - (-38.19628, 142.86869)

Longitudinal cracking in major patch.

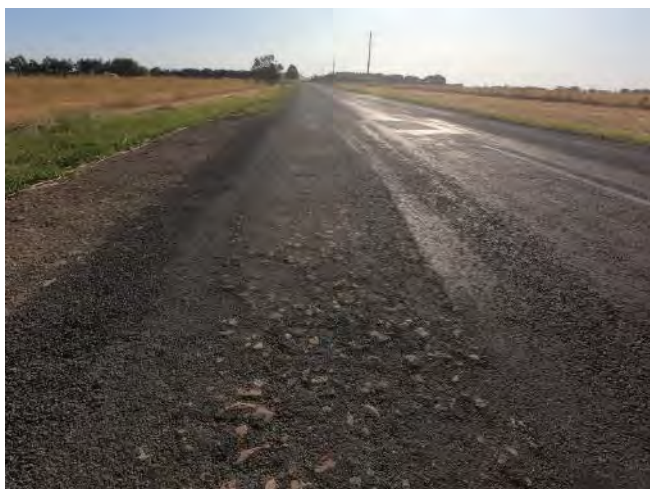
Photo 44 'GOPR7883.JPG' - (-38.19595, 142.87047)

Recent patches starting to break open.

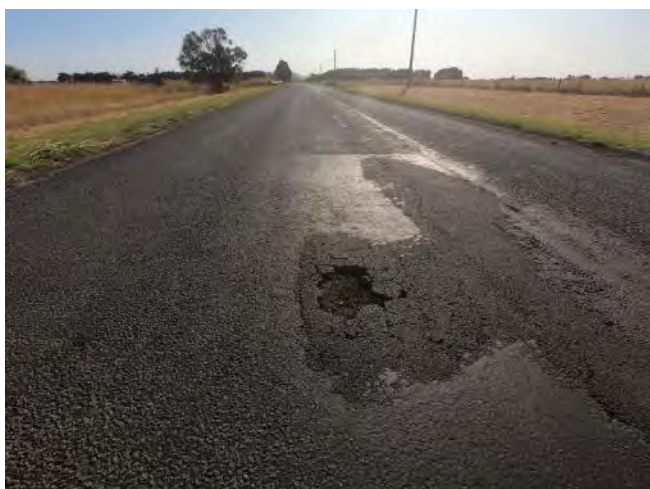
Photo 45 'GOPR7884.JPG' - (-38.19529, 142.87377)

Thin seal on patch stripping

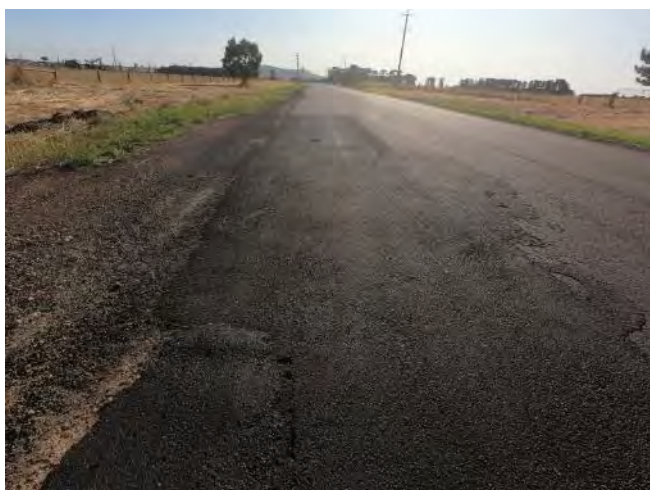
Photo 46 'GOPR7885.JPG' - (-38.19519, 142.87438)

Patch in crown reopening.

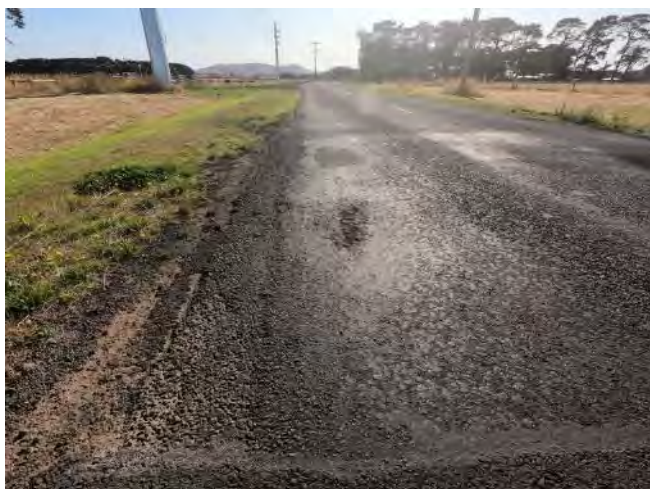
Sisters-Noorat Road - CH 9.128

Damaged guide posts both sides and seal stripping

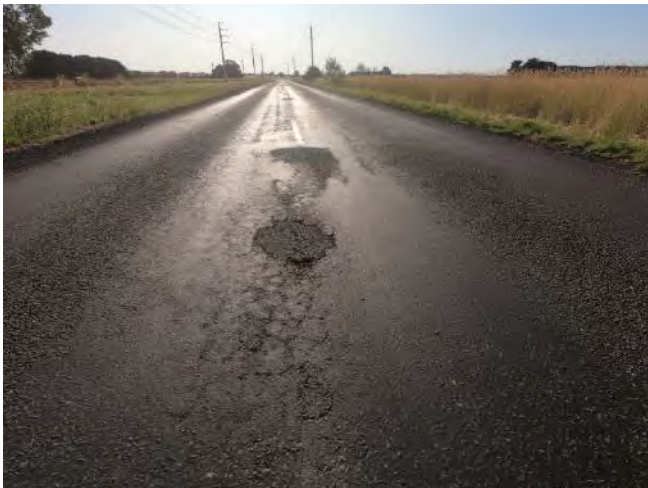
Sisters-Noorat Road - CH 10.150

Recent patch breaking out.

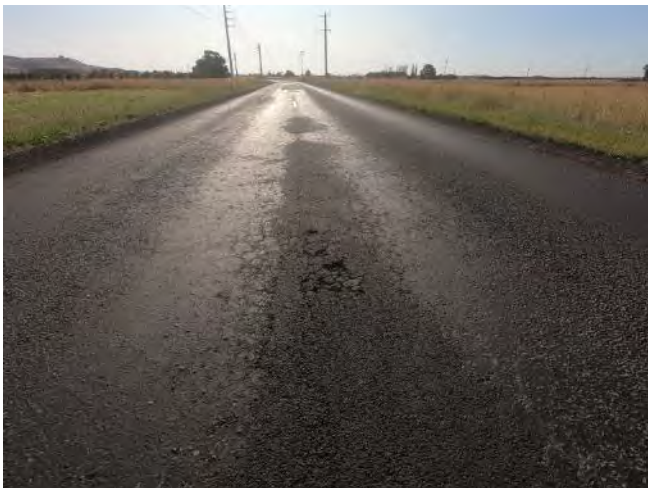
Sisters-Noorat Road - CH 10.296

Recent patches breaking out in crown.

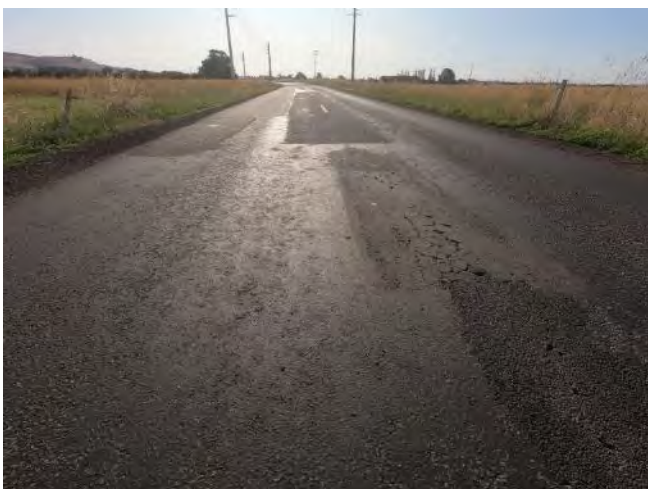
Sisters-Noorat Road - CH 10.324

Crocodile cracking around recent patches.

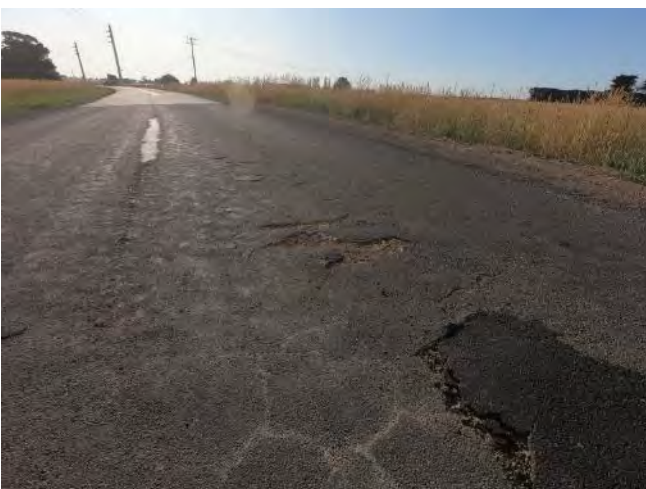
Sisters-Noorat Road - CH 10.387 – 10.409

Recent major patch stripping, some patching performed.

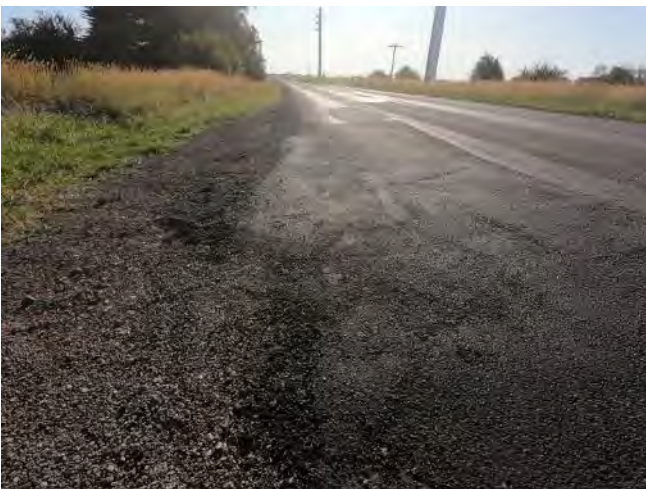
Sisters-Noorat Road - CH 10.555

Edge break out repaired.

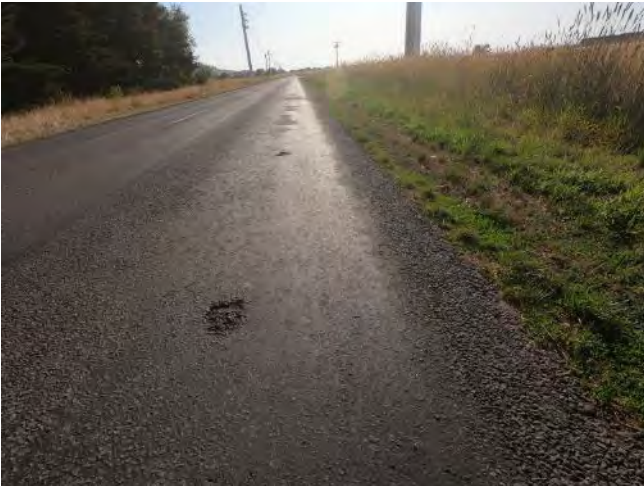
Sisters-Noorat Road - CH 10.660 – 10.680

Small patched potholes reopening on west bound side.

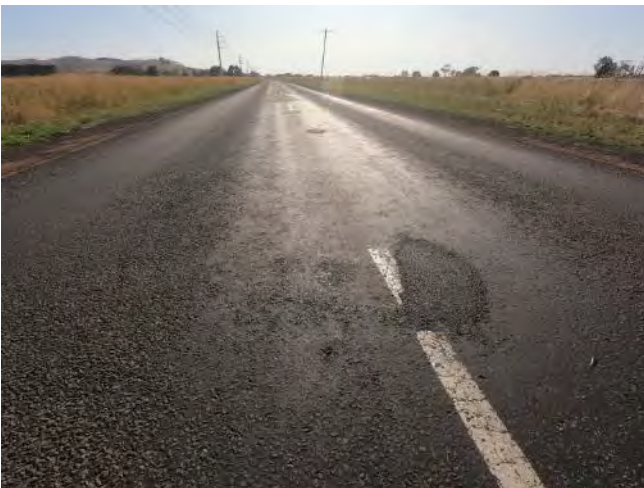
Sisters-Noorat Road - CH 10.970 – 11.037

Recent patches breaking out have been repaired.

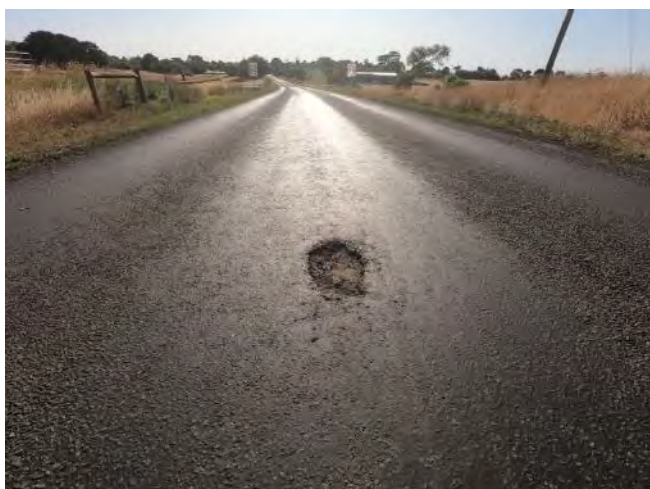
Sisters-Noorat Road - CH 12.702

Seal breaking out

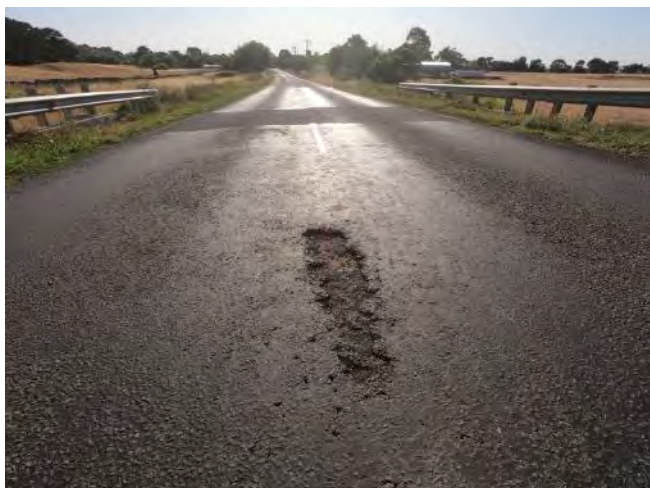
Sisters-Noorat Road - CH 12.753

Seal breaking out

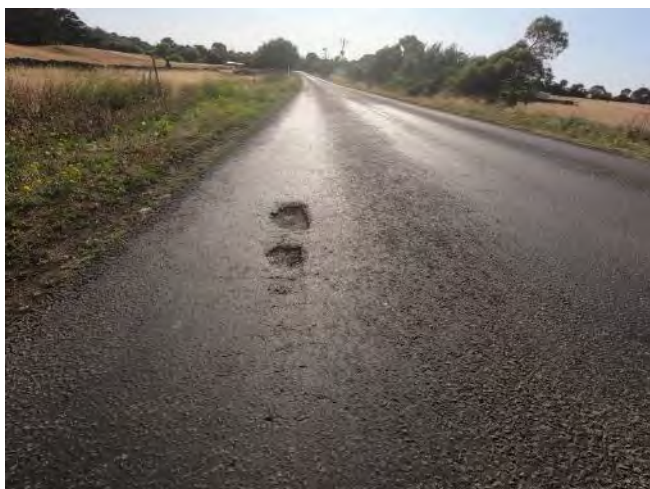
Sisters-Noorat Road - CH 12.772

Seal breaking out and crocodile cracking.

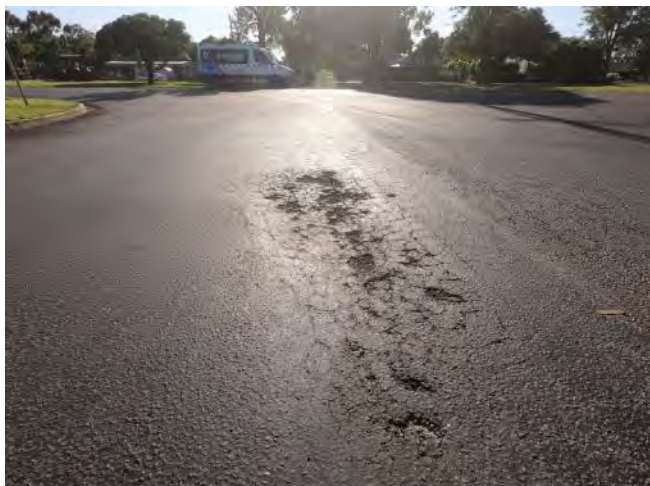
Sisters-Noorat Road - CH 13.107

Seal breaking out and crocodile cracking in lead up to intersection.
